**Subject:** RE: Emmanuel Church Croydon, gutters to west elevation  
**Date:** 2 May 2023 at 09:29  
**To:** Peter Chapman pjchapman@blueyonder.co.uk

I visited the church on Friday lunchtime, and the gutters generally look good.

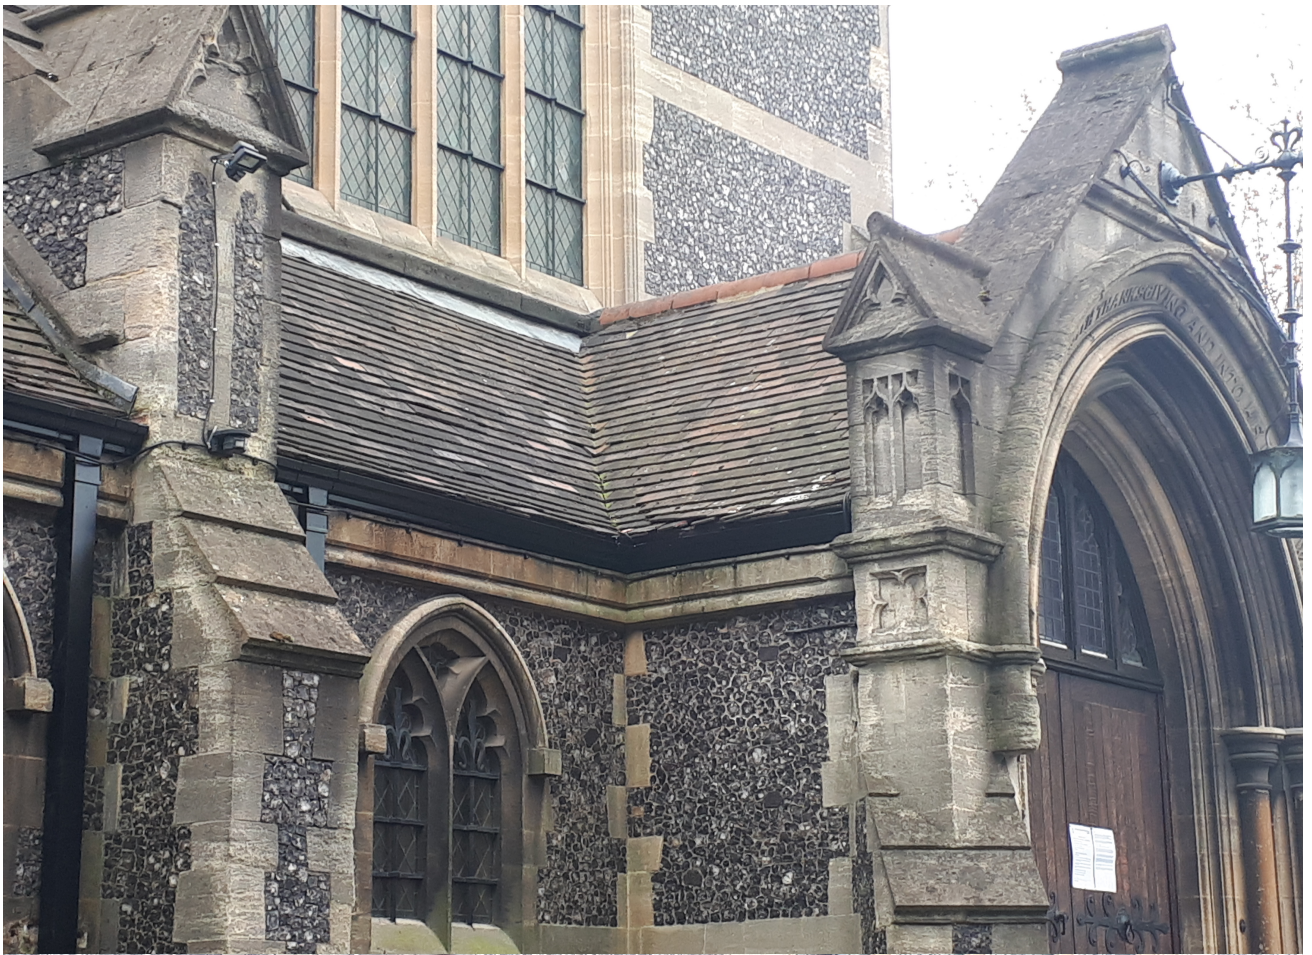
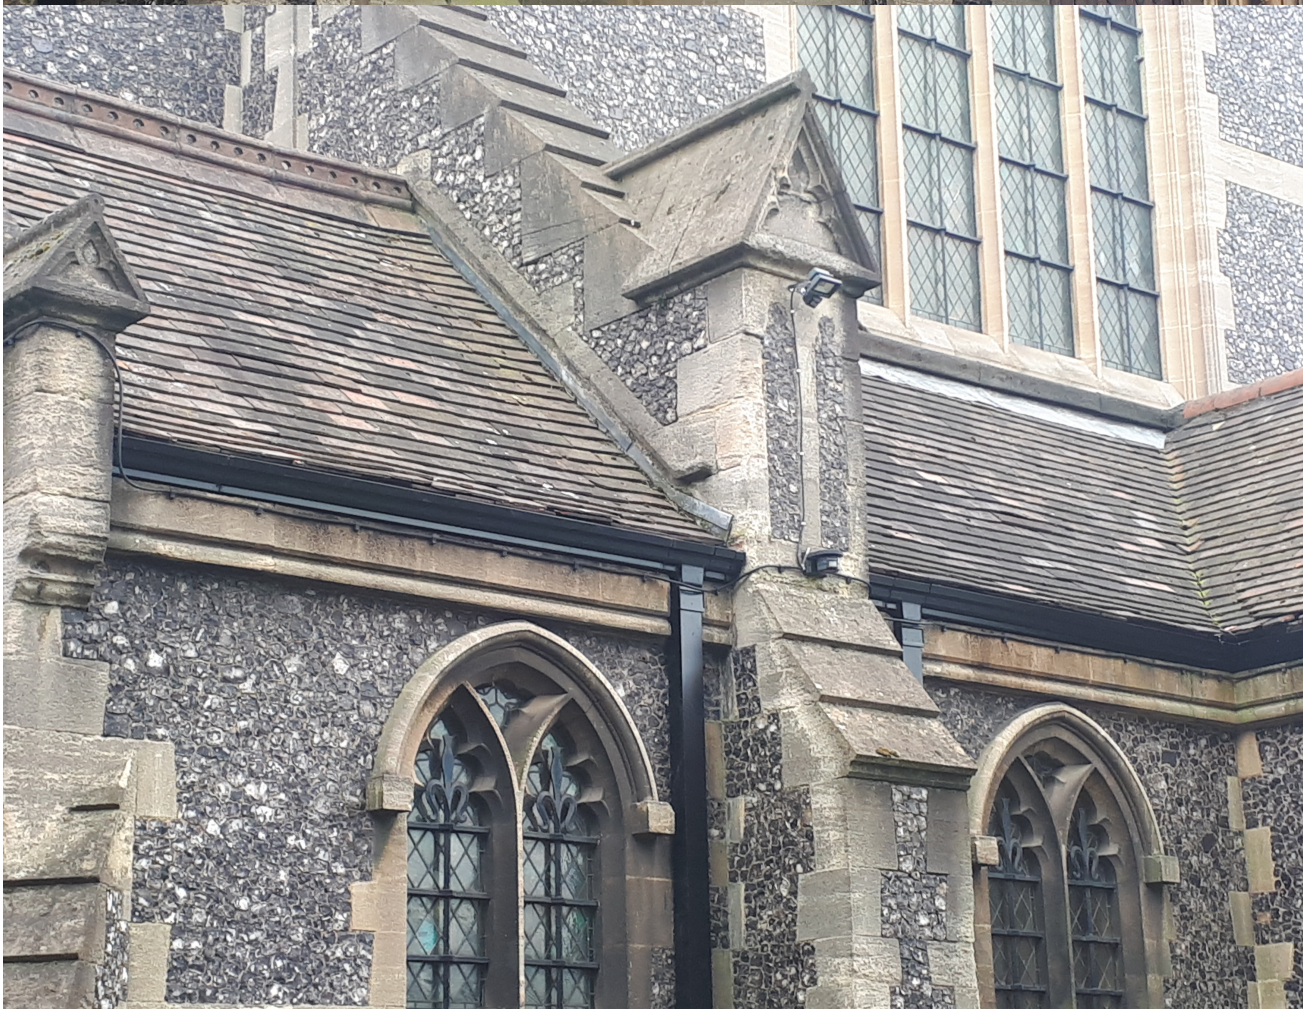
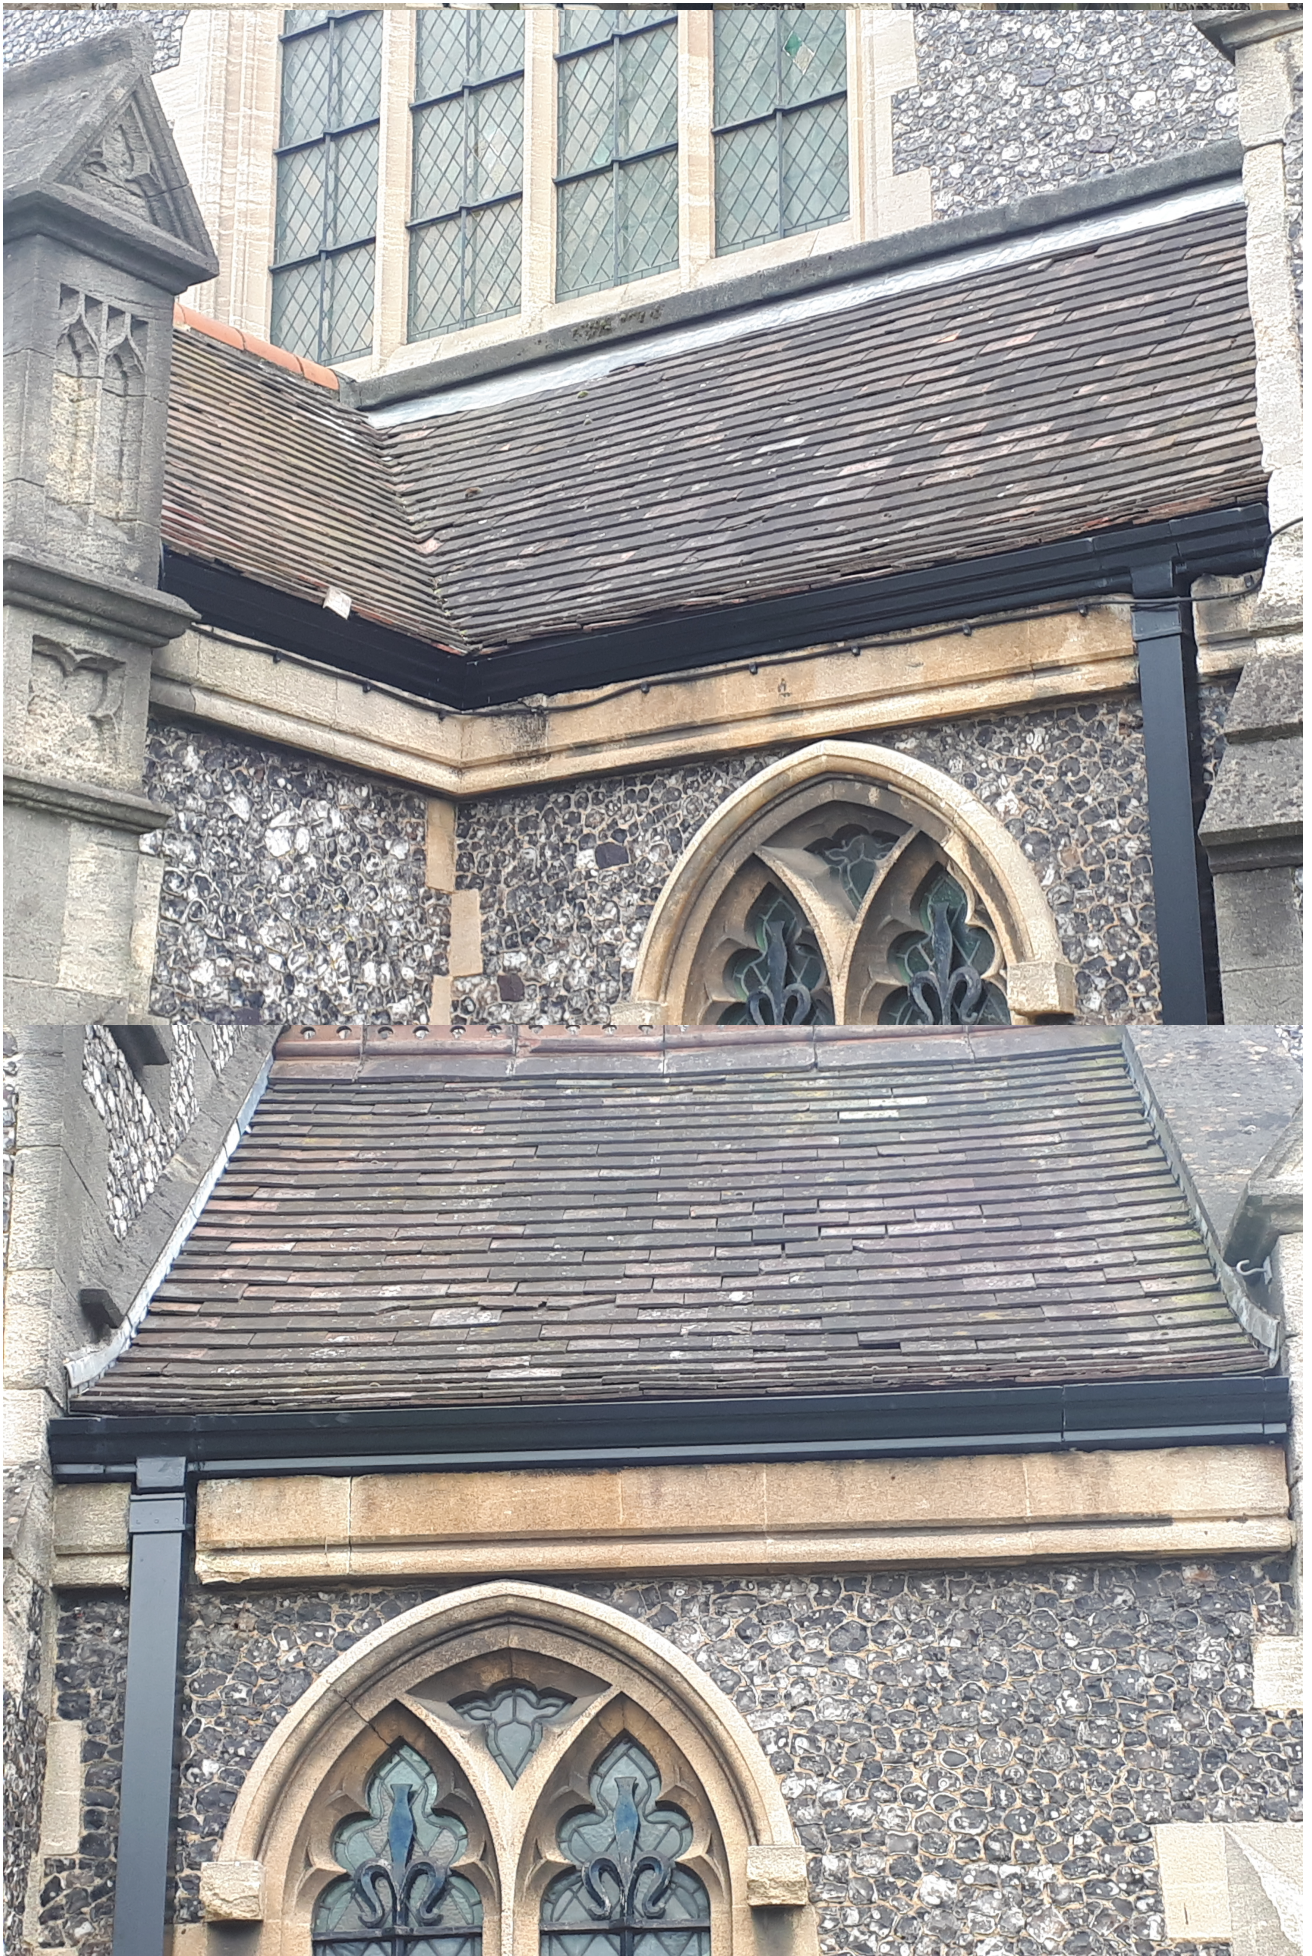
HOWVER, where they have been installed, the lower rows of tiles have been disturbed and not replaced in a satisfactory manner.

From the outside, the joints do not look particularly well sealed. I assume that this is not the case internally to the gutter, which I could not see.

Zoom in on the attached photos.

I would strongly suggest that monies are withheld until this is rectified, unless this was clearly omitted from their scope of works. I think that without this omission, you could have very reasonably expected the installation to be undertaken without damaged or misplaced tiles.
