EAST ELEVATION

## 0490.SK006

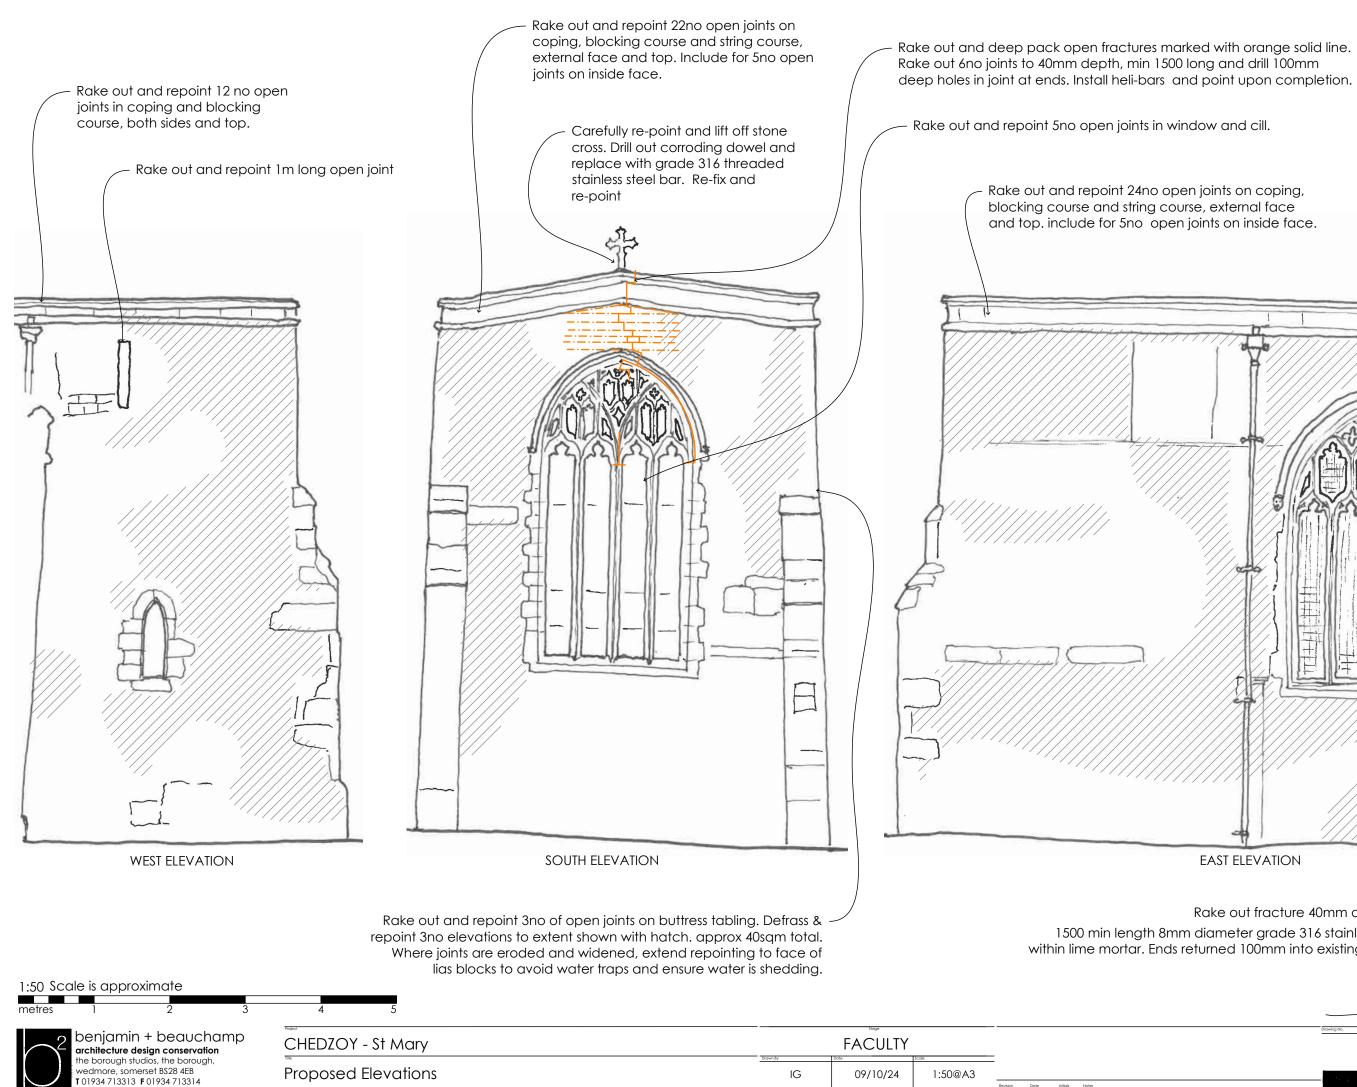
Drill out rusting iron pin and repair with mortar

Defrass and Repoint Rake out fracture 40mm and deep pack repoint 1500 min length 8mm diameter grade 316 stainless steel helical ties set within lime mortar. Ends returned 100mm into existing joints at ends of bars.
