**South Porch:**

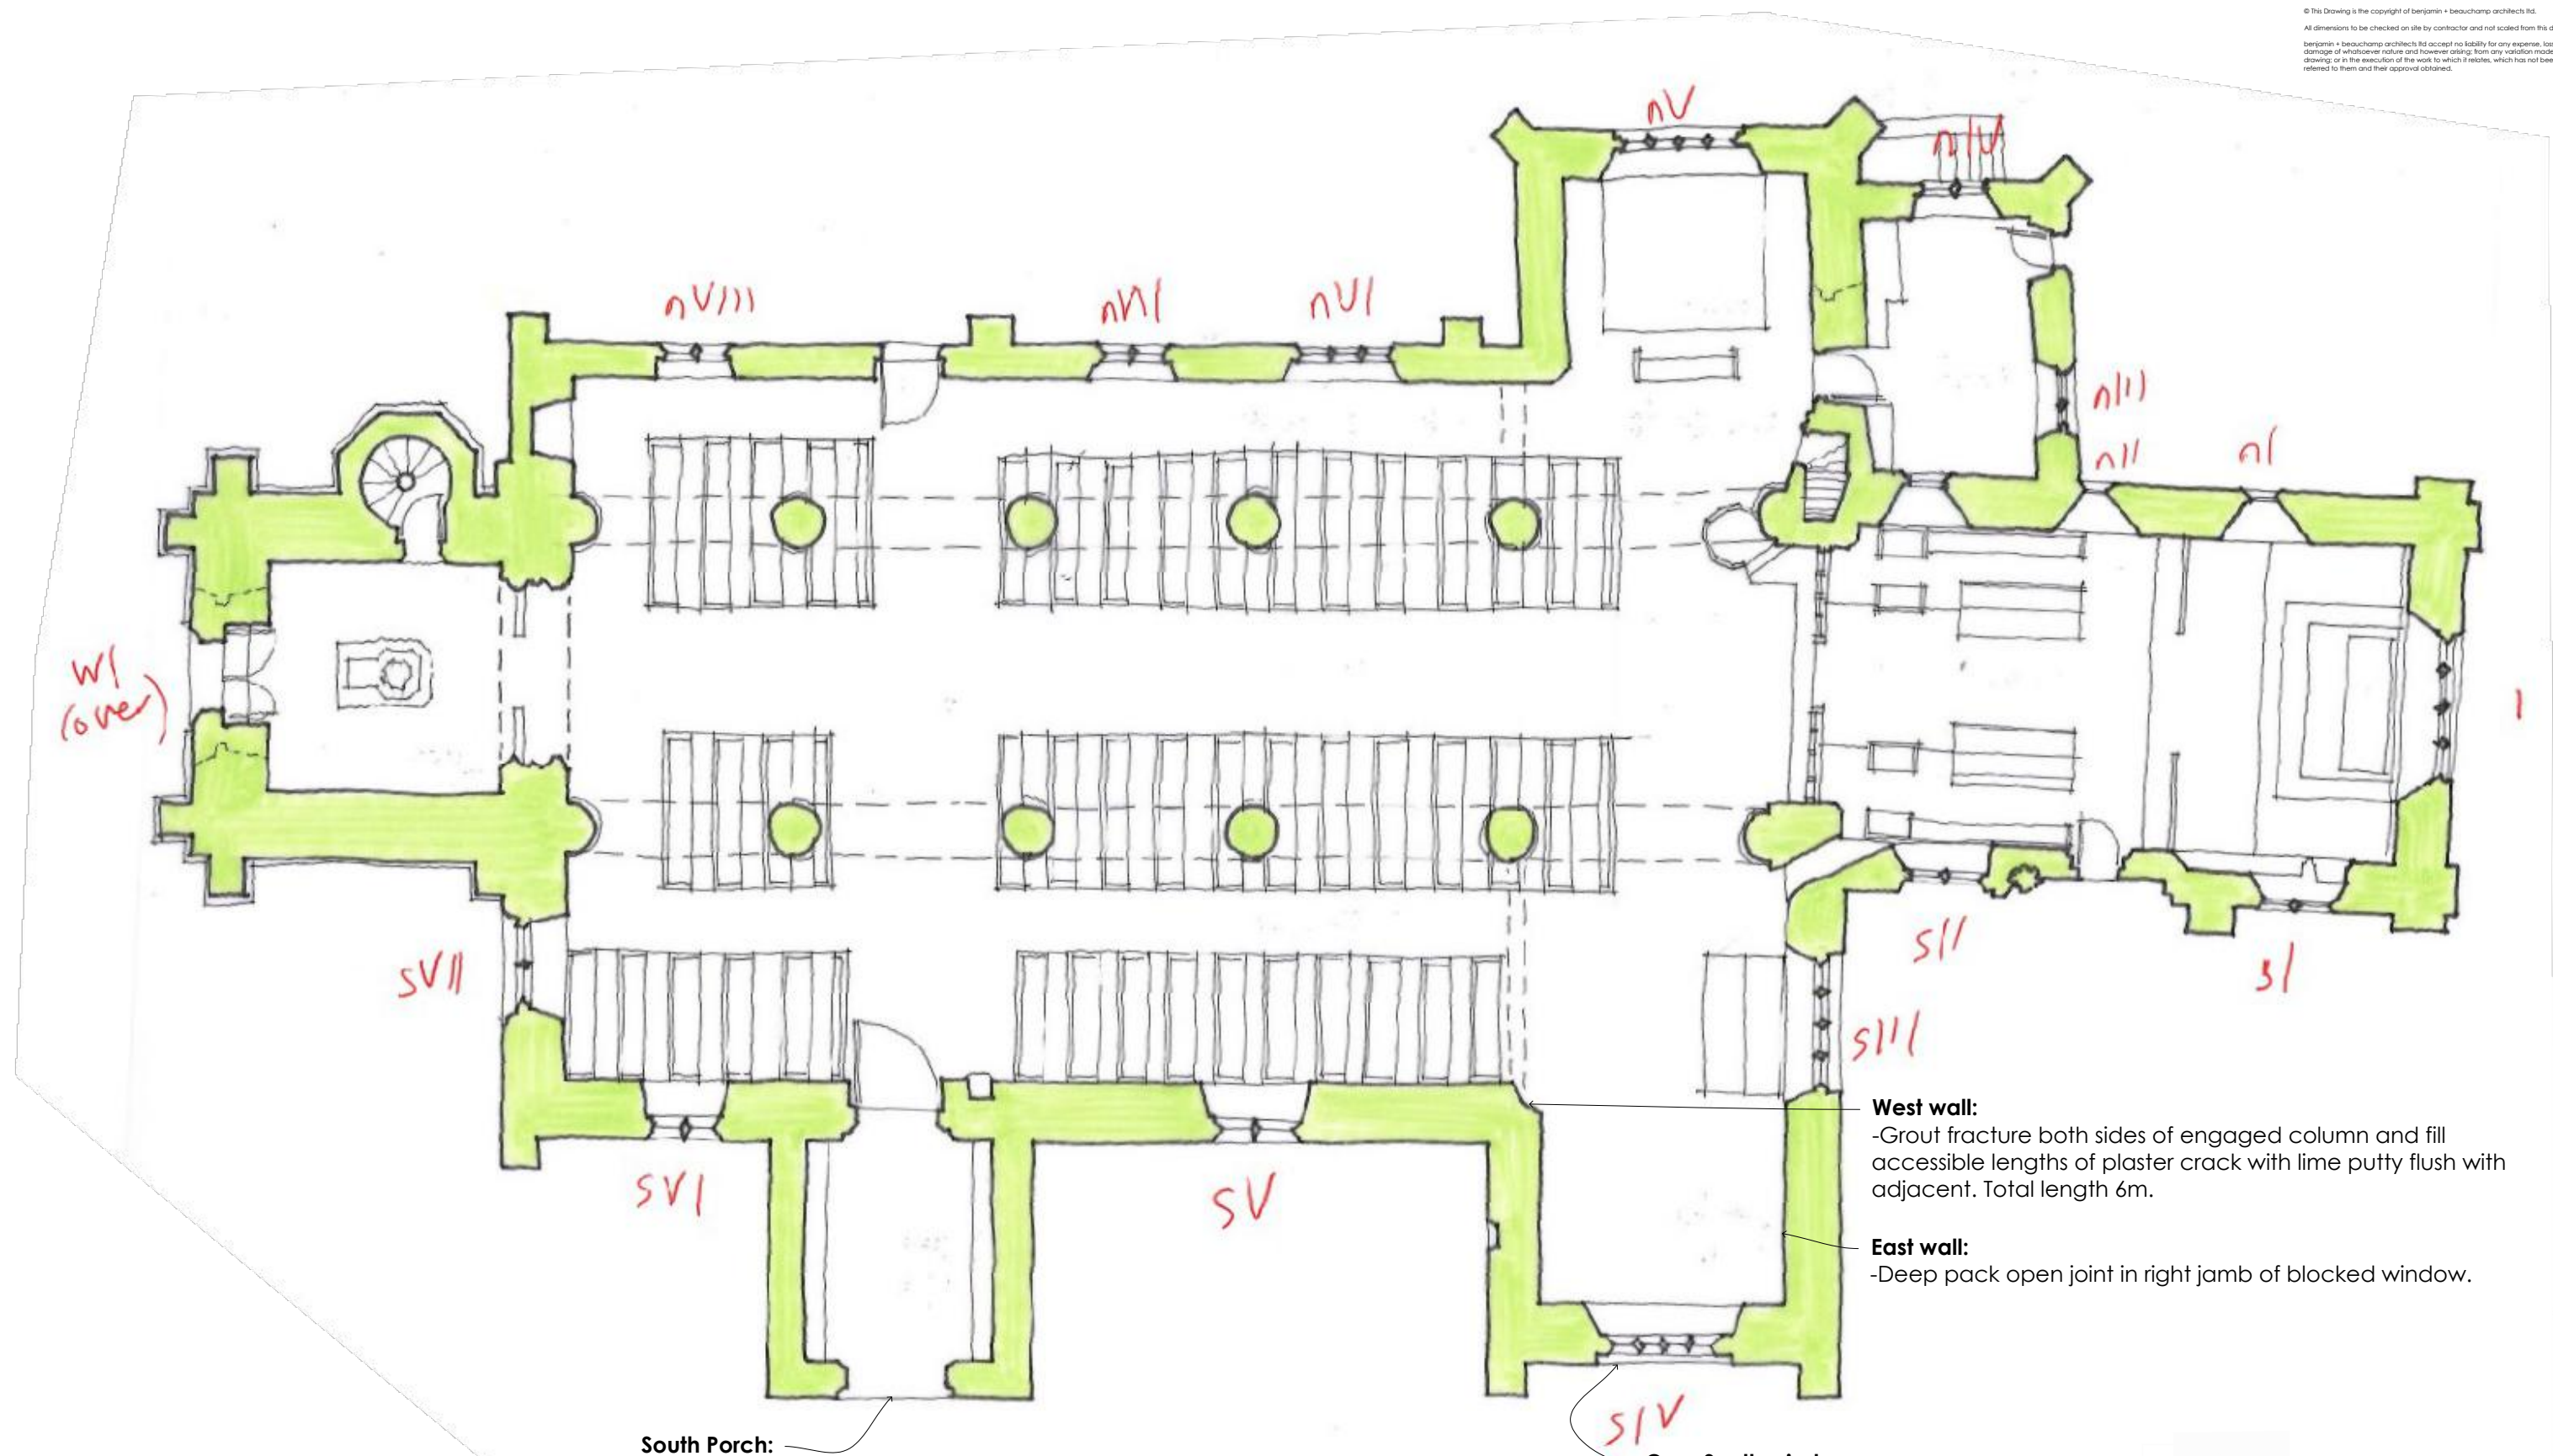
**West wall:**

**East wall:**

**Over South window:**

Carefully re-point and lift of stone cross. Drill out corrodng dowel and replace with grade 316 threaded stainless steel bar. Re-fix and point.

-Grout fracture both sides of engaged column and fill accessible lengths of plaster crack with lime putty flush with adjacent. Total length 6m.

-Deep pack open joint in right jamb of blocked window.

- Remove 2 sqm plaster. Rake out 3 no joints 2m long x 40mm deep and insert spiro ties with ends returned 100mm into wall. Repoint and supply 3-coat plaster with limewash to match adjacent.
- Slate pack open fracture from apex to springing point.
- Deep pack point fracture and grout.
- Fill open joints in tracery.
