Report on Archaeological Monitoring

Drainage trench, St John the Baptist, Stoke by Clare, Suffolk

Felix Reeves Whymark, February 2025

Project name	St John the Baptist, drainage trench monitoring
Parish	Stoke by Clare
District	West Suffolk
Grid reference	TL7410143344
Date of fieldwork	Several days over period 18th September - 18th November 2024

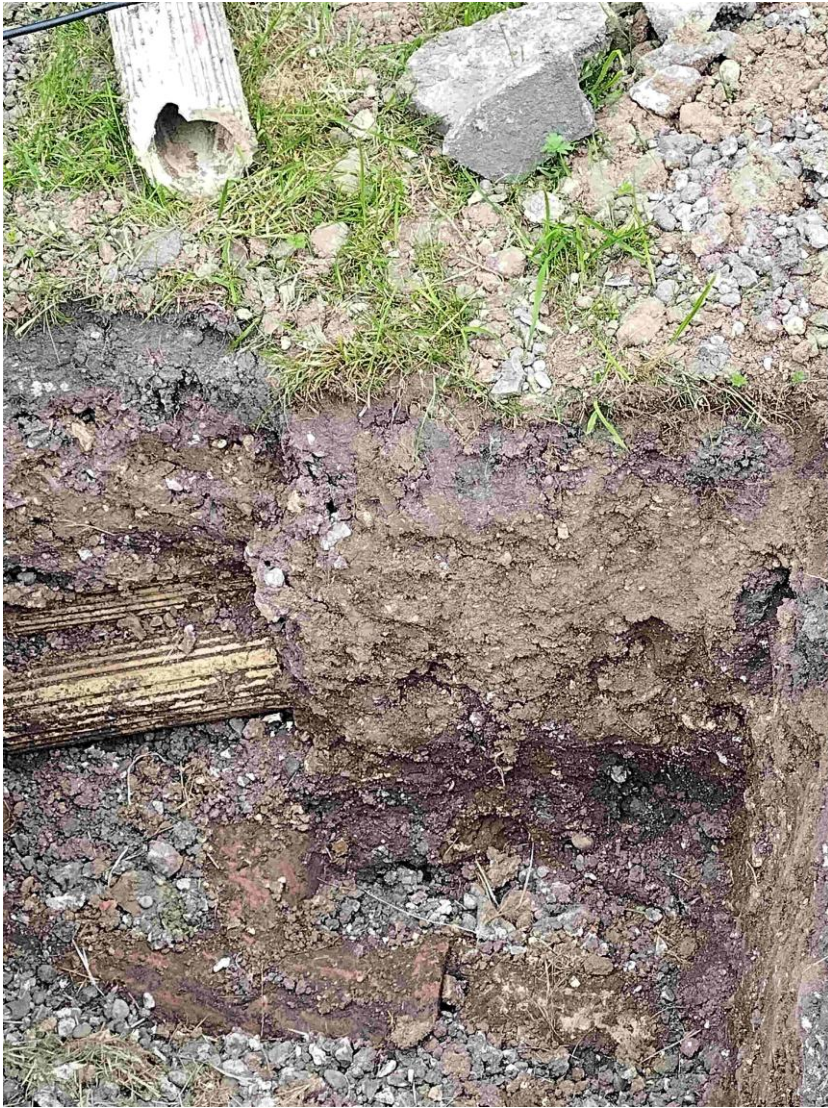
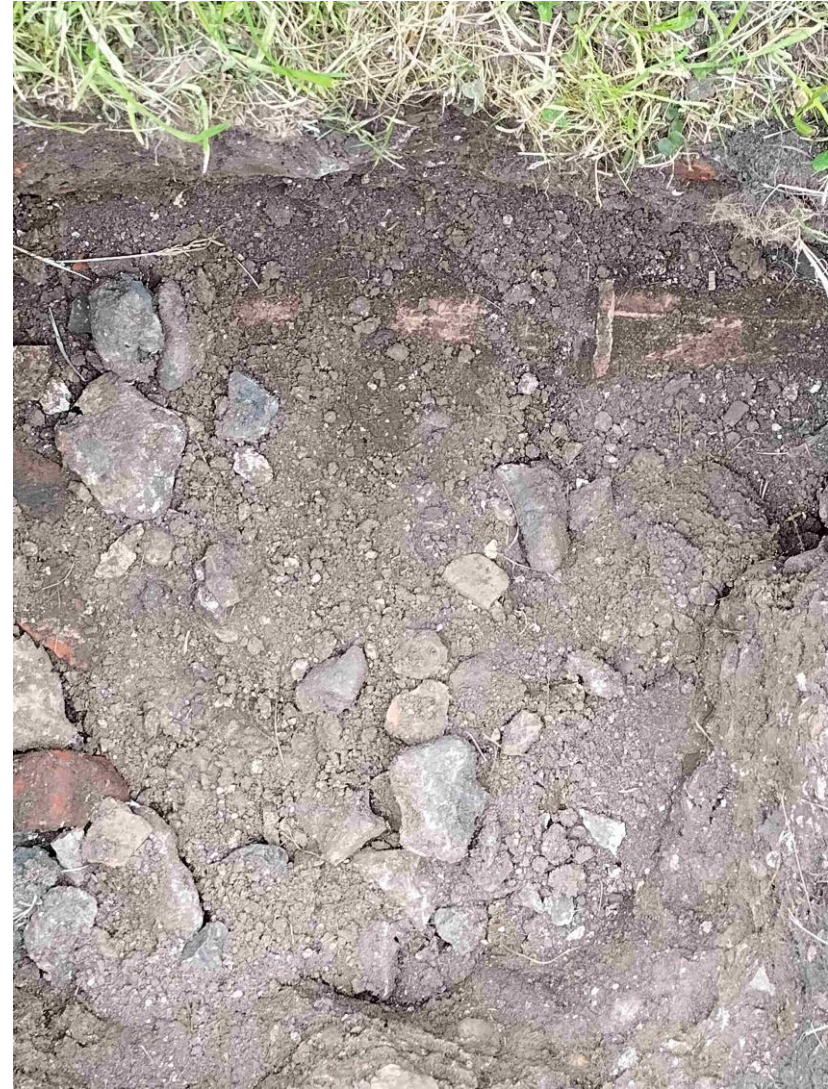
Previously disturbed layers at land drains and early form of socketed drain pipes in white clay with later red clay pipes not salt glazed.

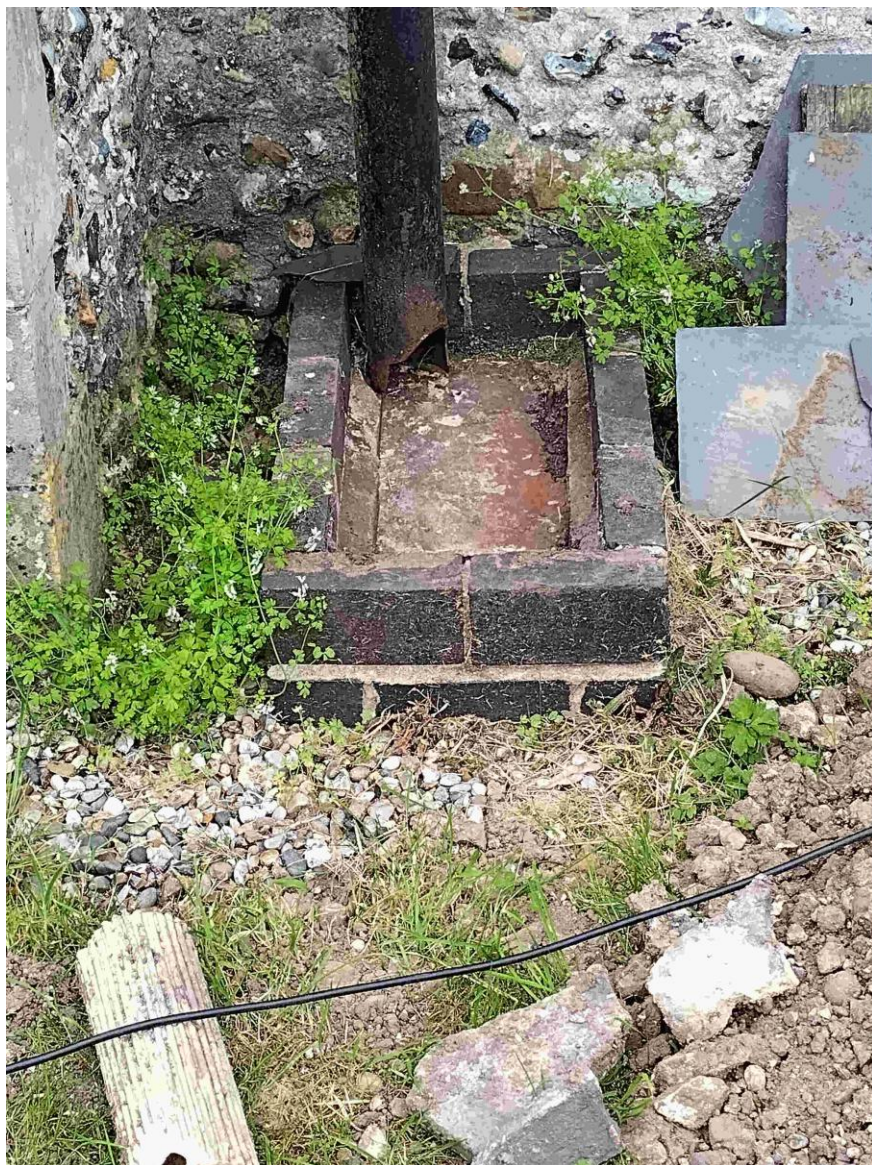
The most likely location of interest close by the church walls where fabric fragments such as tile, glass and worked materials was impacted by previous intervention with no archaeological control to form engineering brick gully catch pits connected to the old drains. These were updated to yard gullies with lift out silt buckets and reusing the bricks at all down pipes around the building.

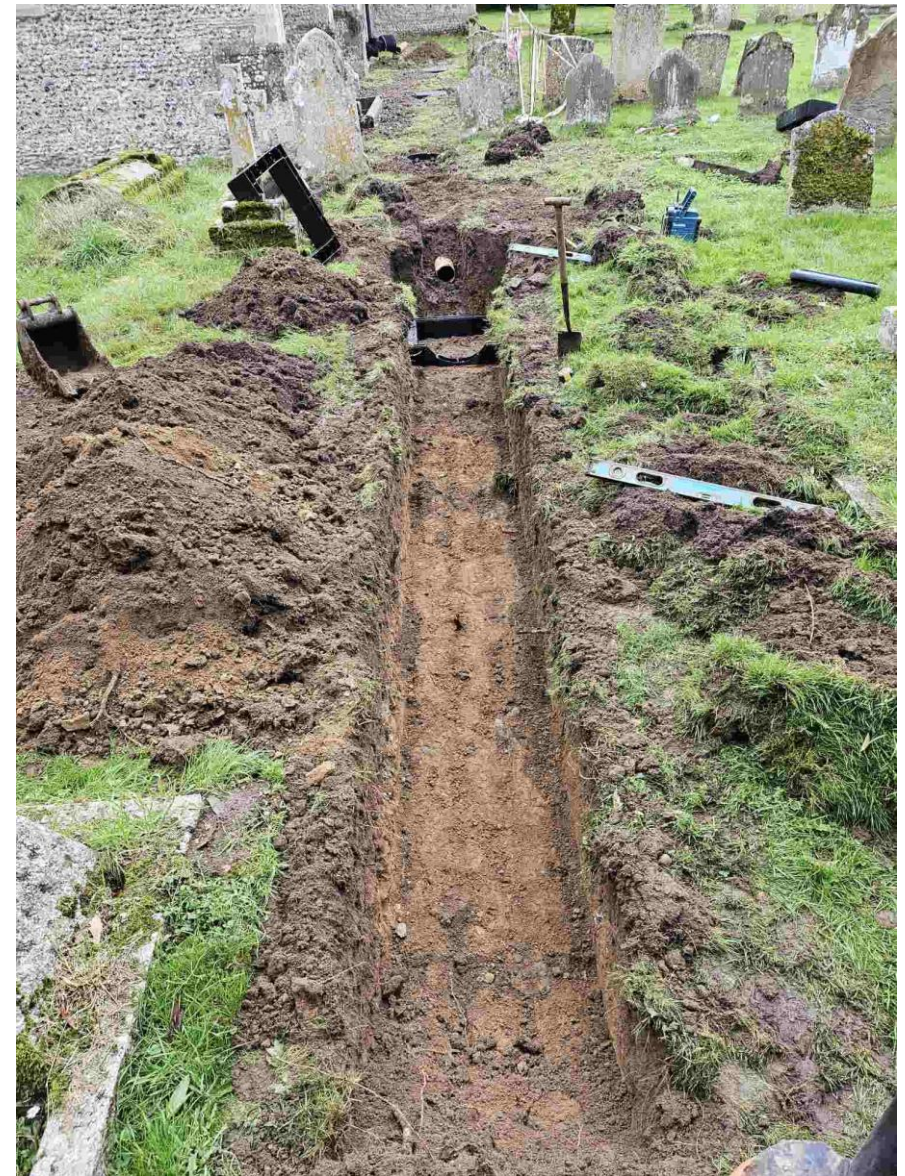
East drainage trench looking west, over old drain trenches.

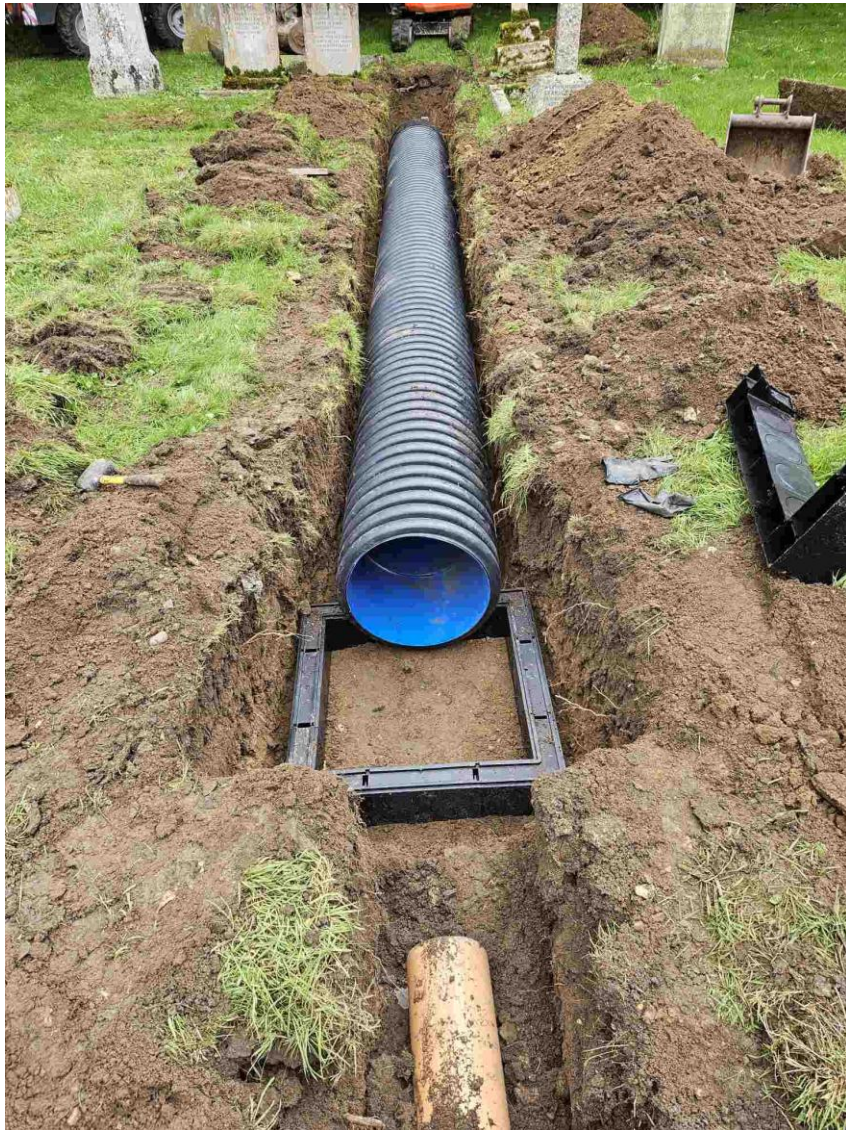
East soakaway 450mm diameter perforated Twinwall pipe in situ with 150mm plastic pipe from north drains. Looking east prior to back filling.
