St. Cyr's Church

**Stinchcombe,
Gloucestershire.**

Report on the Conservation of six Churchyard Monuments.

October 2019.

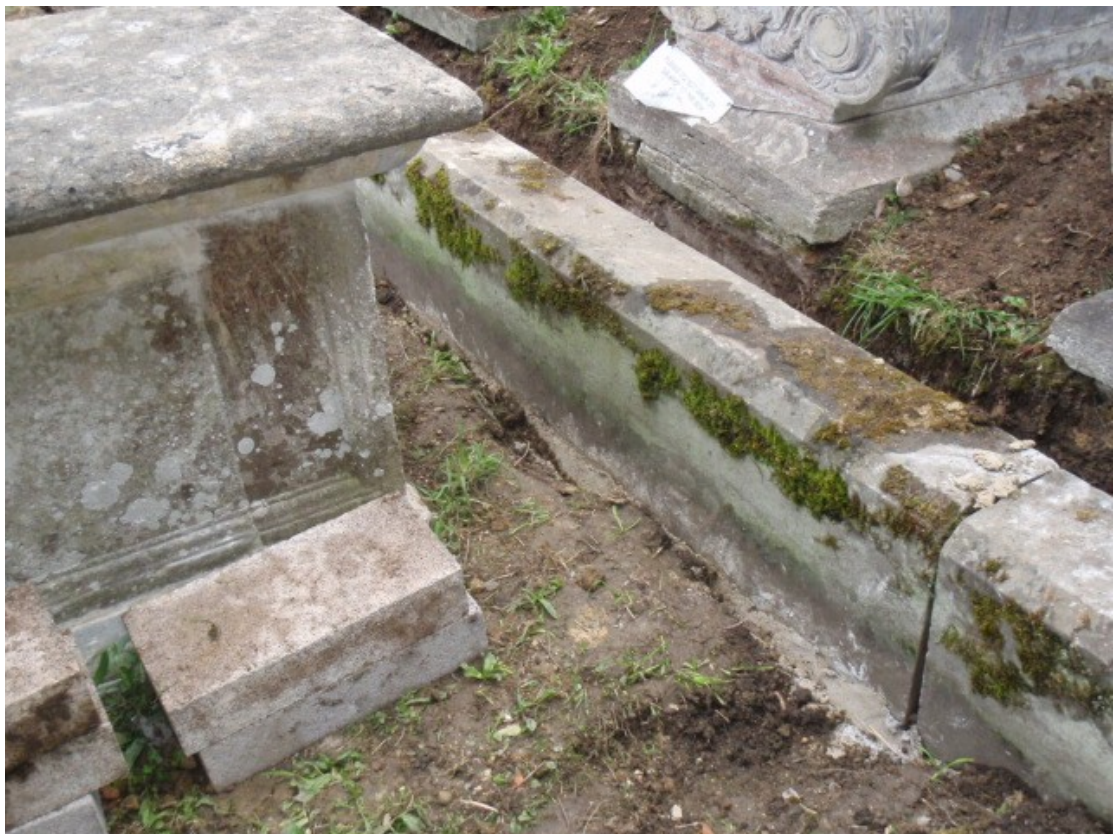
The stones rebbeded on lime concrete.

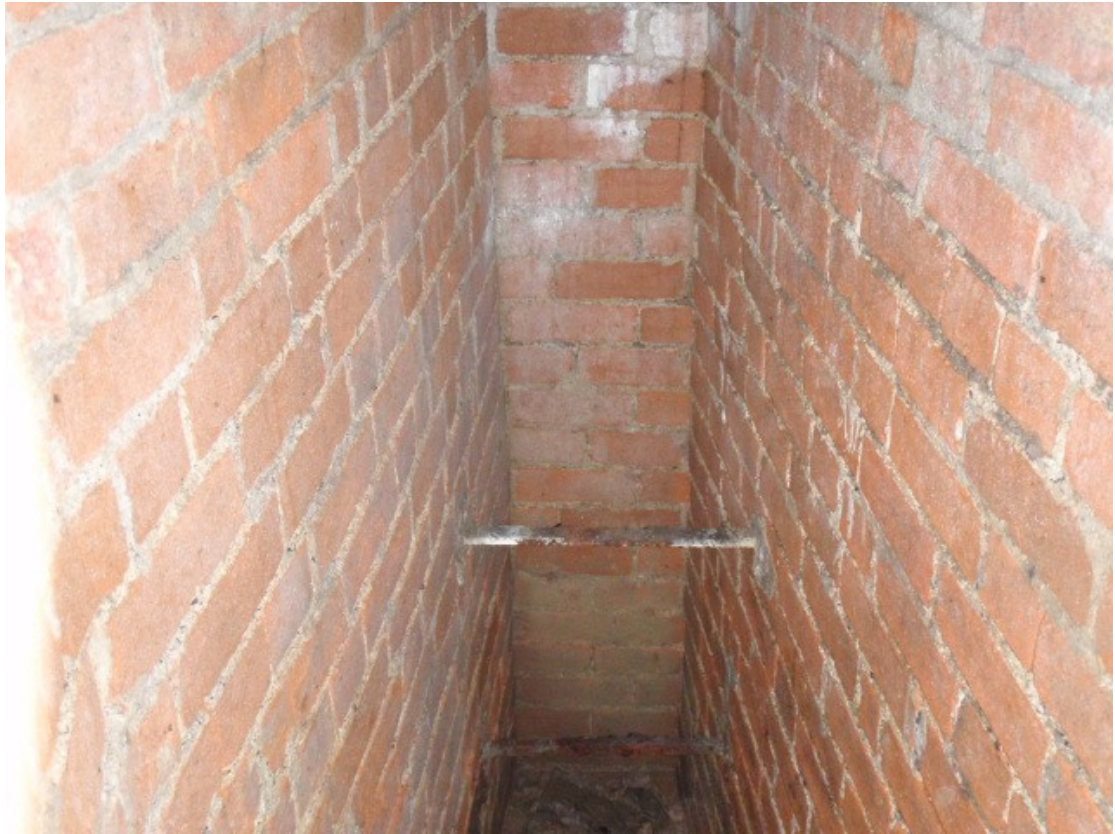
The brick-lined shaft beneath the John Marbett 1879 monument.

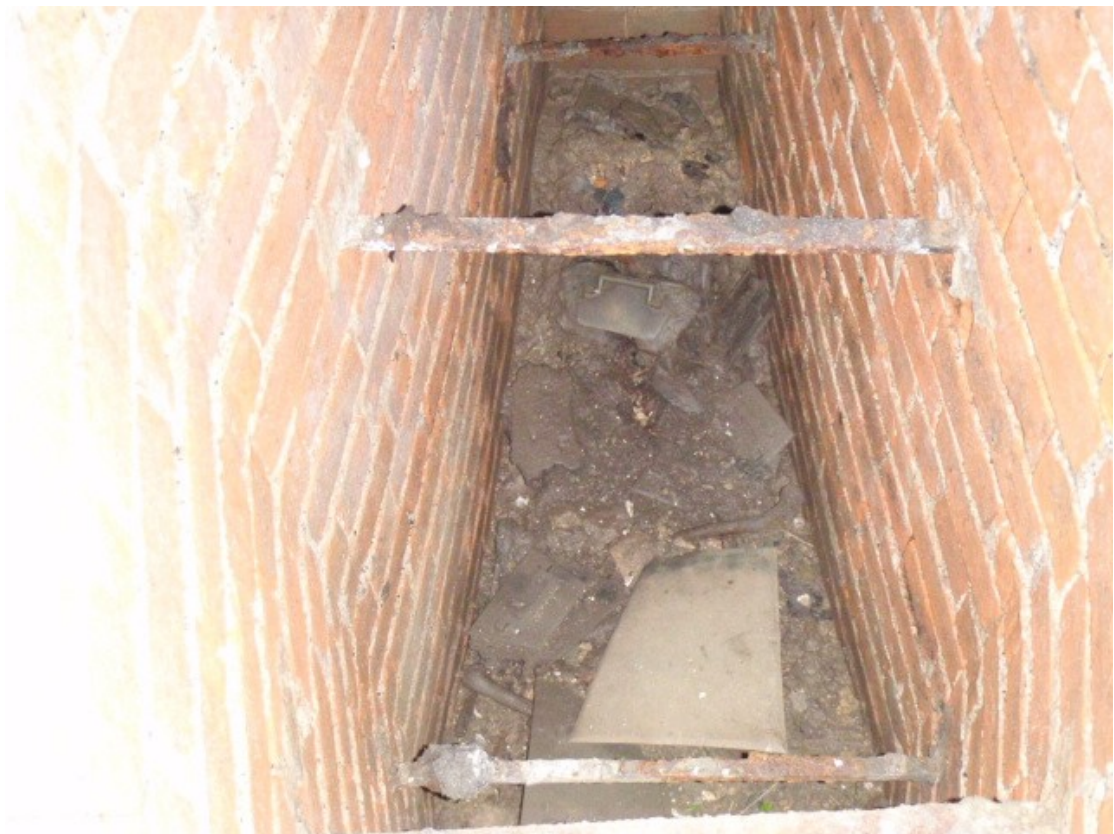
At least two coffin-plates and a coffin handle are visible.

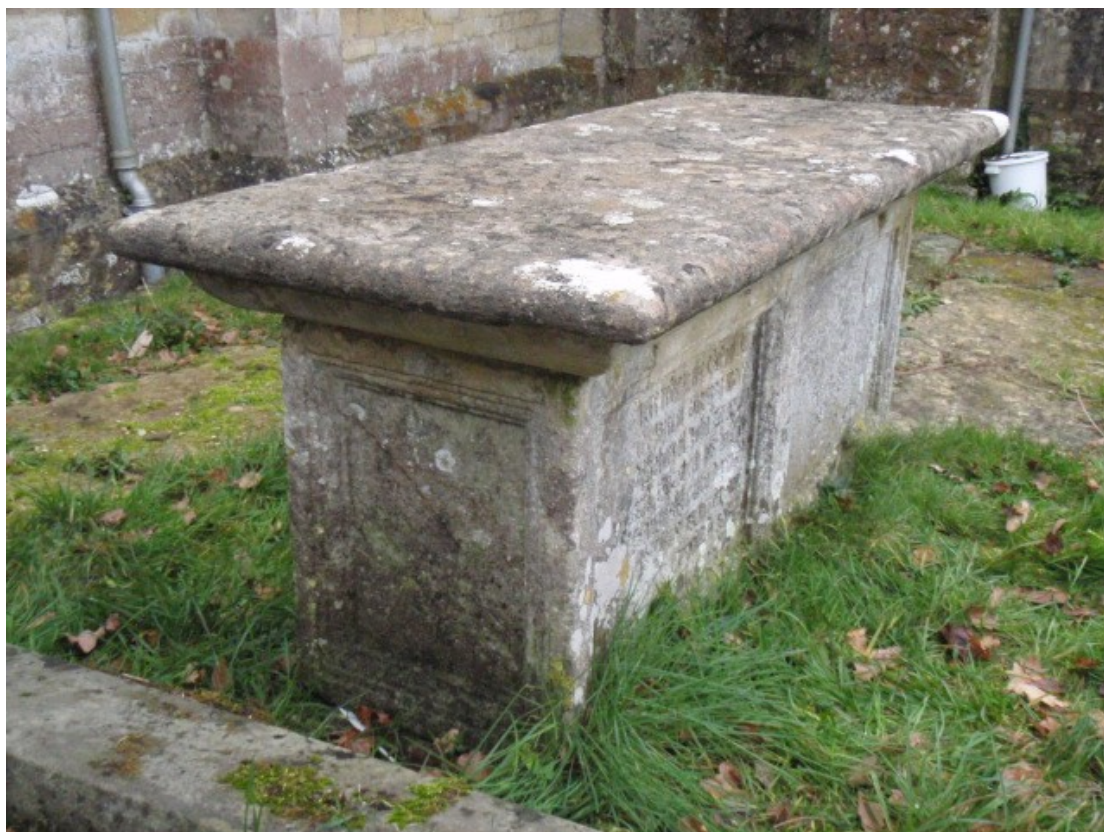
East end.

The limestone is in sound condition, with moderate weathering of the surface and some growth of lichens. Some of the lime mortar in joints between the stones has weathered back, potentially allowing more water to enter. The plinth below the side and end panels is now largely buried, due to a rise in the ground level within the churchyard. There is no sign of iron cramps at the corners, and no signs of the damage they usually cause, and the lid has not been lifted or displaced.

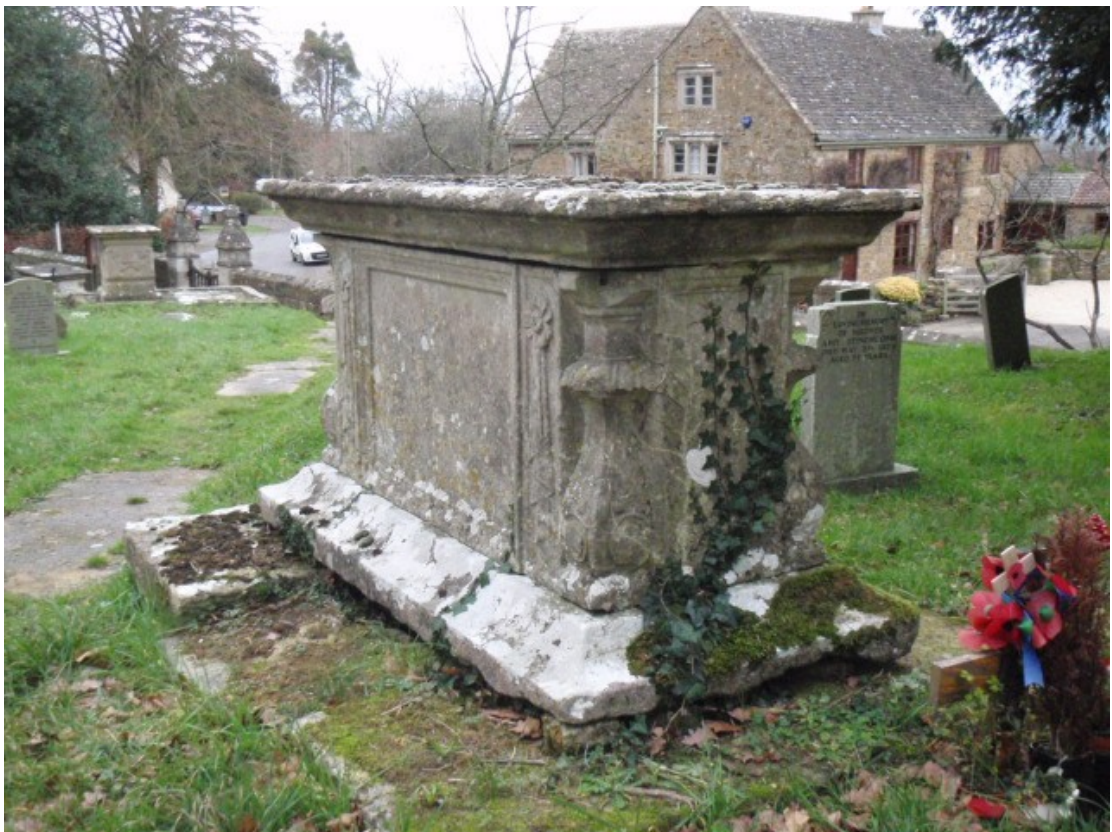
East end.

Individual stone elements are in sound though moderately weathered condition. Due to its construction with a one-piece plinth and thick end panels, the chest has remained in place despite movement in other parts of the monument. Iron cramps at each corner have rusted, expanded, and lifted the lid, and the cramp at the SE corner has also broken part of the stone away. Although the covering slabs (which cover the top of the burial chamber) at the E and W ends are wide enough to bridge right across and have stayed in position, the smaller ones used for the N and S sides have subsided outwards. Although the monument is not in a state of collapse, its long term stability is compromised.

The lid was lifted, rusting iron cramps removed, and replaced with stainless steel ones, before repositioning the lid on a bed of lime mortar. Open joints between the ends, sides and plinth were repointed. All ivy was removed, and the roots treated using a systemic root killer. The N and S side covering slabs were repositioned on firmer foundations made with concrete blocks and lime mortar. The very wide joint between the covering slabs and the plinth stone was repointed with a coarser mortar of 3 parts Ashton Keynes sand, 2 parts Frithend sand and 2 parts NHL 2 and Cotswold stone roofing tiles, packed in deeply. This will prevent future recolonisation by ivy.

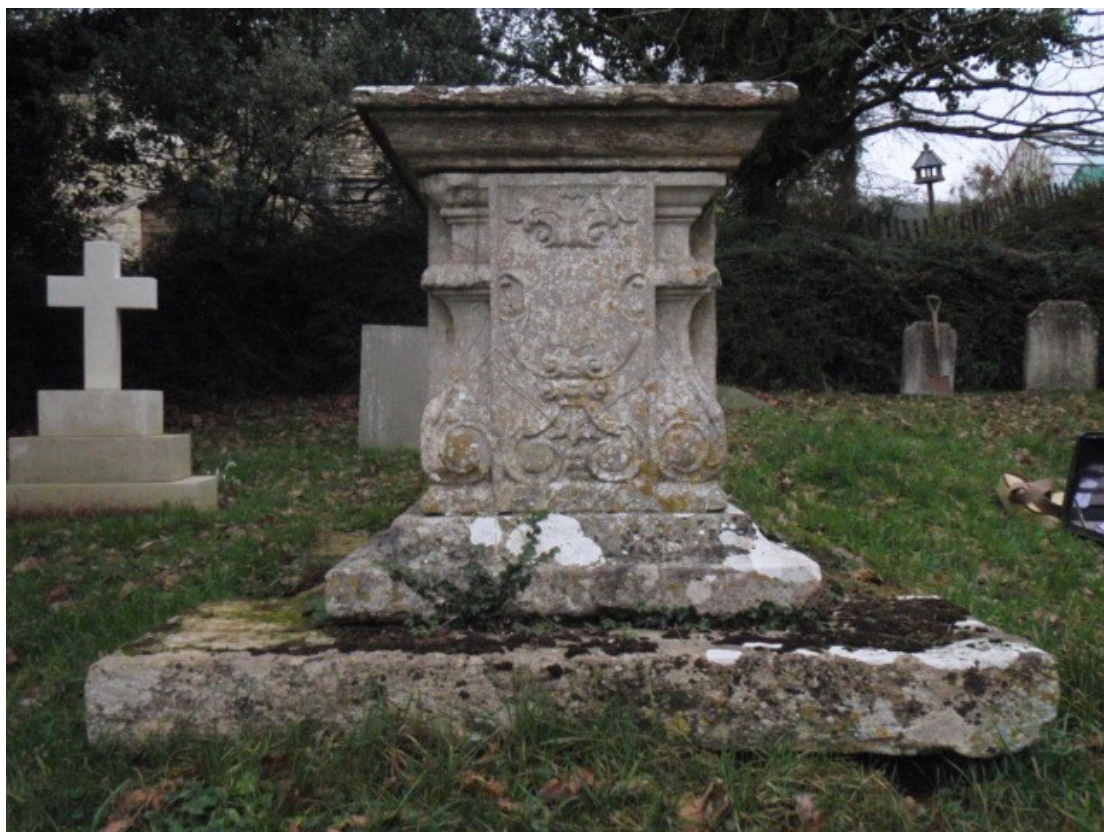
West end before conservation.

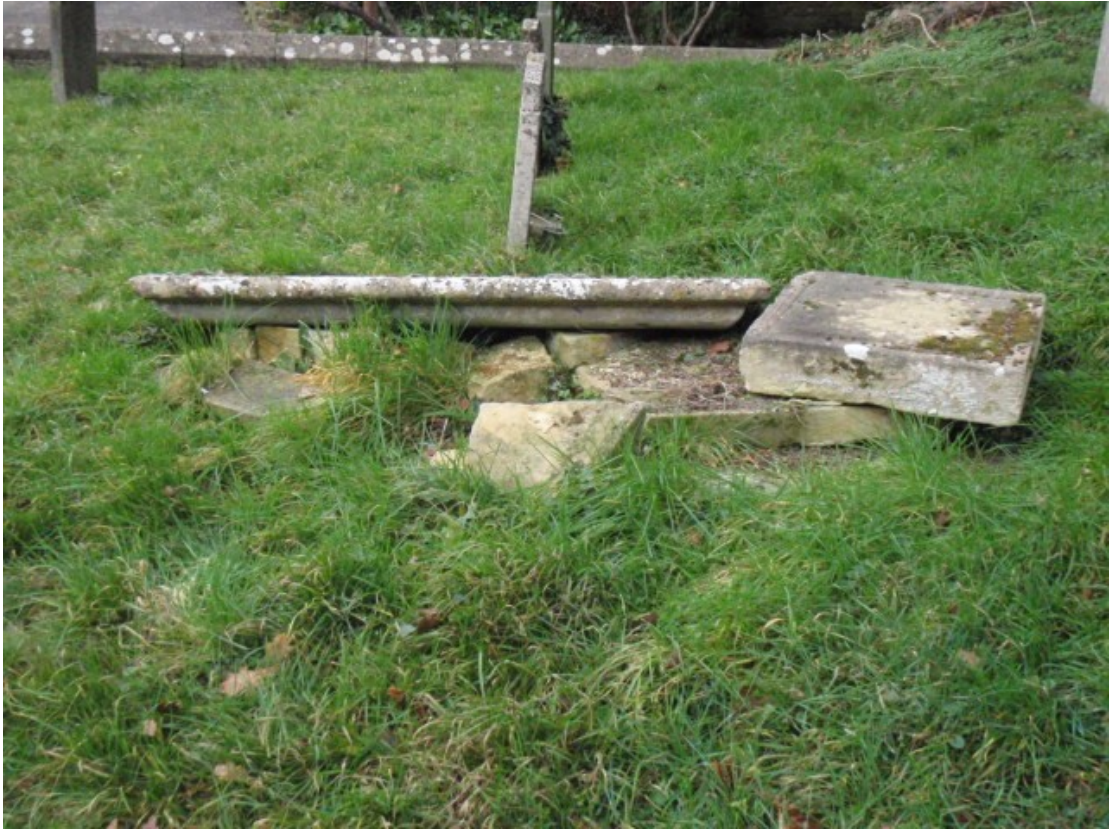
This monument has collapsed completely. The stone itself is moderately weathered, but the material is sound. Some components have broken on impact, due to point loadings, but these are “clean” breaks. All components are still present.

The completely collapsed monument, from the west.

The pile of stones was taken apart and all broken edges cleaned with water and a nylon scrubbing brush. After drying, the “jigsaw puzzle” was reassembled using polyester resin and stainless steel threaded dowels. The N, S and W panels were all broken into several pieces, particularly the N side, as this had been hit by the S side and the lid when the monument collapsed. It was reinforced by setting stainless steel flat bars into slots cut with a small angle-grinder using polyester epoxy resin.

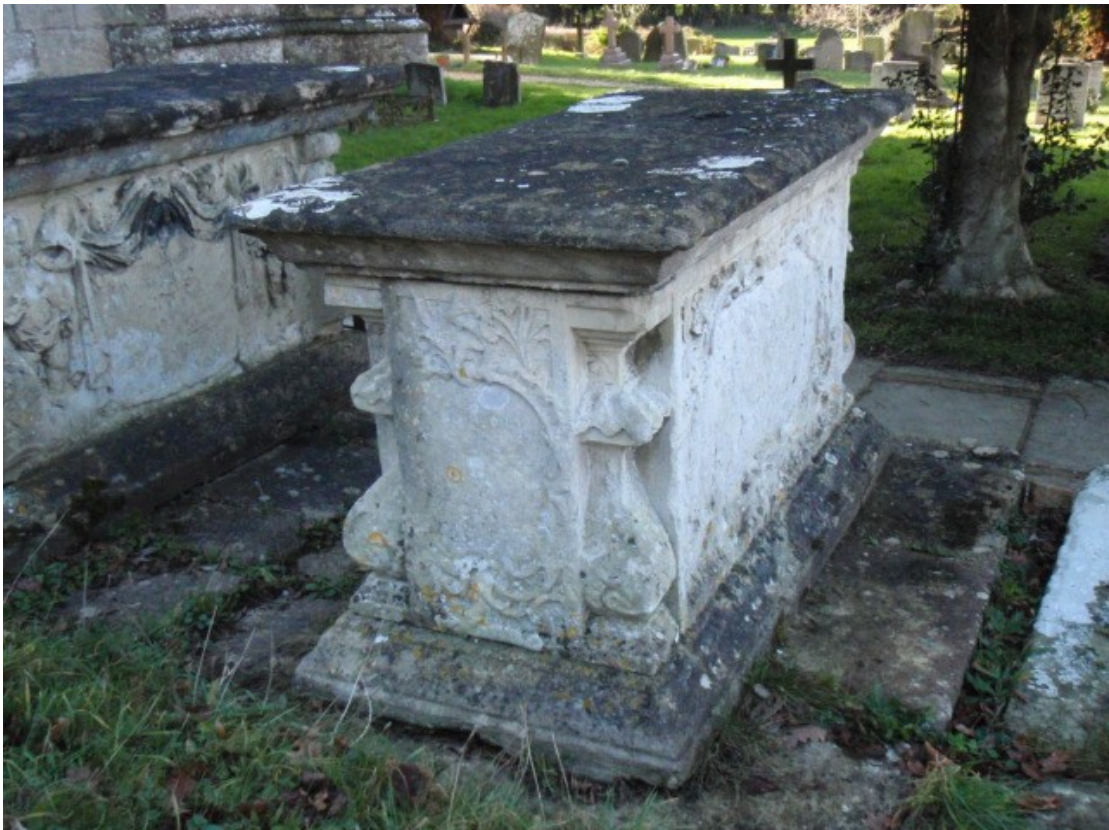
The east end.

The limestone is in sound condition, with moderate weathering of the surface and some growth of lichens. Some of the lime mortar in joints between the stones has weathered back, potentially allowing more water to enter. Iron cramps present at the corners have rusted, expanded, and lifted the lid to a considerable degree. The lid is now unstable. The plinth has not moved on the covering slabs beneath, and is stable.

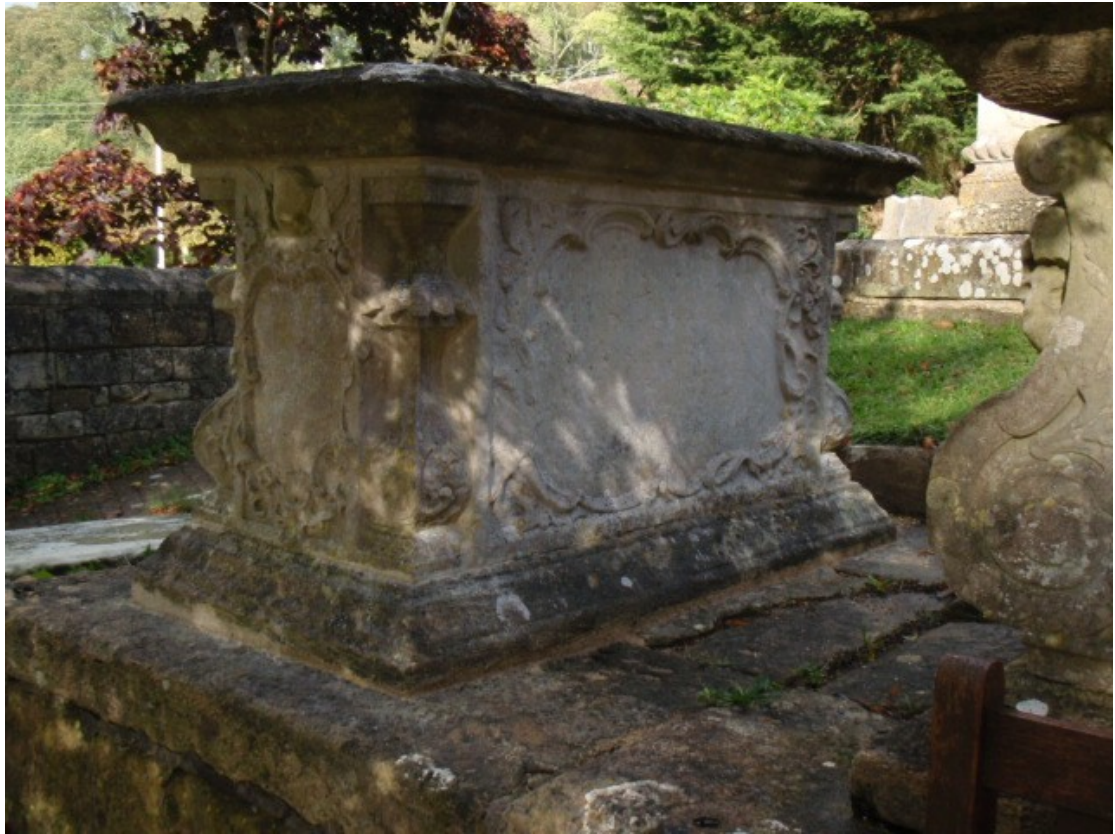
The monument after conservation. South side.
