CHURCH OF ST. LEONARD, FARLEIGH HUNGERFORD, SOMERSET

FOUR MONUMENTS IN CHANCEL

REPORT ON CONSERVATION WORK CARRIED OUT

January - May 2020

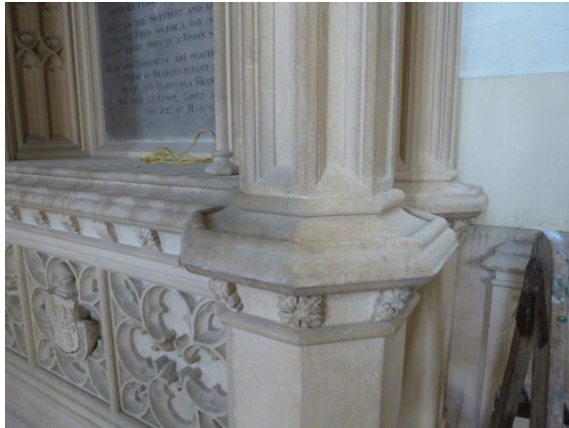
During Cleaning

The monument was then cleaned by gentle brushing with water in handsprays.

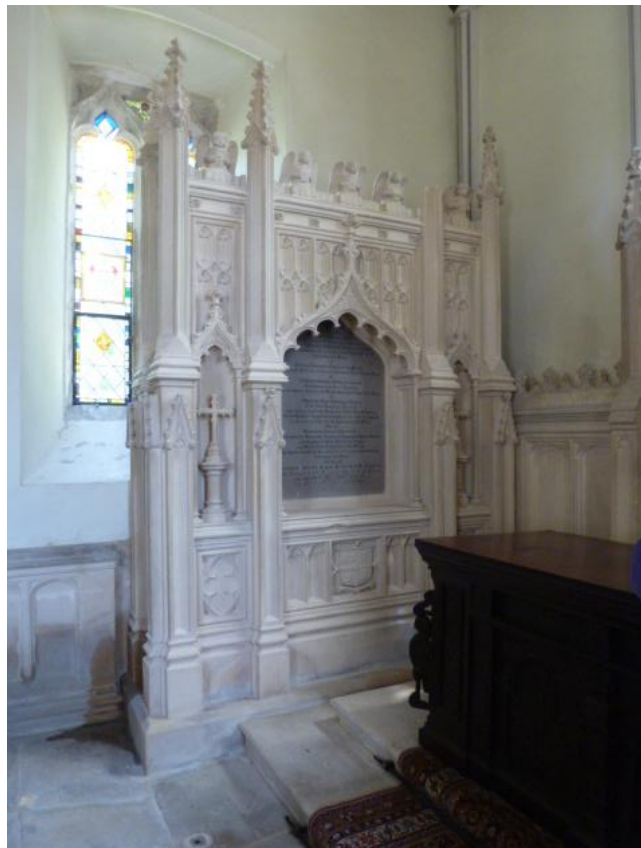
During cleaning

The monument was cleaned with gentle brushing and water in handsprays.
Open joints were filled with a non-hydraulic lime and sand mortar coloured to match the stone.

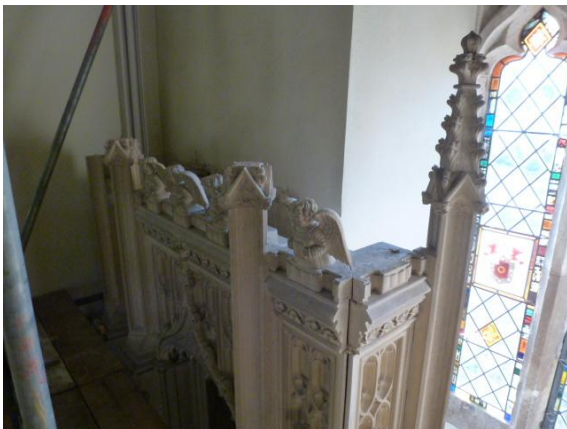
View from above

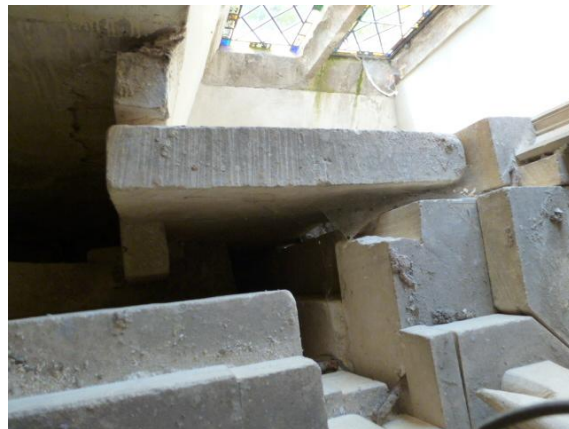
View from behind - movement out from wall, unfixed sections

Once movement had started, the design was failing, as corner pilasters began to pull out, particularly on the west end, which was unsupported.

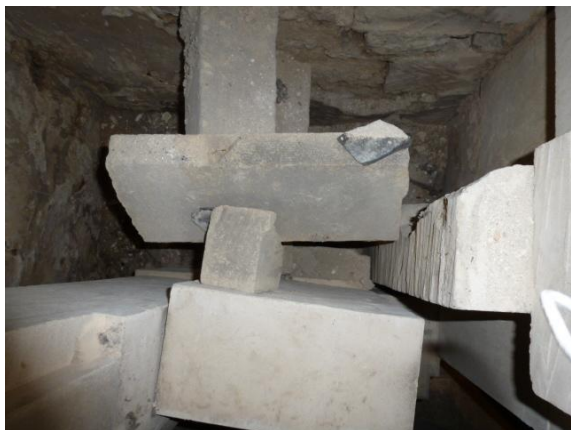
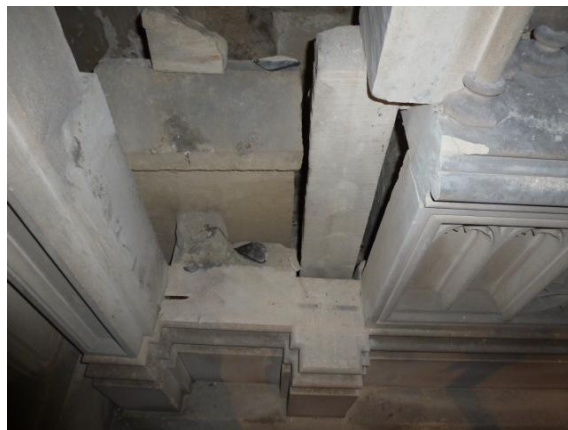
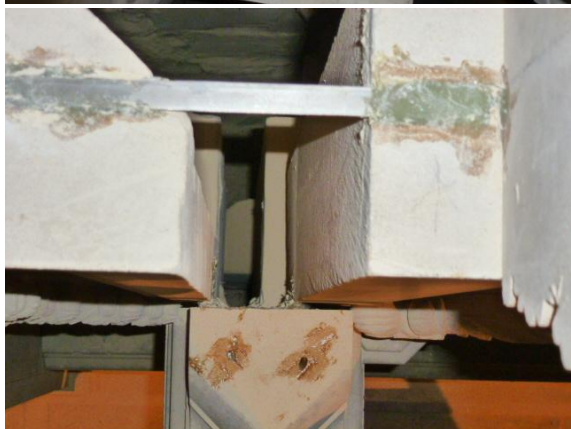
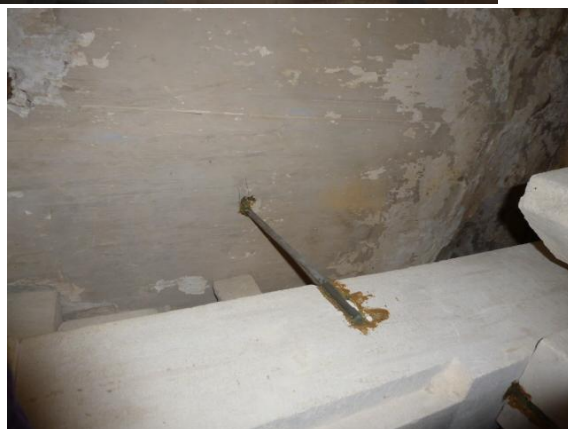
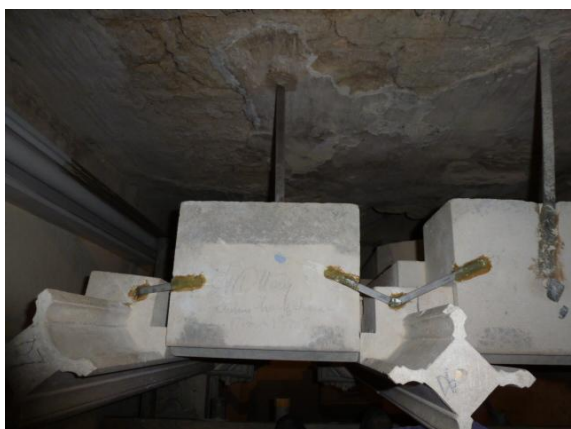
On the top was discovered a signature, 'H Ottery Hinton Charterhouse 1897' (see above photos)

The fixings in the base were replaced as for the west end and the east end was rebuilt, tying the sections back to the wall behind.

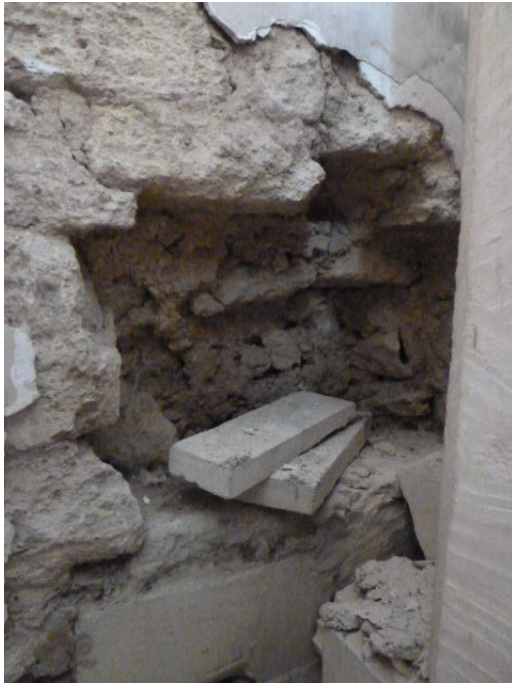
The wall behind the monument contained a cavity which may be the remains of the old piscina.

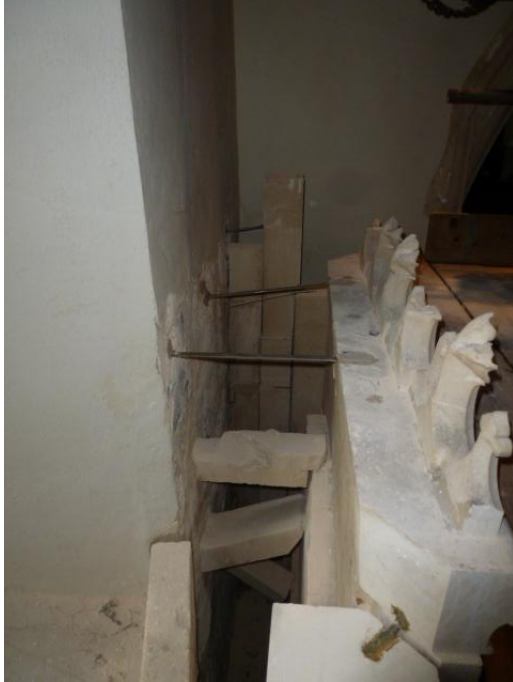
Writing was found on the back, although it could not be deciphered, but consisted of a list of names and the date 1898

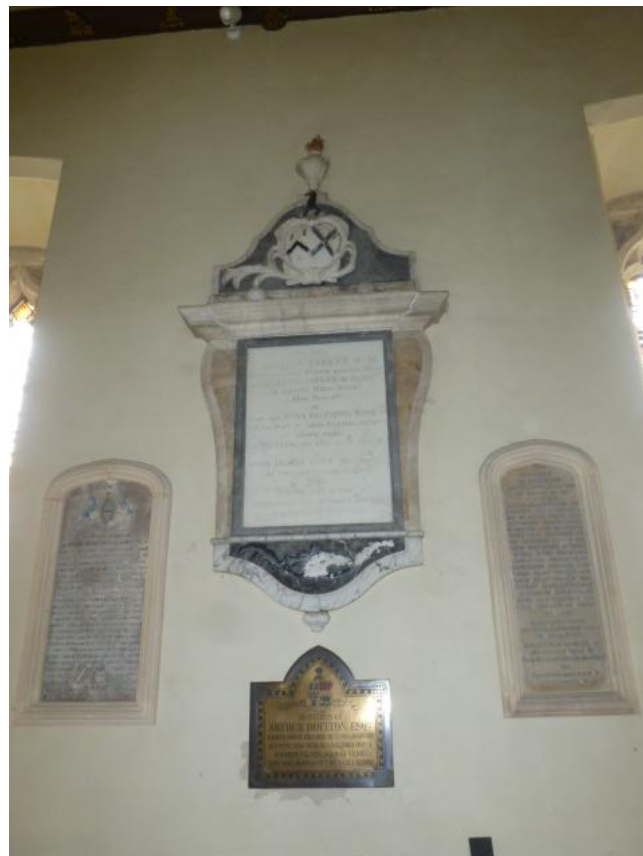
This monument has a similar situation to the one above, with the corroding iron fixings into the top of the inscription tablet causing the sections above to lift.

In this situation, accessing the fixings would mean removing the ornate top sections of the monument and the problem was not considered severe enough to justify this. Instead, the open joints were filled with a non-hydraulic lime mortar which would make any further movement obvious and it should be kept under observation.
