THE CHURCH OF ST JOHN THE BAPTIST, ROYSTON

CONSERVATION TREATMENT OF THE WALL PAINTINGS

JULY 2021

Report No: RTJB01.2 **Date:** 20th July 2021

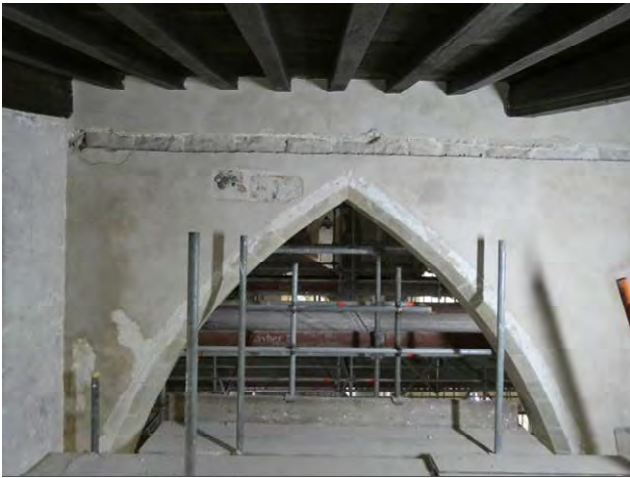
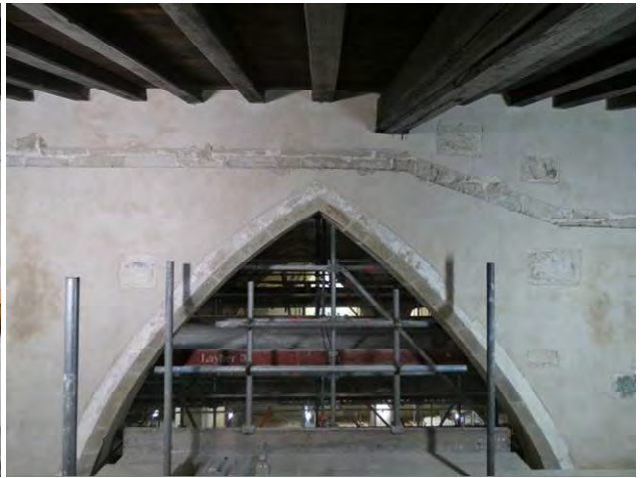
Figures 16 & 17. Arcades 1 and 2 before treatment.

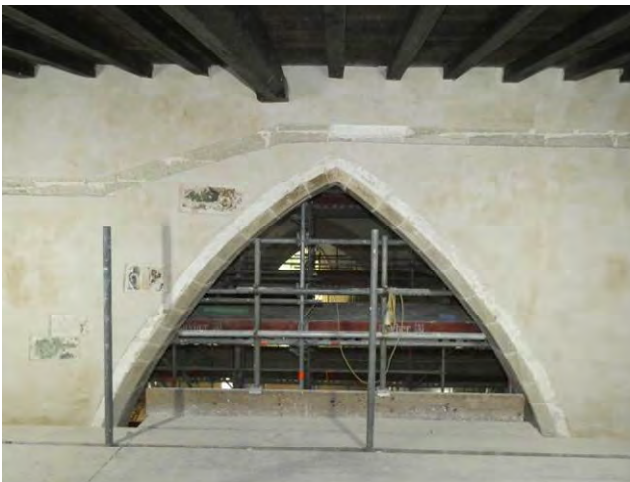
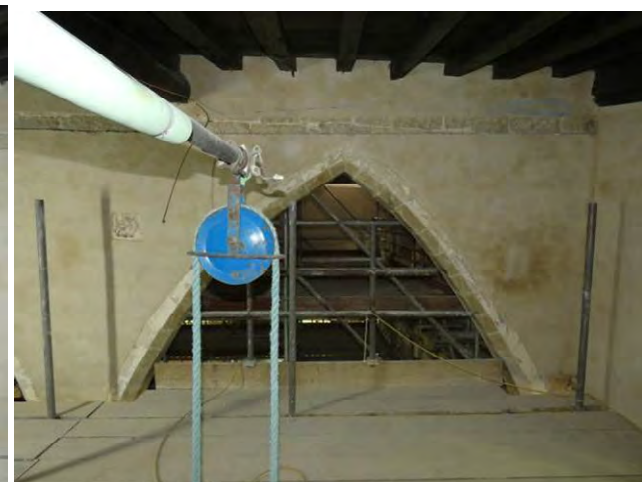
Figures 18 & 19. Arcades 3 and 4 before treatment.
