## **St Mary's, Nettlecombe, Somerset (Diocese of Bath and Wells)**

**Effigies attributed to Sir Simon, Sir John and Maud Raleigh**

### **Conservation and Relocation Report**

**February 2022**

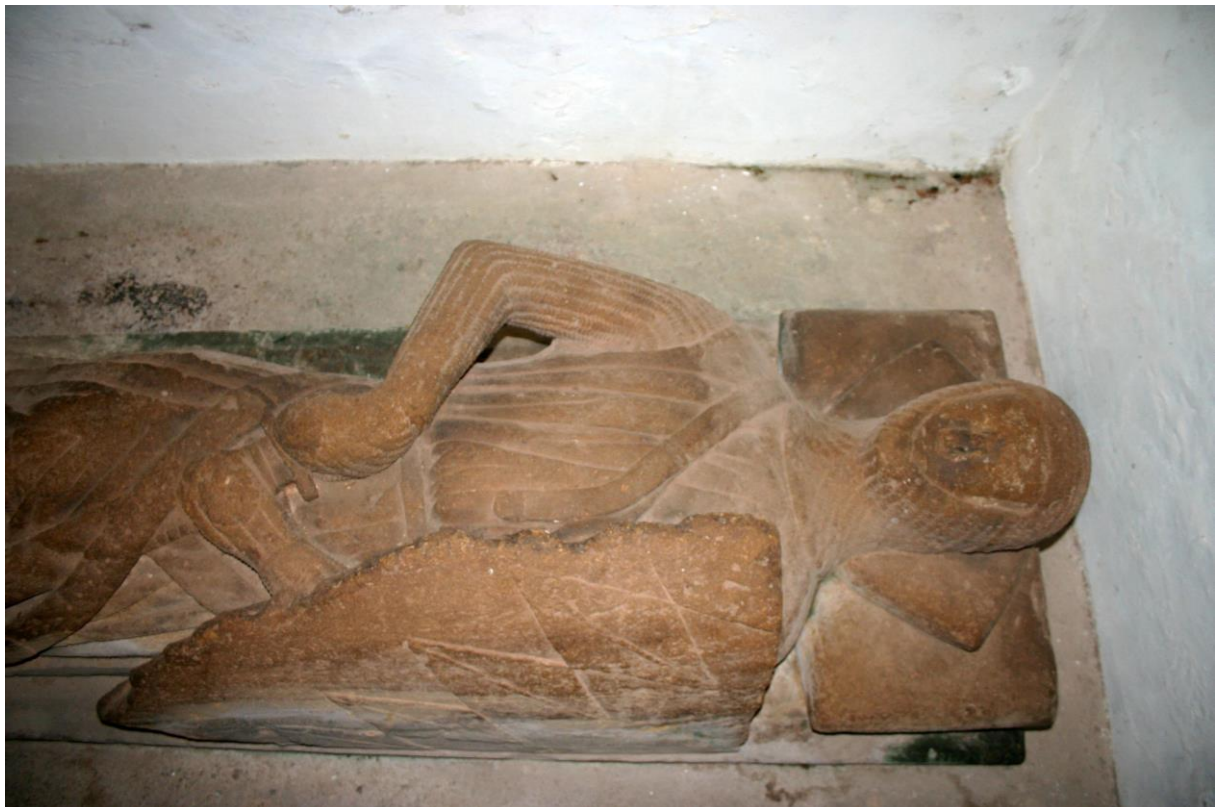
Plate 4: Effigy from above before work

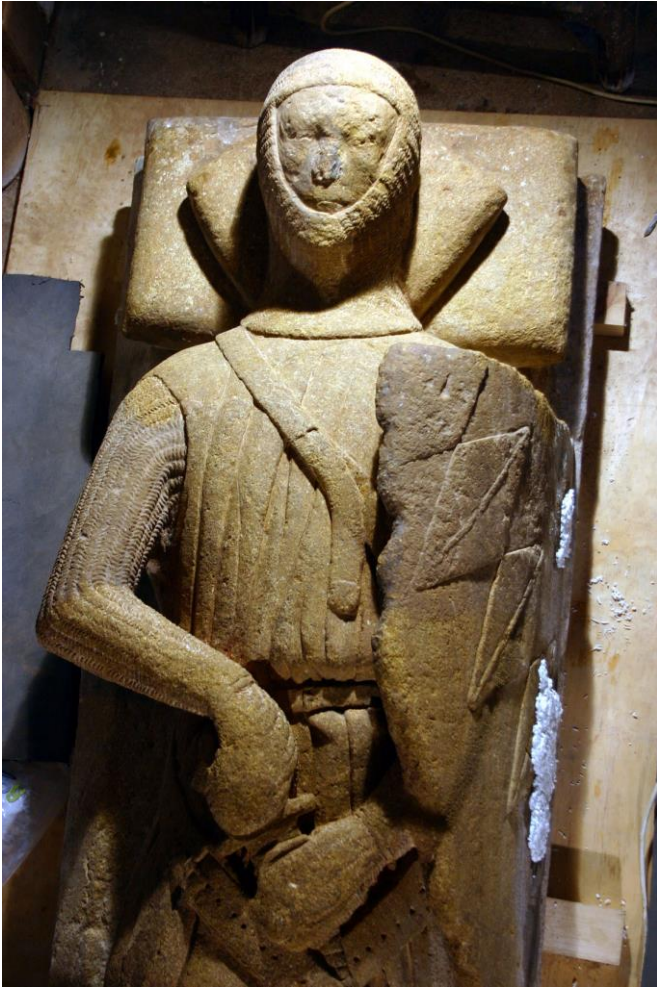
Plate 5 (left): cleaning in progress: view from above

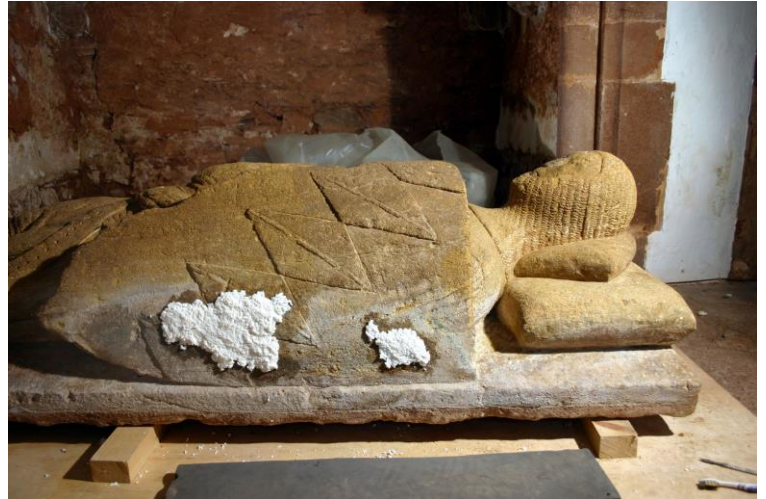
Plate 6 (above): cleaning in progress; poultices applied

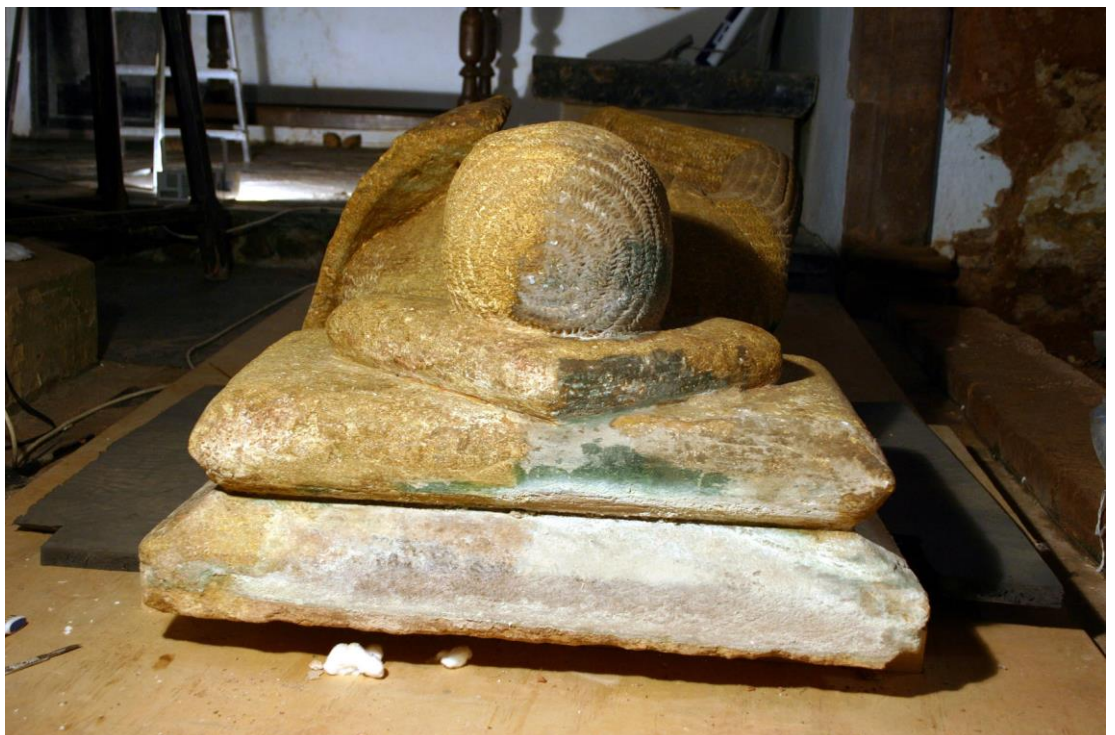
Plate 7 (below): cleaning in progress; the head end

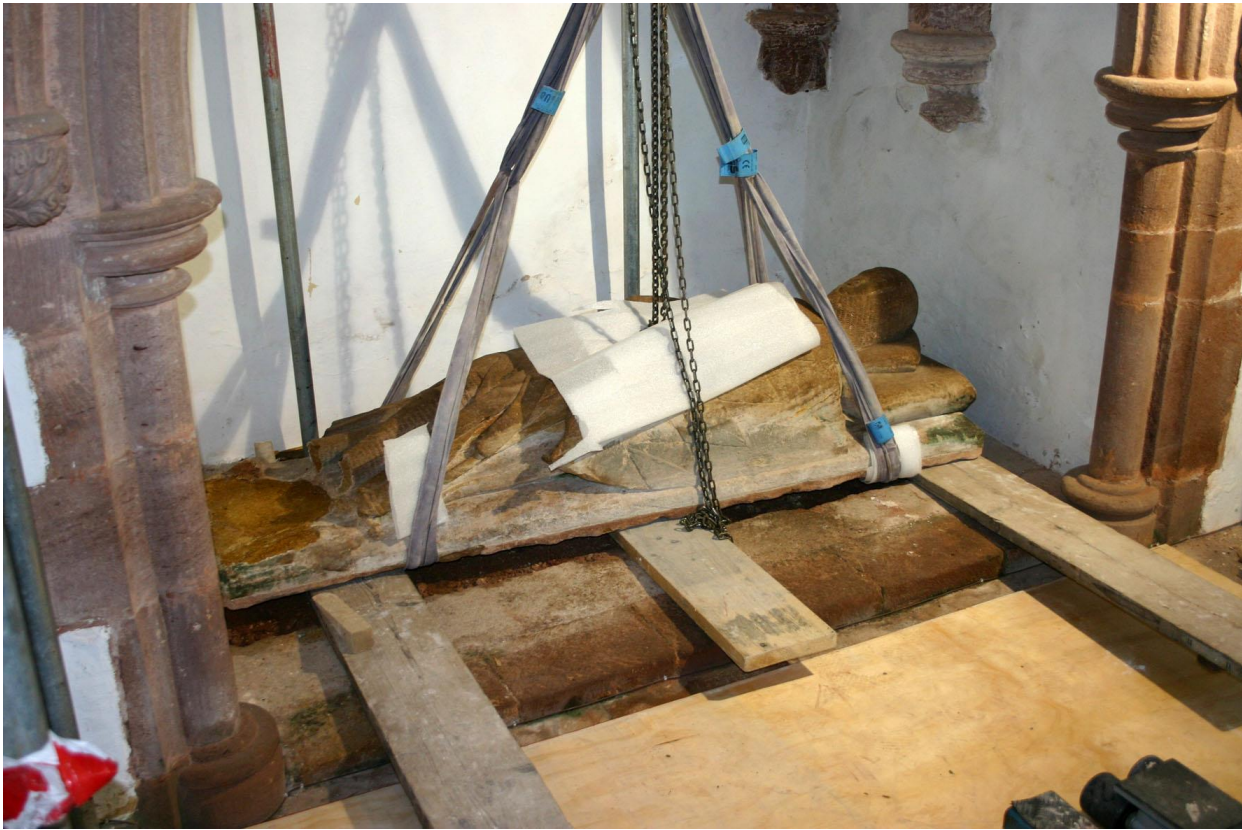
Plate 8: Work in progress: above, lifting the effigy out of the recess

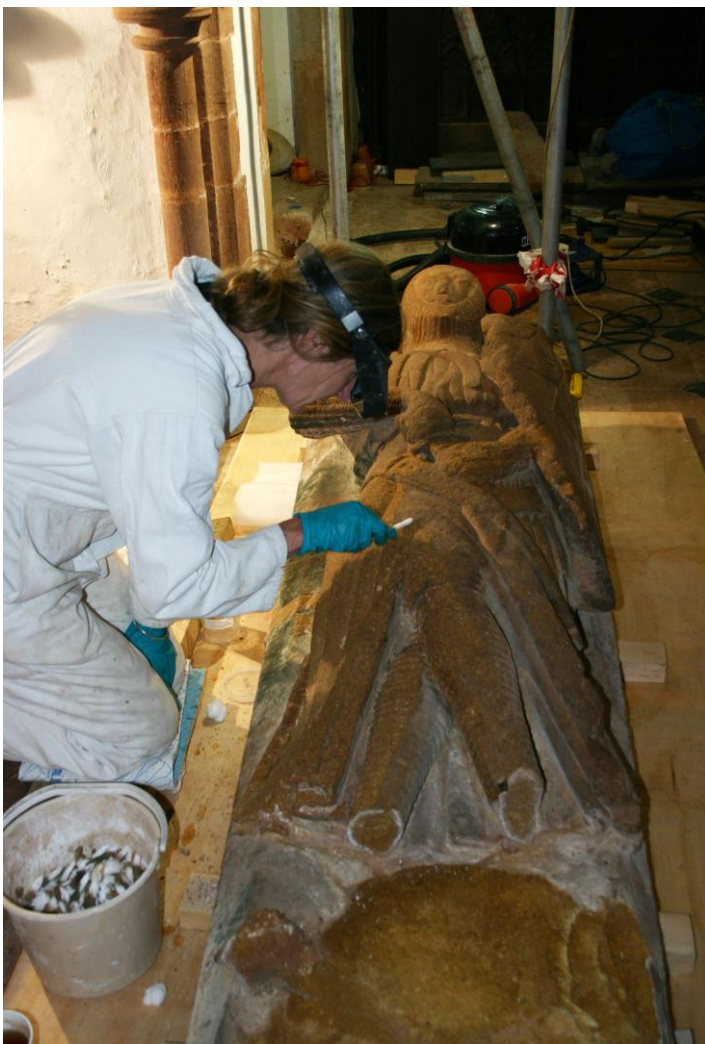
Plate 9 (left): conservator in action

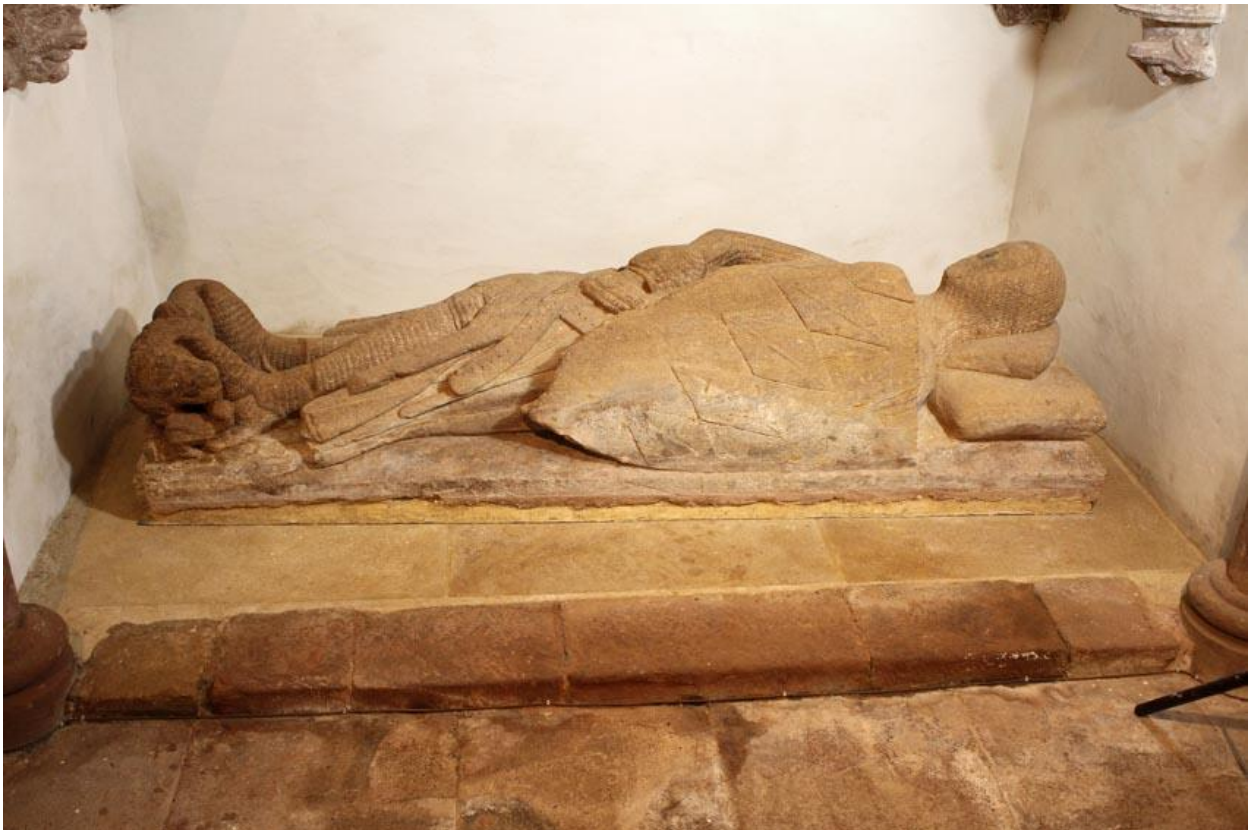
Plate 13 below: the effigy of Sir Simon Raleigh after work finished

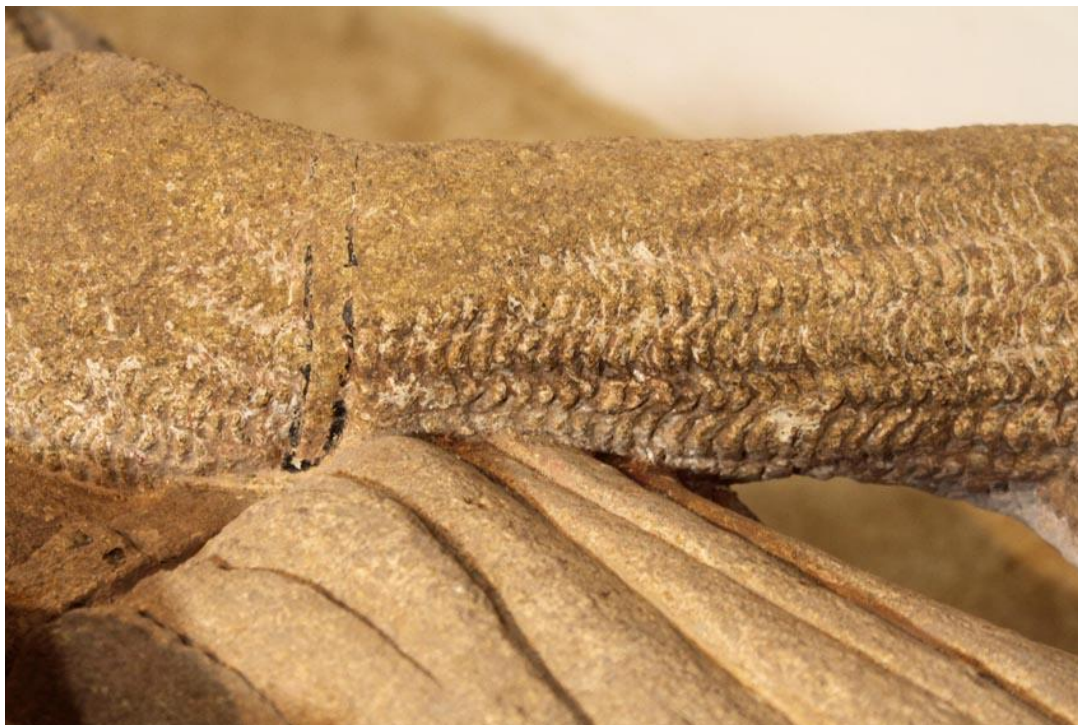
Plate 16 polychrome on the mail: the spurs picked out

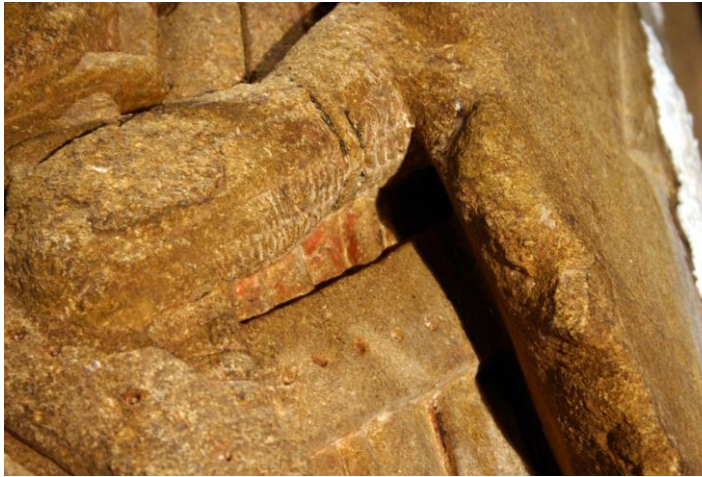
17 left: red on the surcoat

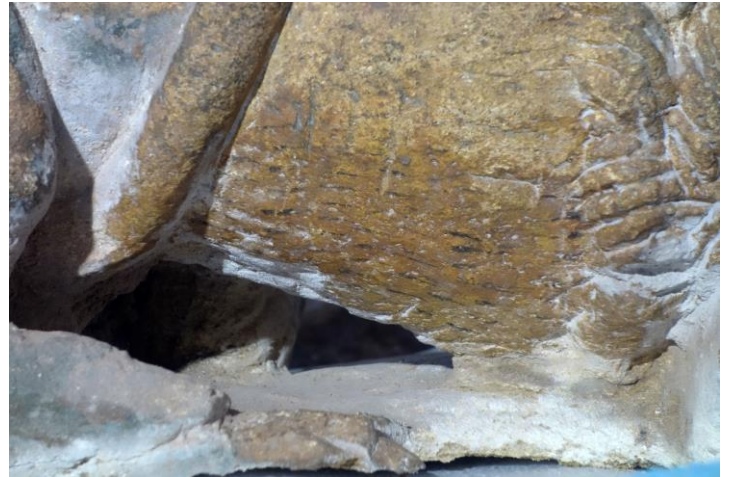
19 below right: gold and black stripes on the lion

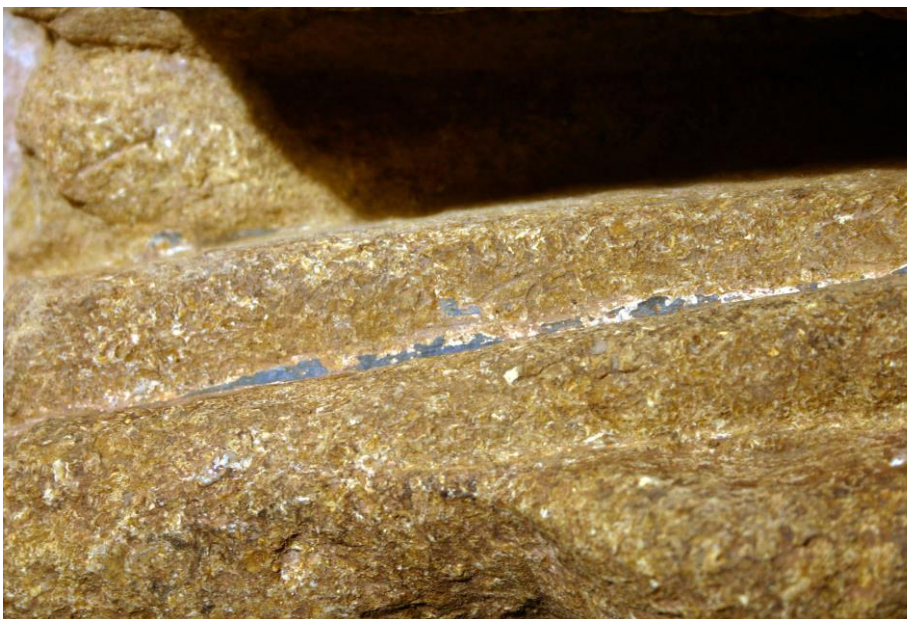
20 bottom: blue along the edges of the surcoat

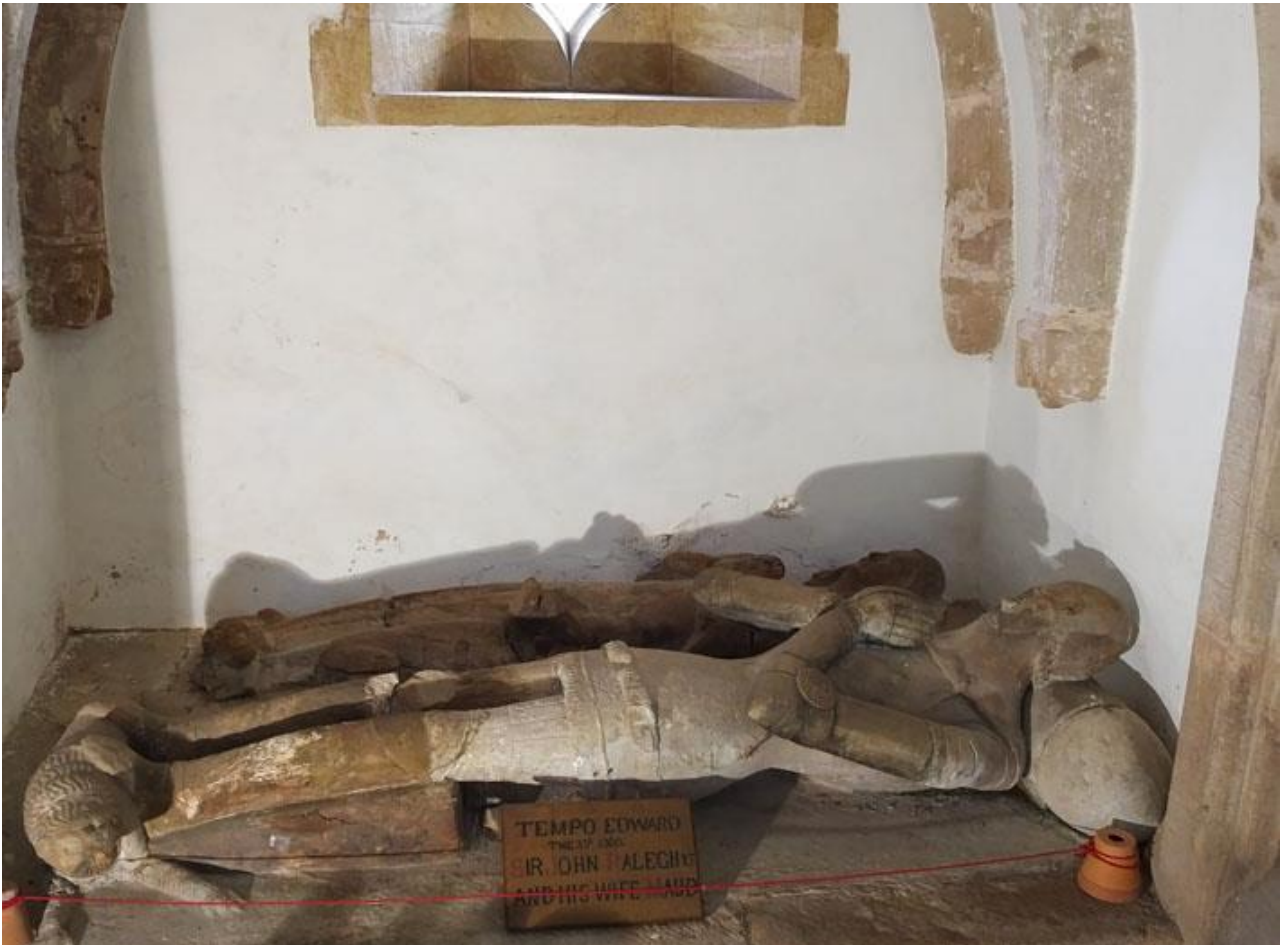
Plate 23: the figure of Maud obscured behind that of Sir John

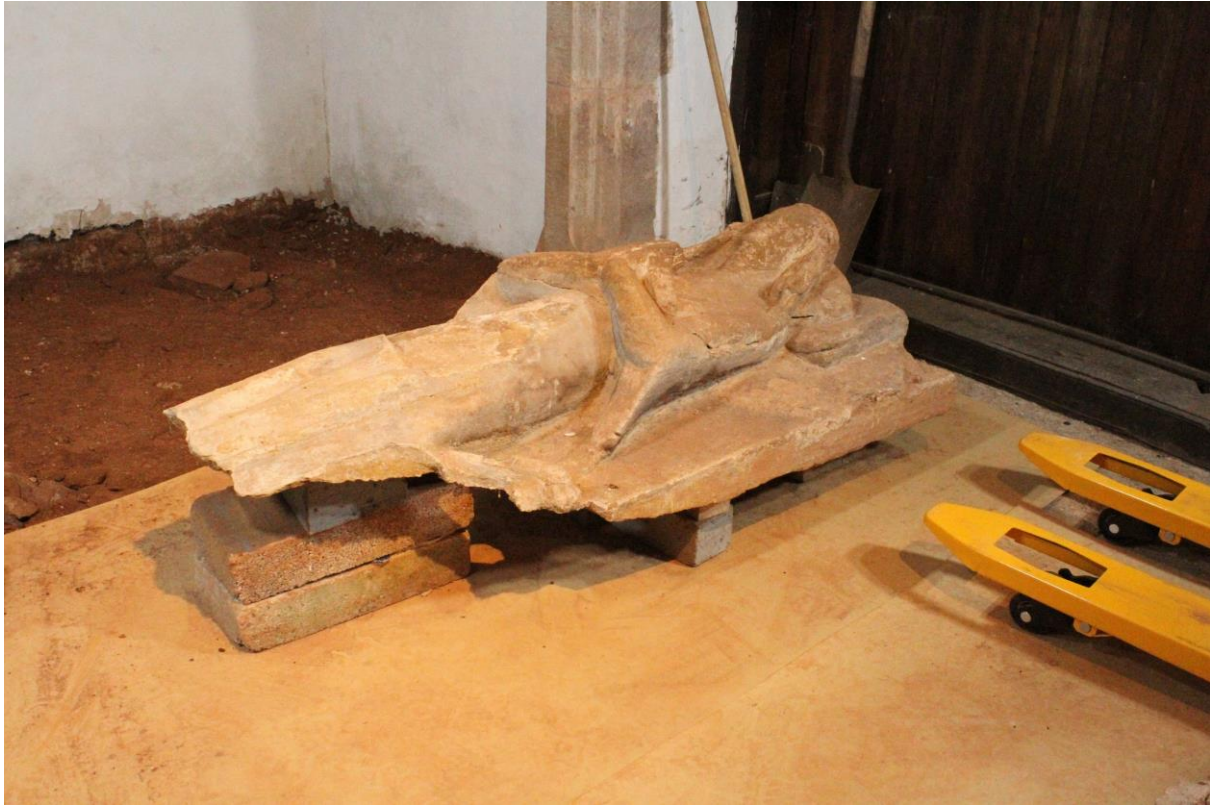
Plate 33: lower fragment, showing poor condition and stone weakness

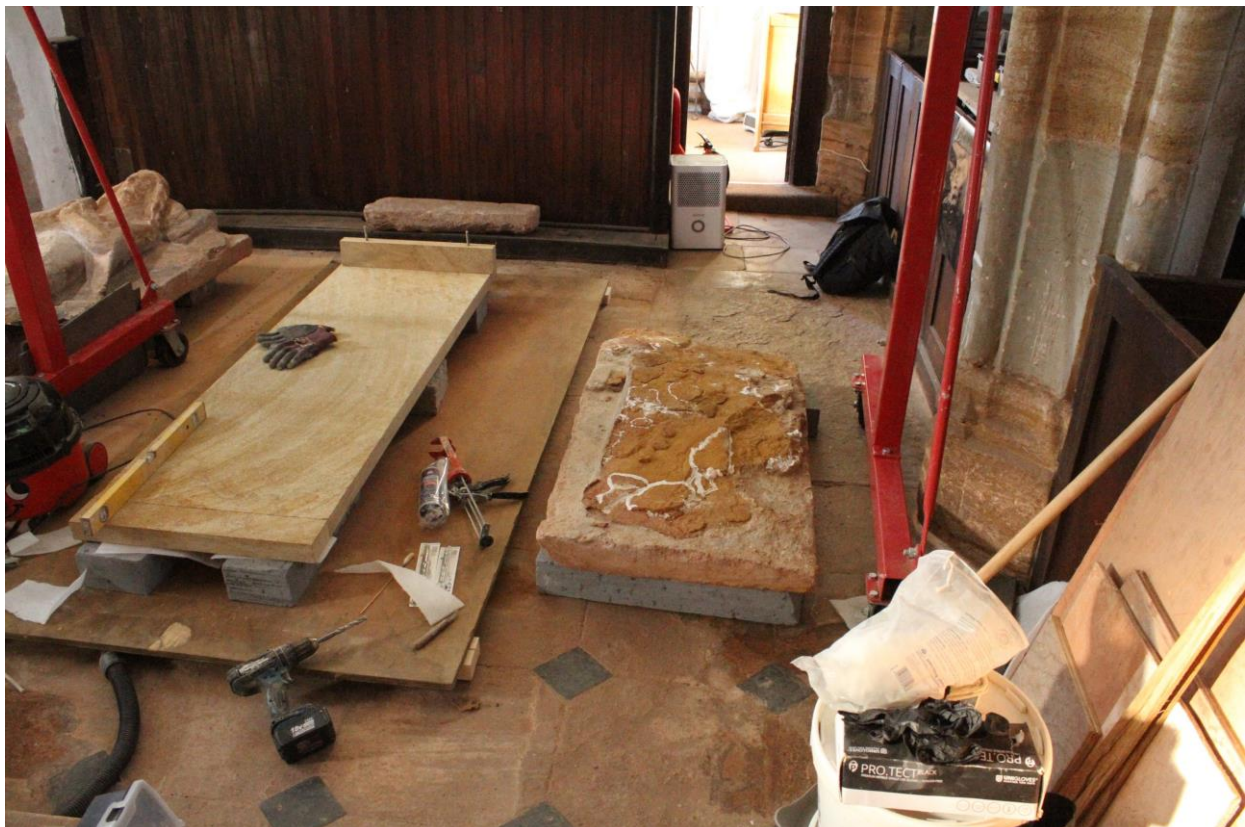
Plate 35: new support slab supplied, and consolidation in progress with nanolime to lower fragment

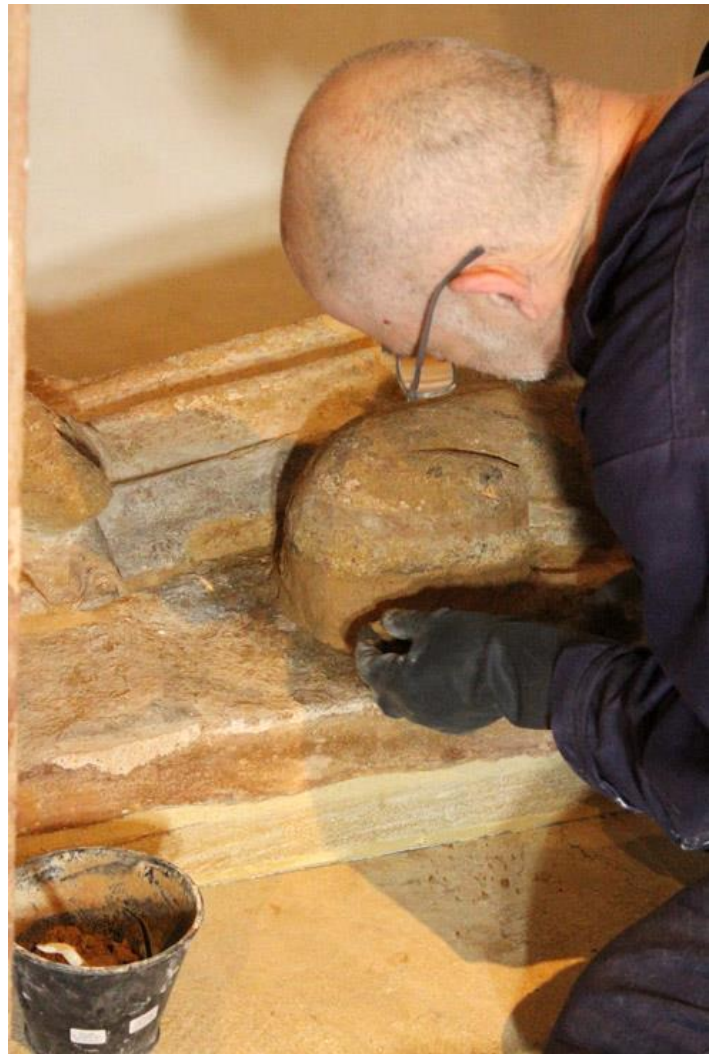
Plate 37: Mortar repairs to the companion hound in progress

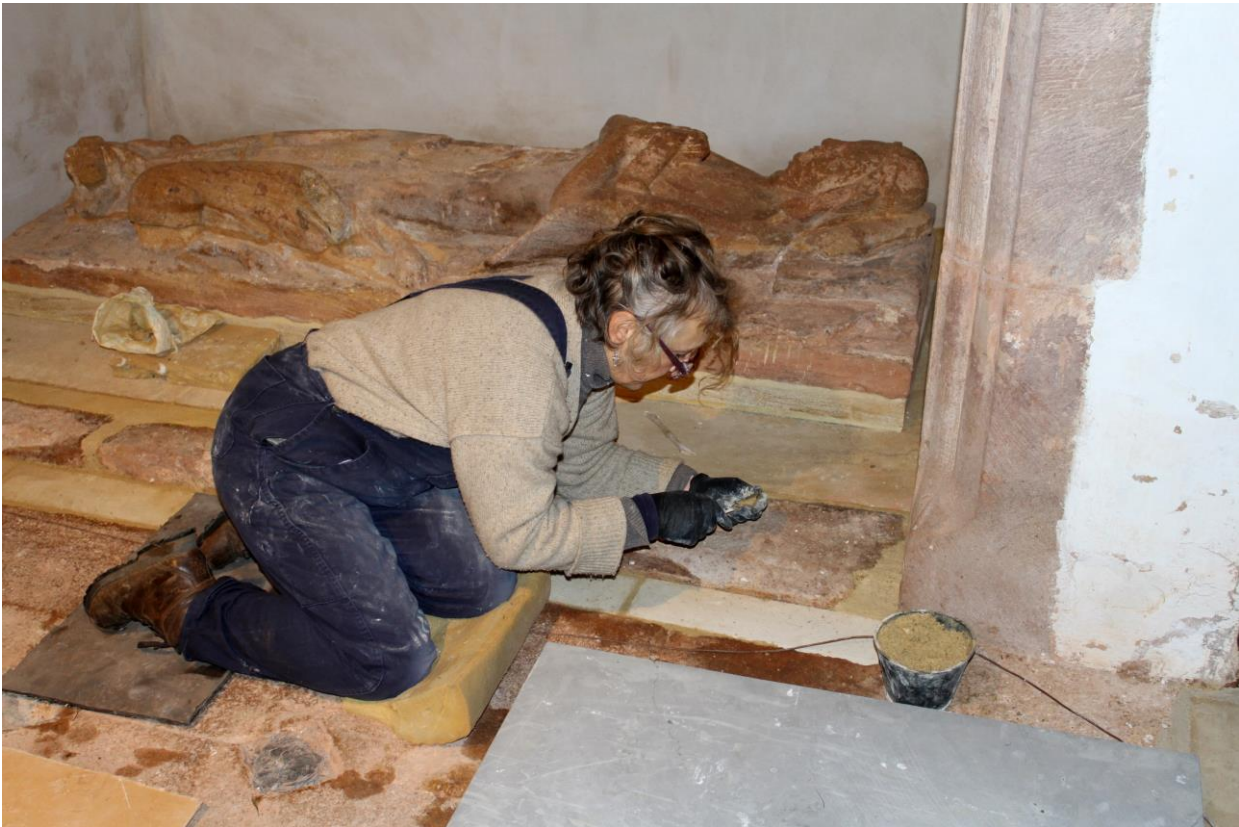
Plate 39: pointing of new floor slabs in progress

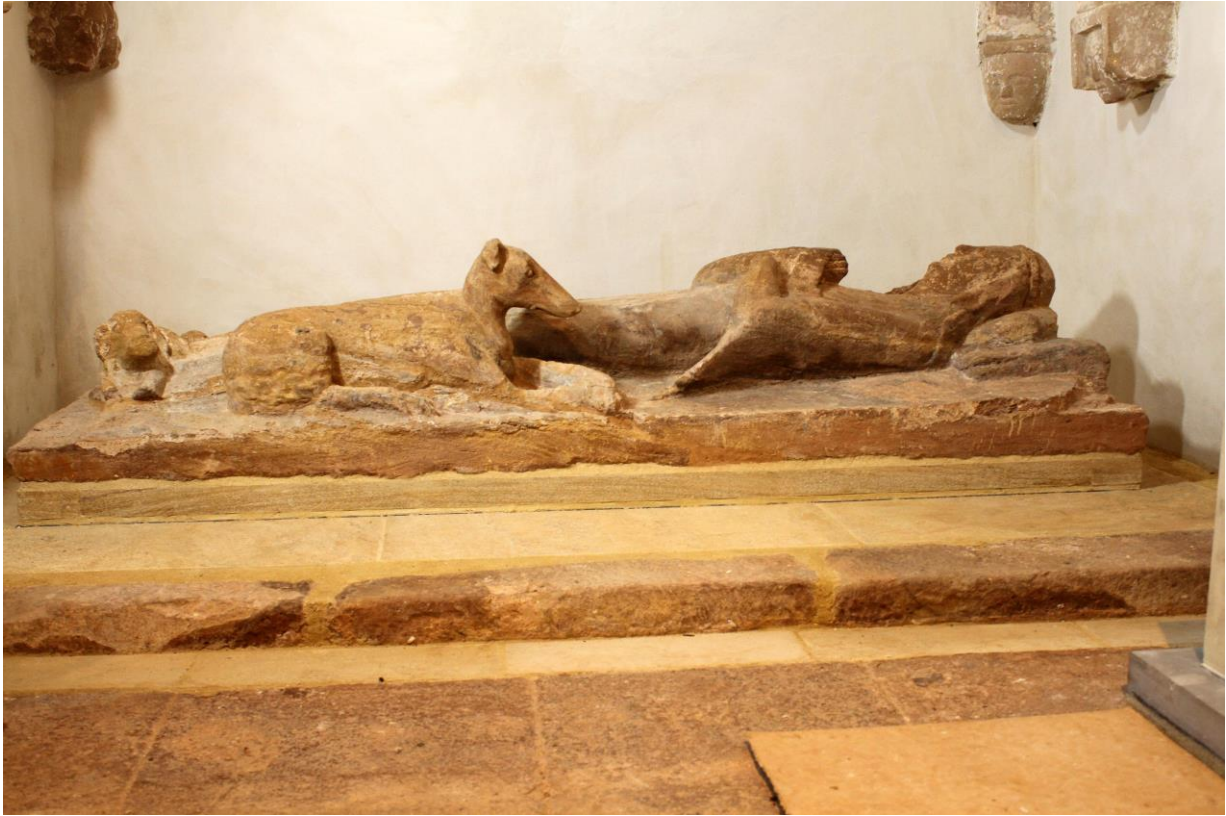
Plate 40: Effigy of Maud reinstated and complete

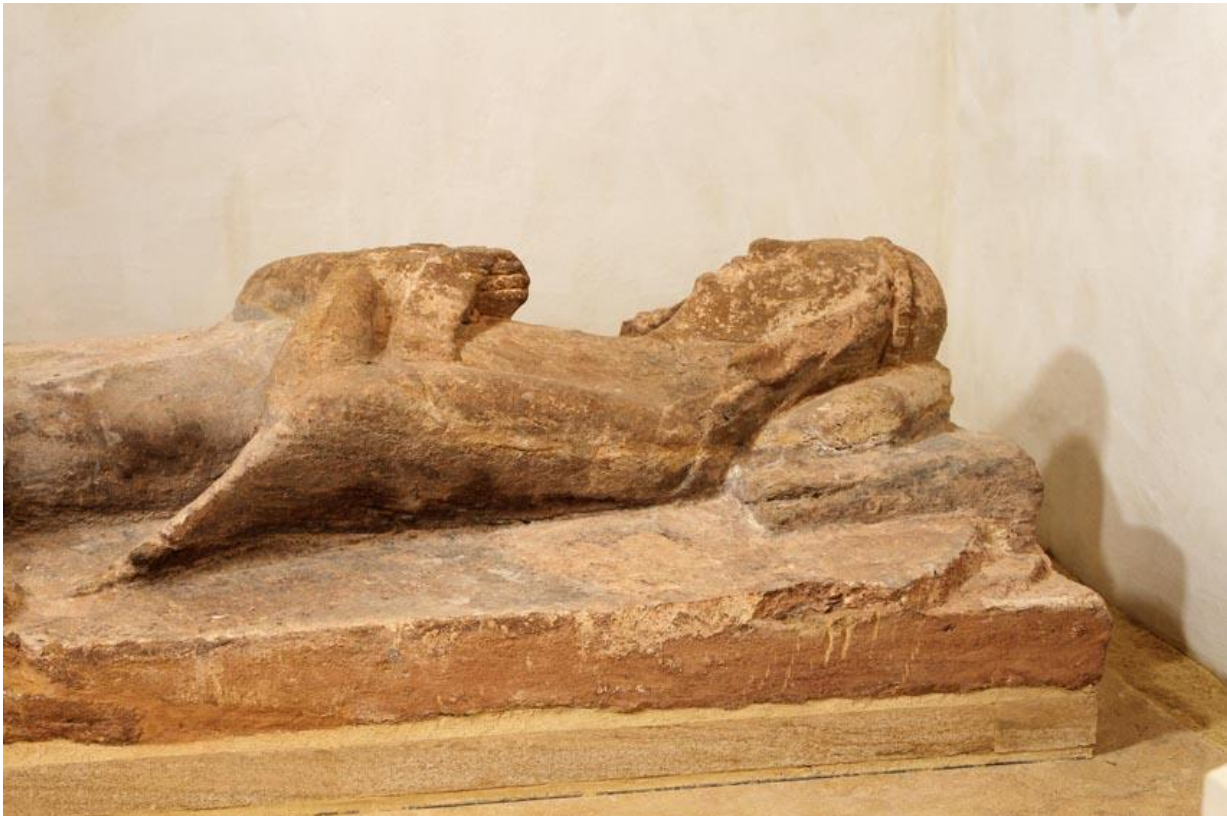
Plate 41: the upper section of the effigy after work

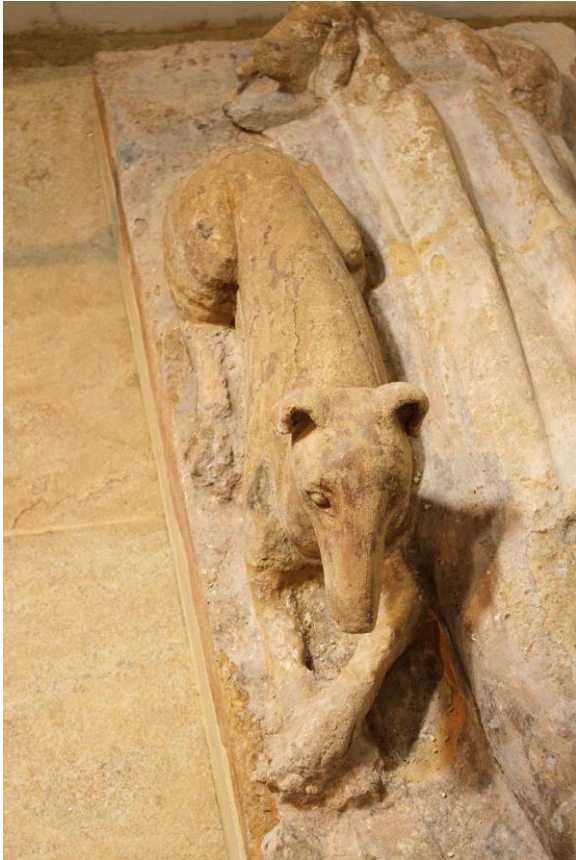
Plate 42: the Companion hound from above

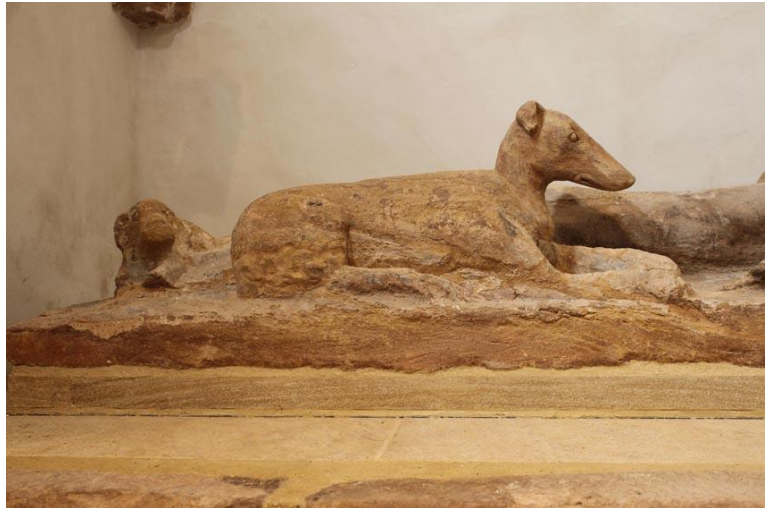
Plate 43 The companion hound from the side

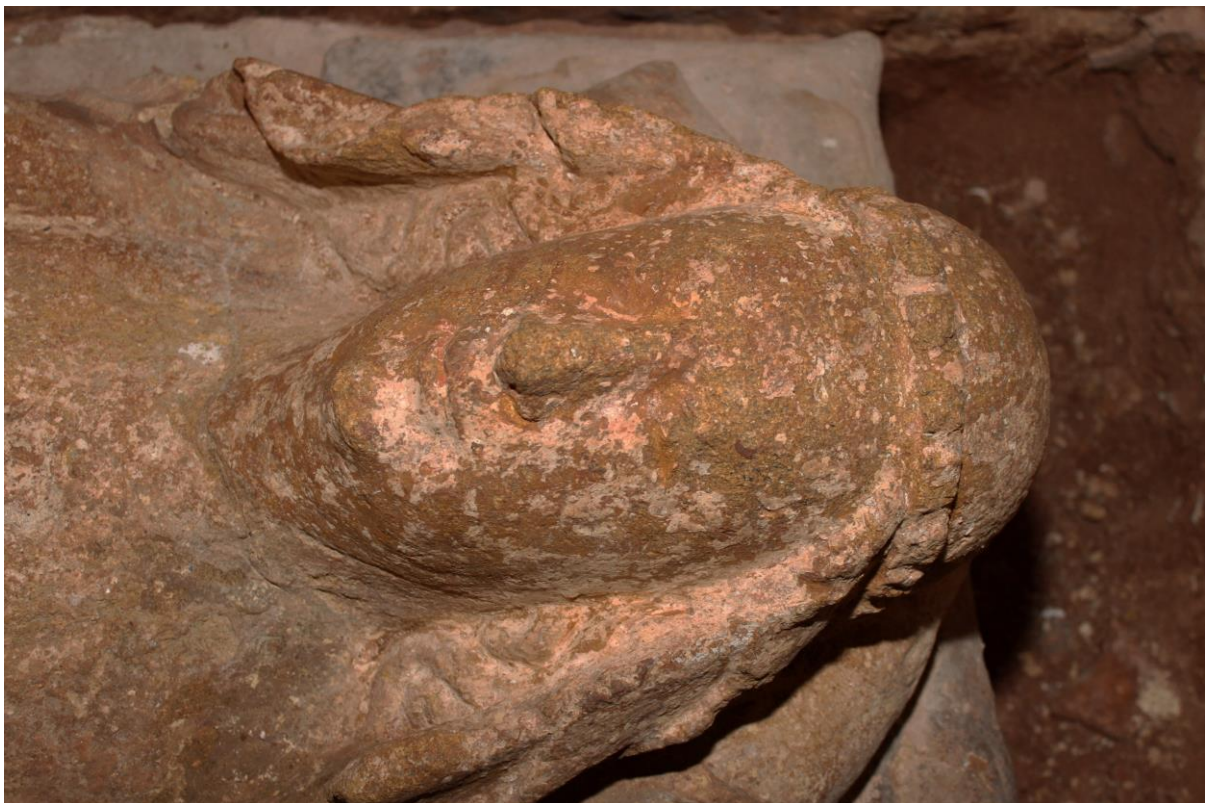
Plate 44: Maud's head, with kerchief, curling locks of hair and tiny remnants of red colour on the lips

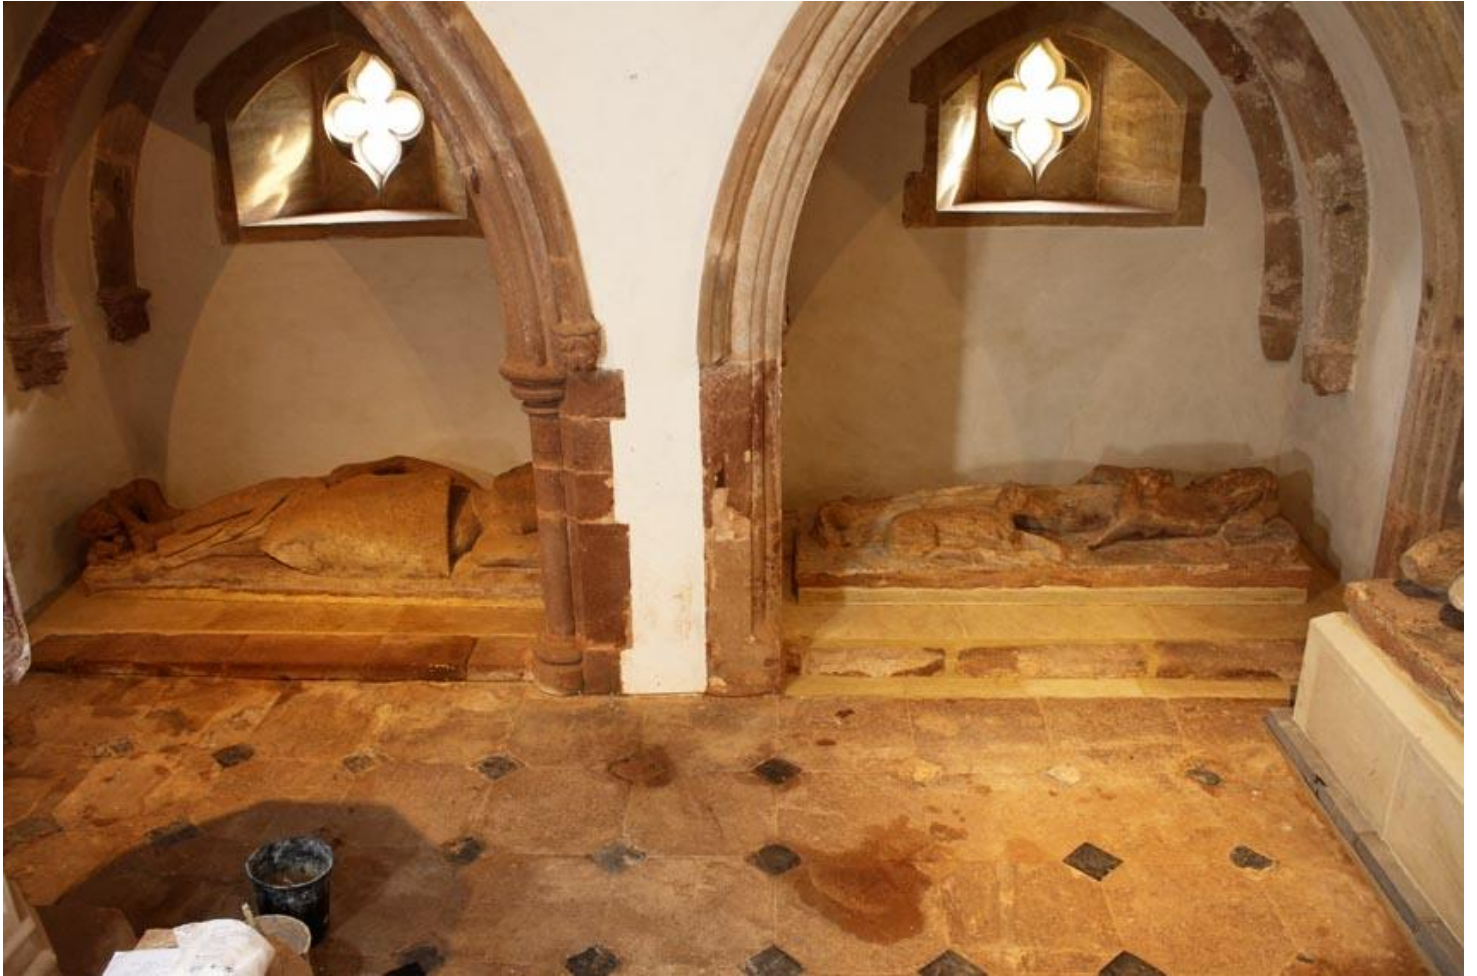
Plate 45: view of the two recesses after work

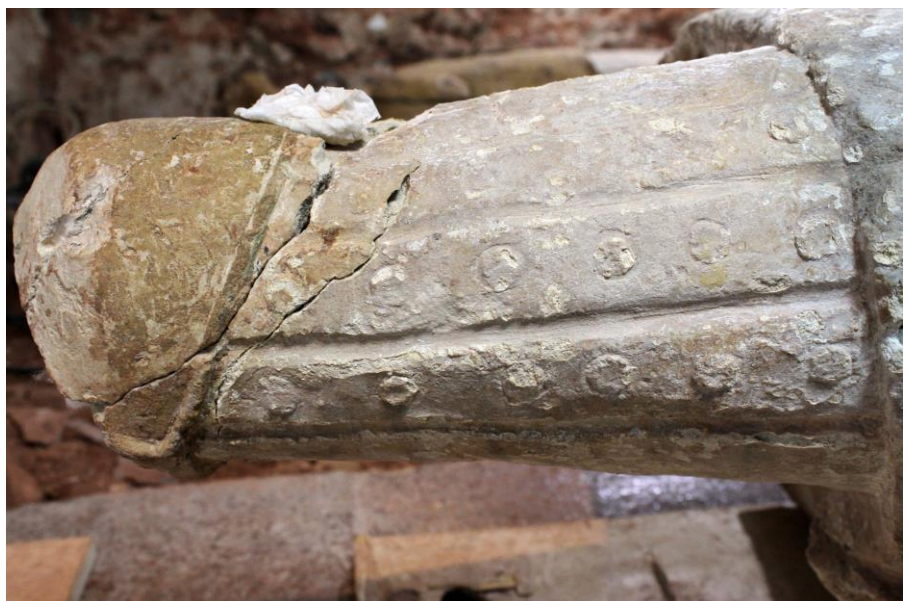
Plate 56: Repairs to sinister leg in progress

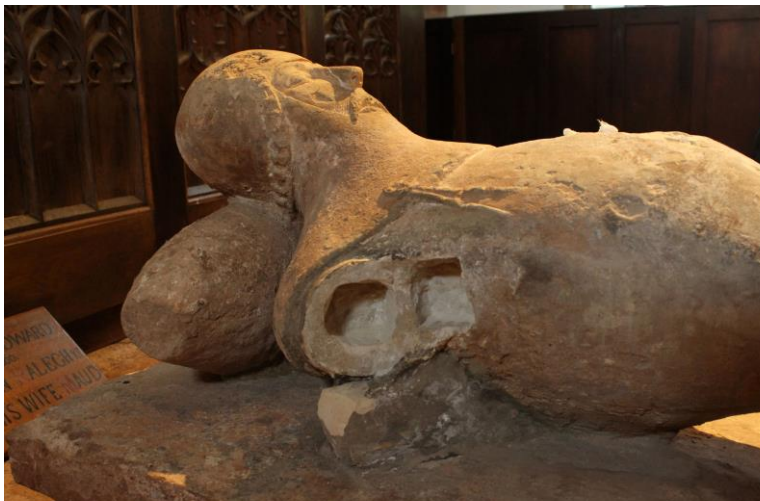
Plate 58: holes cut to take previous arm repairs, and cemented block to support those arms

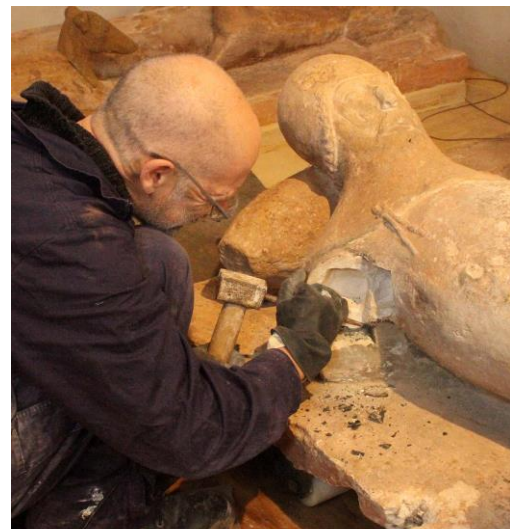
Plate 59: removing the cement and block

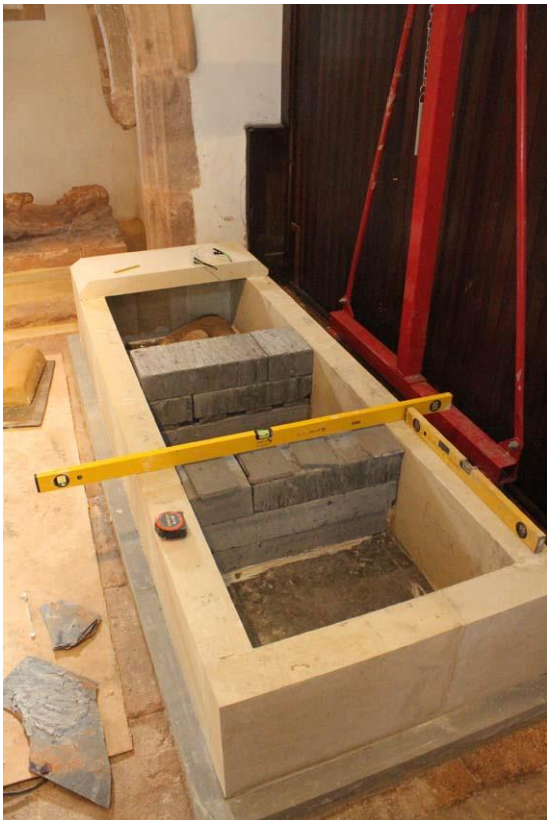
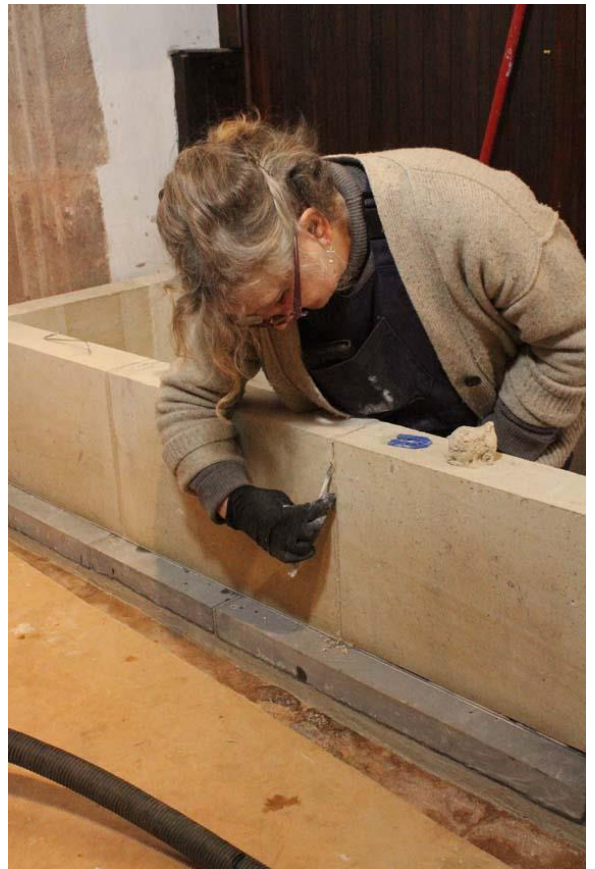
Building the side walls: cross walls of light block inserted; pointing the side walls

The plinth was built, bedded and pointed with lime mortar to provide a level top and plumb walls, which necessitate some variation of the base joint as the floor was worn and uneven. Internal walls of lightweight block were inserted at two points to add strength and stability, and a lead membrane was introduced under the Marnhull stone side panels to ensure no rising dampness could reach the effigy. It was agreed that the modern repairs to arms hands and helm were not to be reinstated, and these were inserted inside the plinth where they could be safely stored against the possibility of future antiquarian interest.

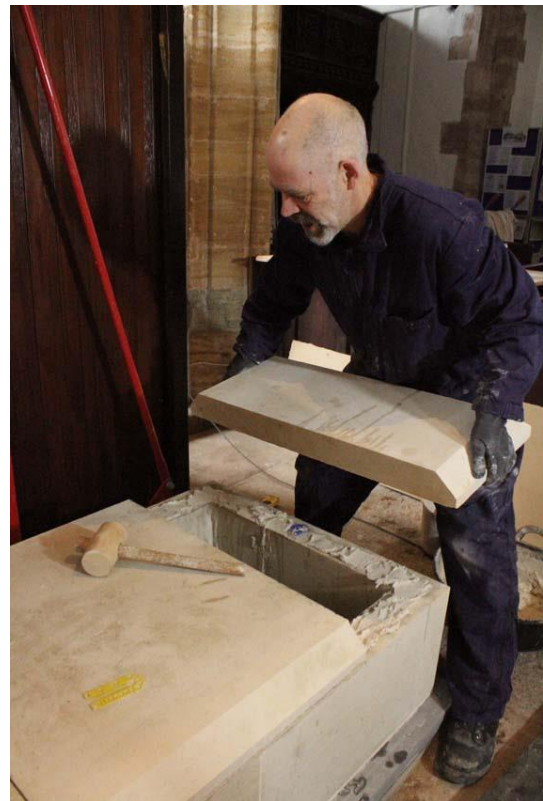
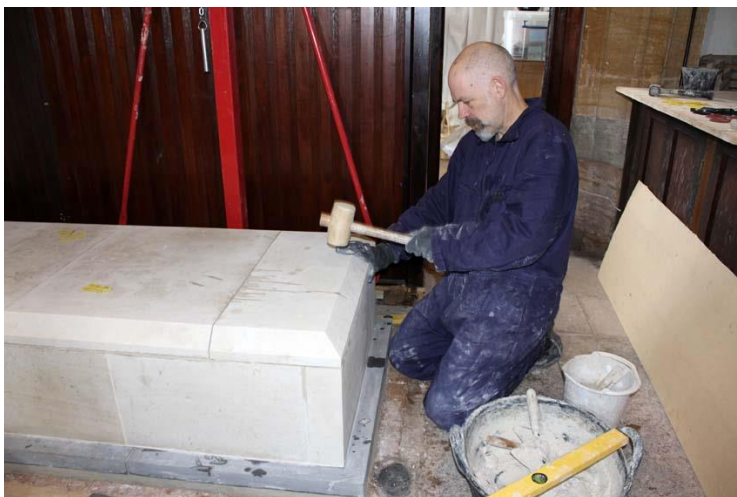
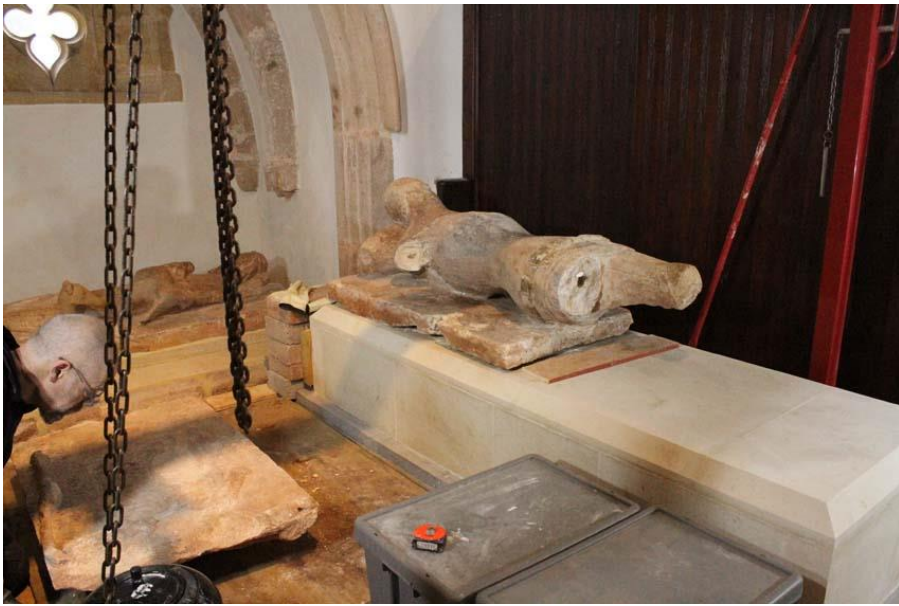
Old repairs installed within the plinth; laying the top slab; tapping the last stone into place
