## **St Mary's, Nettlecombe, Somerset (Diocese of Bath and Wells)**

**Effigies attributed to Sir Simon, Sir John and Maud Raleigh**

### **Conservation and Relocation Report**

**February 2022**

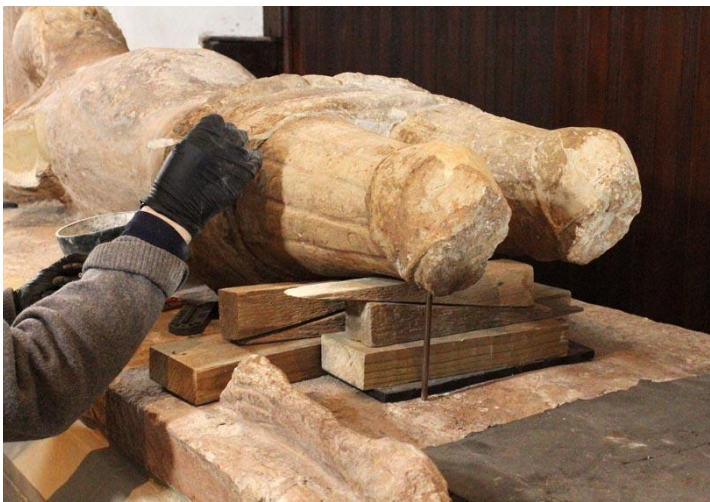
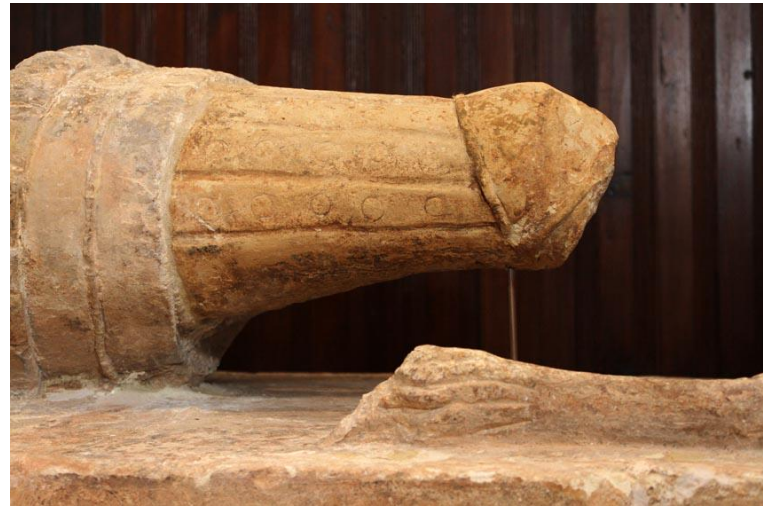
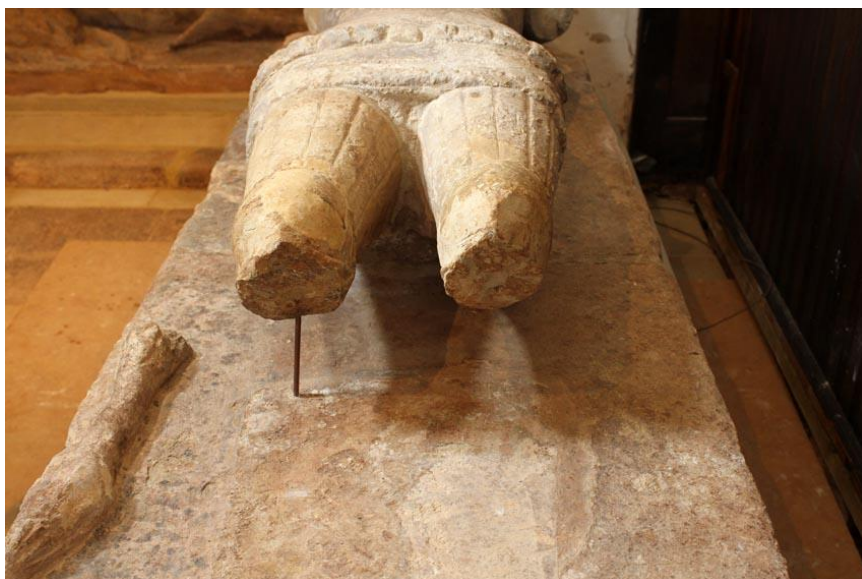
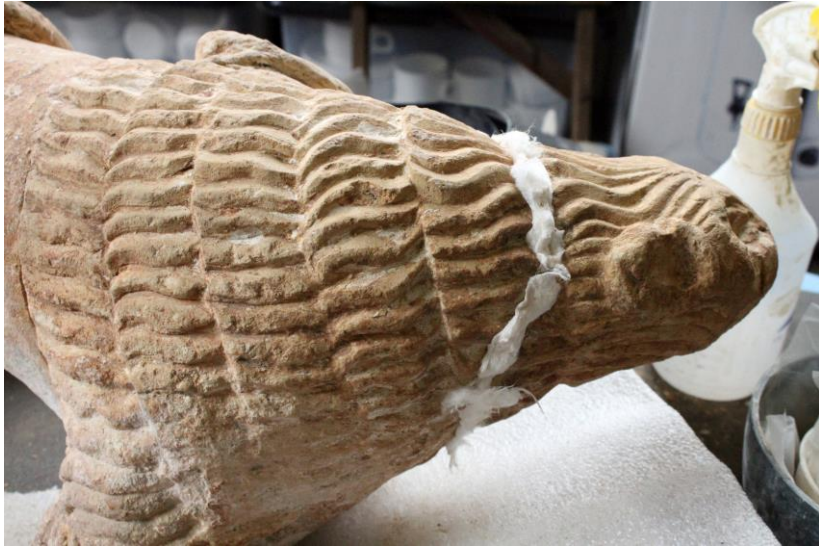
Plates 73-6: Repairs to dexter leg

Left, new basalt dowel inserted

Below right, small phosphor bronze support dowel

Bottom, The completed repair

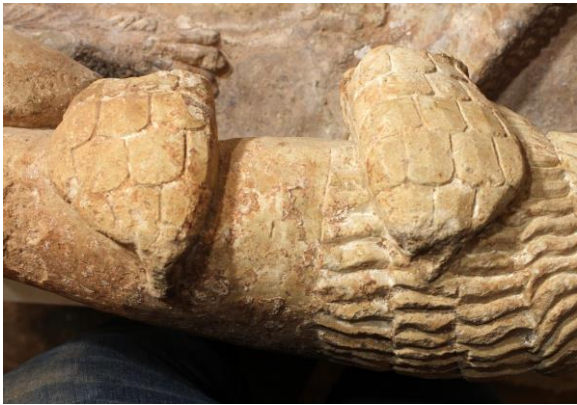
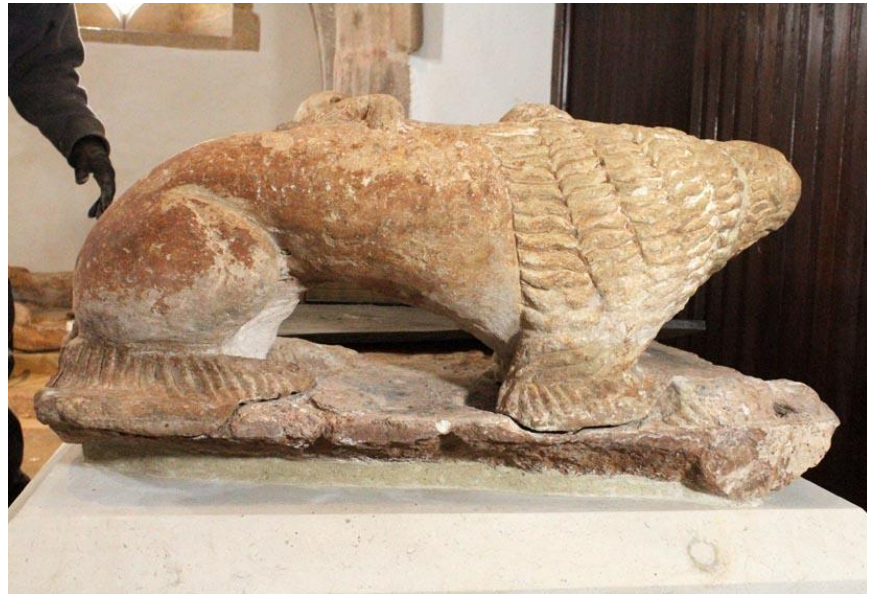
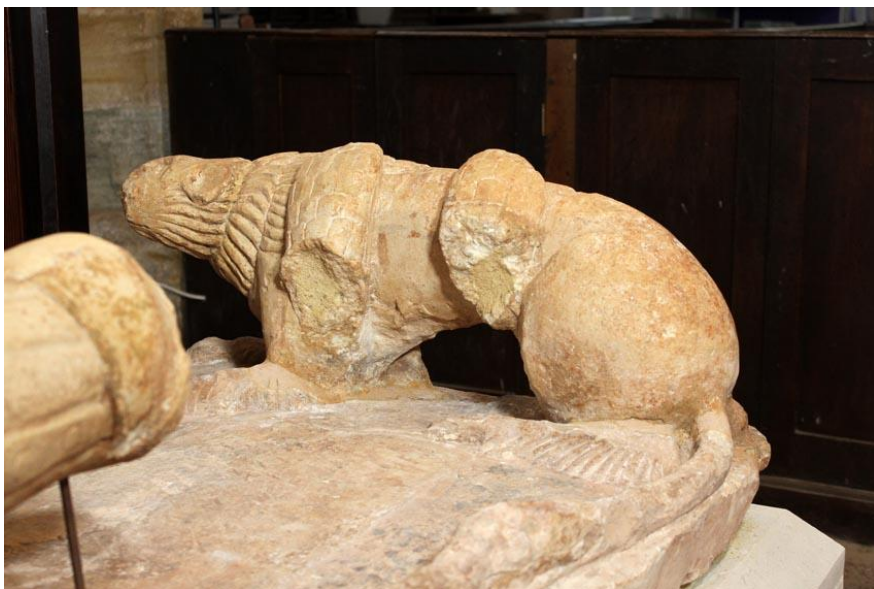
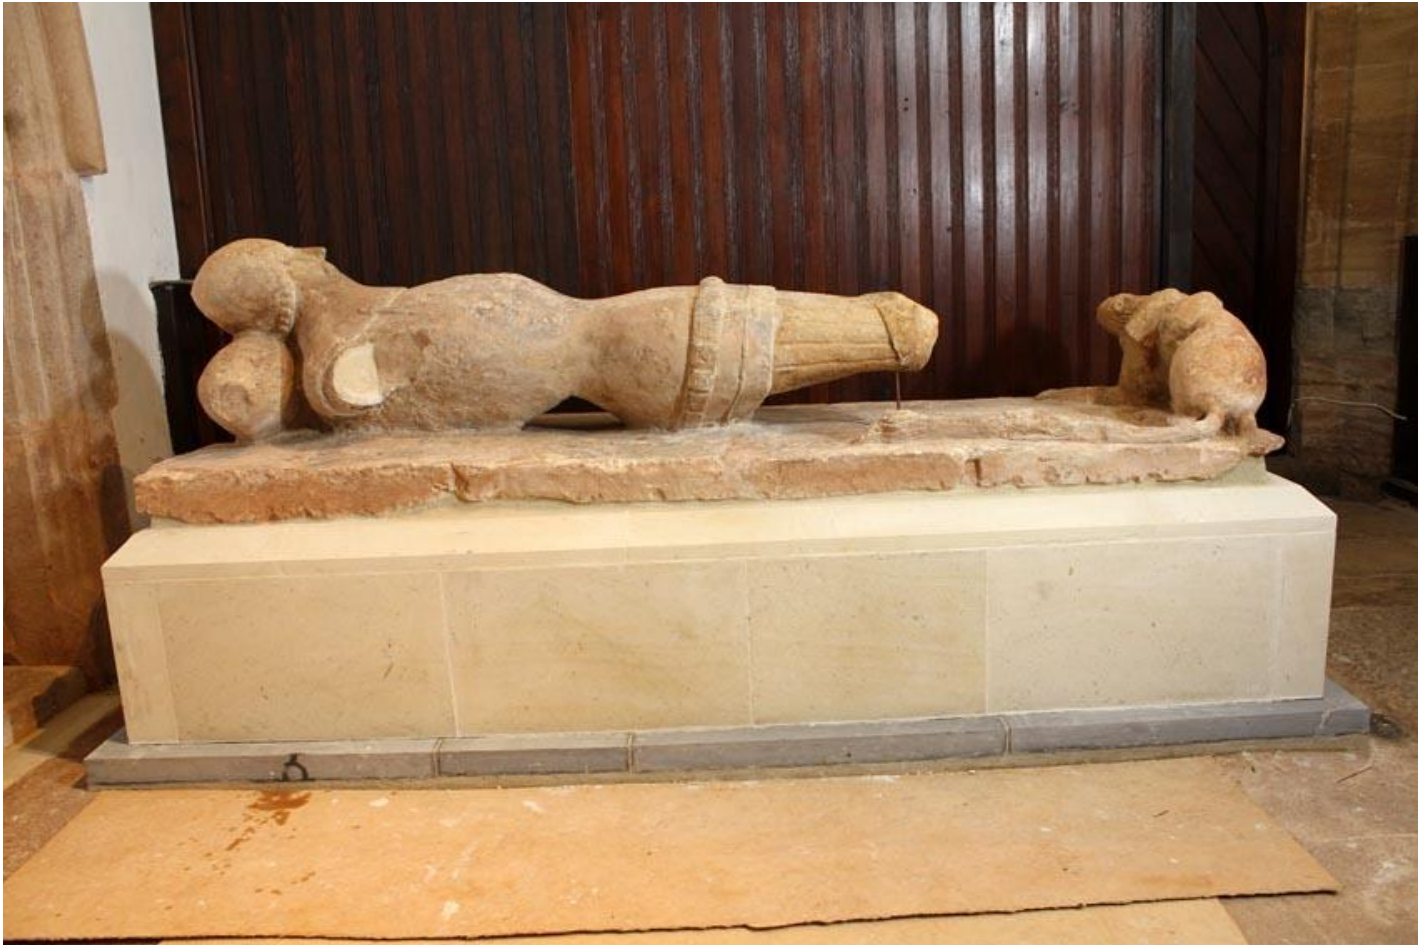
Plates 77 – 80: Repairs to the supporting animal

Left, repairs to the neck in progress

Below left, detail, the knight's shoes

Bottom, the supporting animal in position and complete

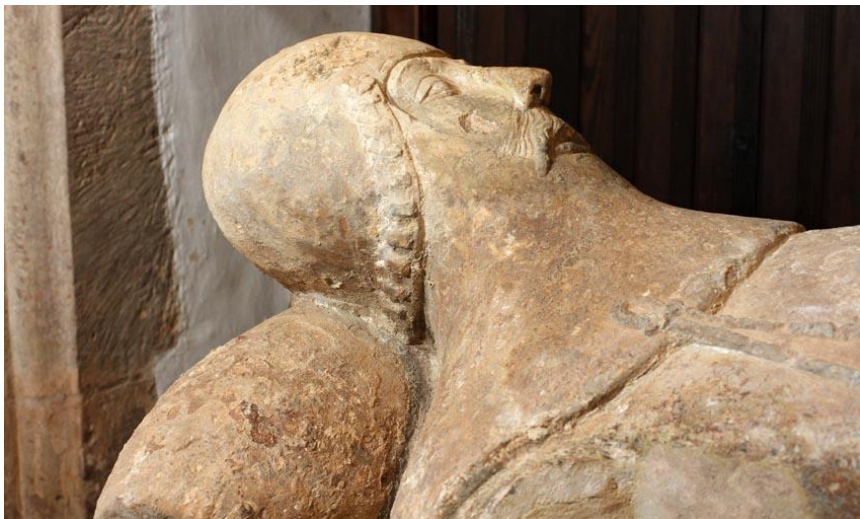
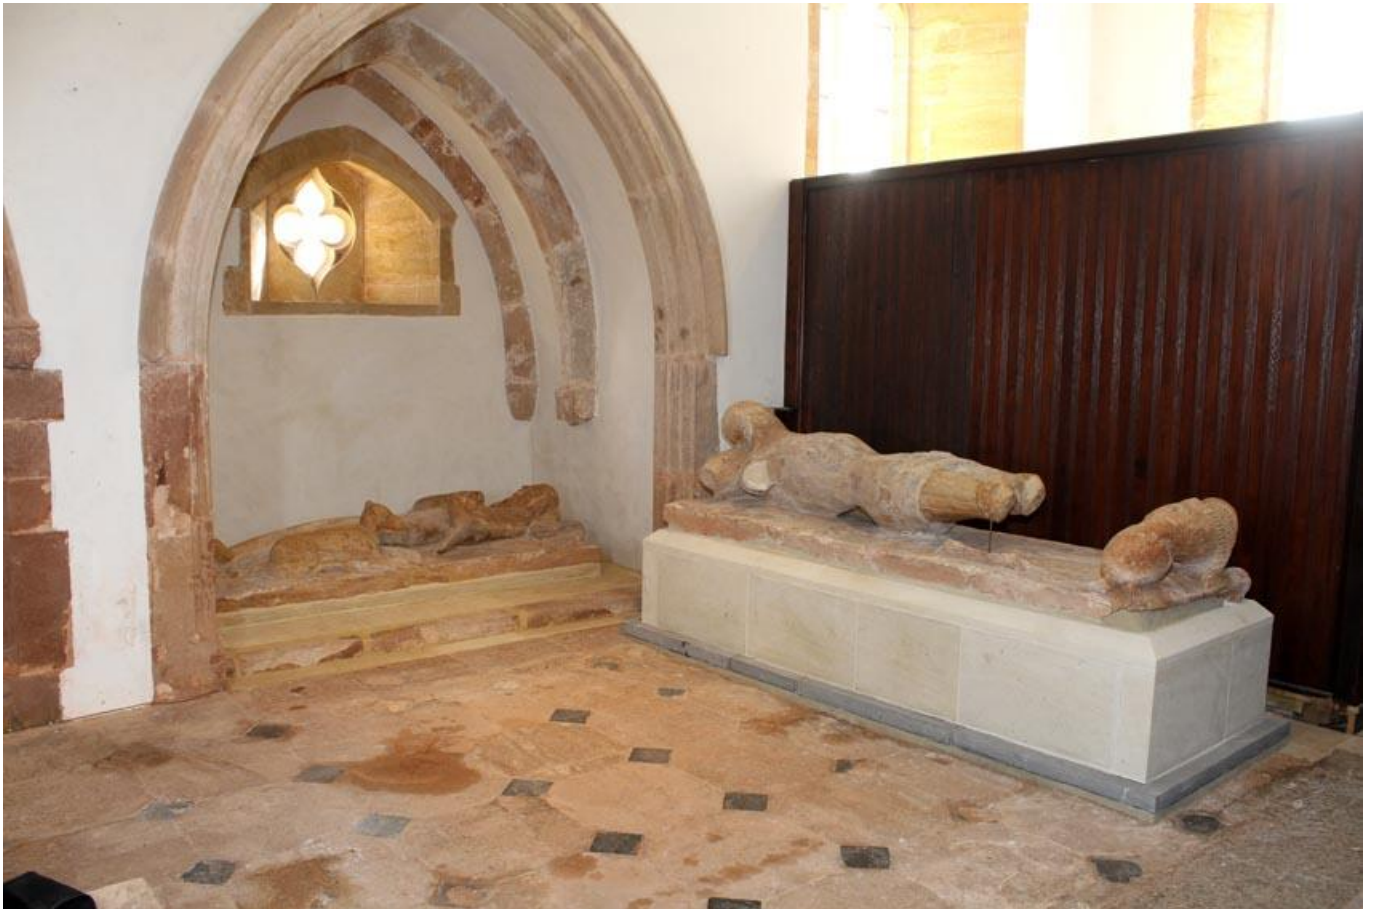
Plate 81: Effigy of Sir John after work was complete  
Plates 82 and 83: details of the knight's face and armour
