Ledbury Surveys Ltd

Refurbishment/Demolition Survey

All Saints Church
Worcester
WR1 2HN

Ledbury Surveys Ltd has undertaken a Targeted Refurbishment / Demolition survey at All Saints Church, Worcester, WR1 2HN

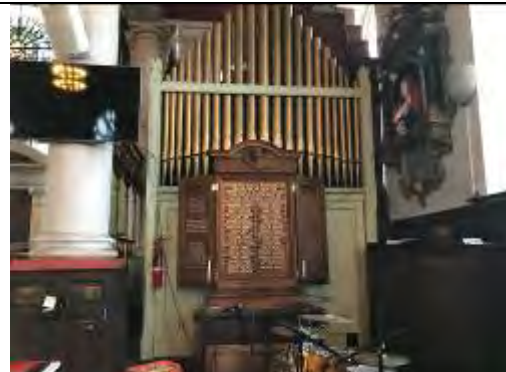
Organ. No access within

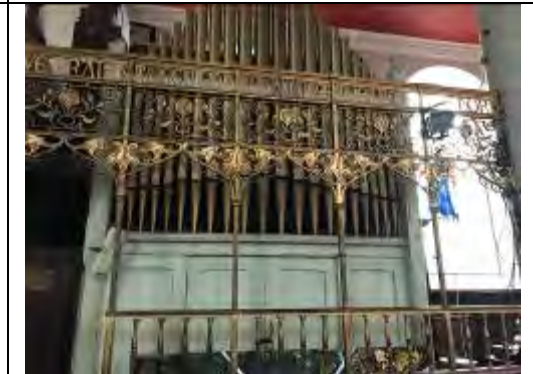
Organ. No access within

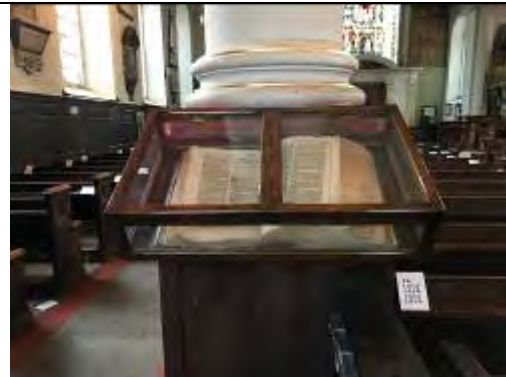
Bible and case to be removed and relocated

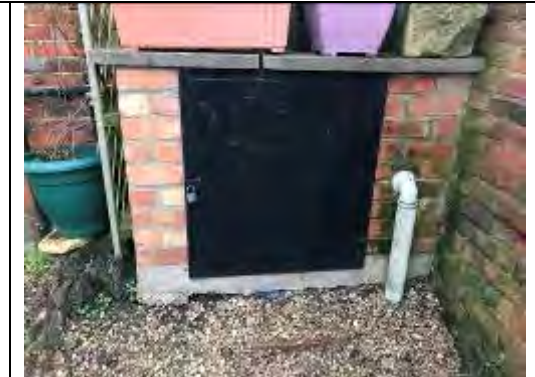
No Access to Tower. Not included in scope of works

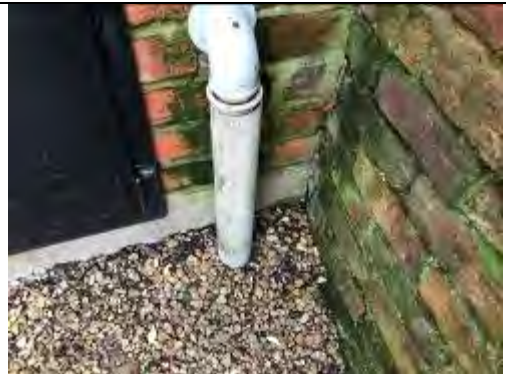
Gas House

Cement pipe sleeve
ASC/3
NADIS

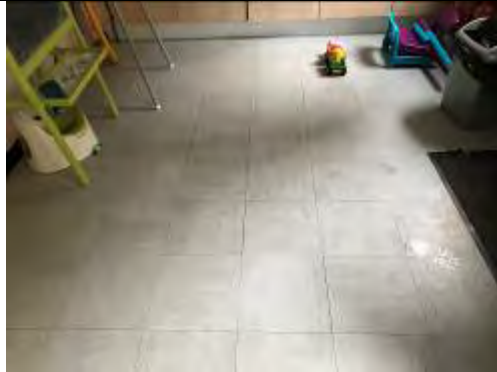
Vinyl floor tiles and adhesive
ASC/4
NADIS
