**THE BLESSED VIRGIN MARY CHURCH, CLOFORD SOMERSET**

**Post Treatment Report for  
The Conservation of The Horner monument  
The Blessed Virgin Mary Church, Cloford, Somerset**

**Job No. 2601**

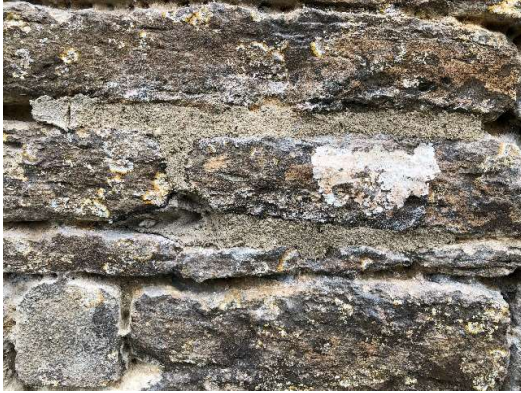
Figure 4 Mortar sample No.1 warm grey

Five samples were made as small tiles and then transferred to the wall to be assessed.

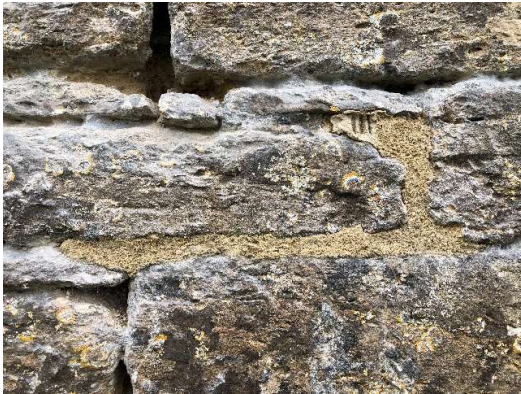
Figure 6 Mortar sample No.3 grey buff

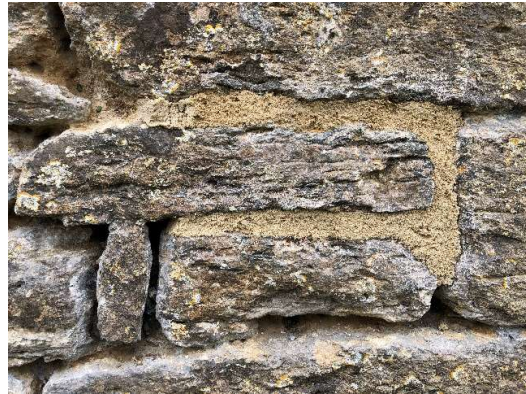
Figure 7 Mortar sample No.3 warm grey buff

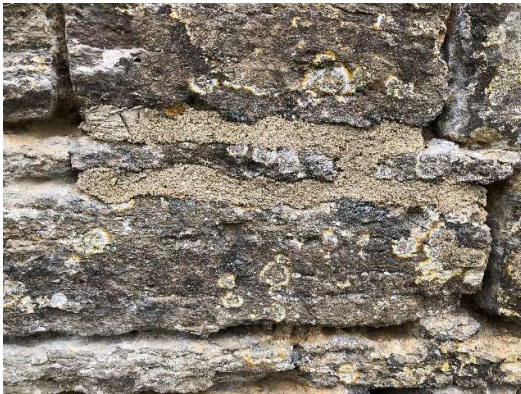
Figure 8 Mortar sample No.5 grey tone

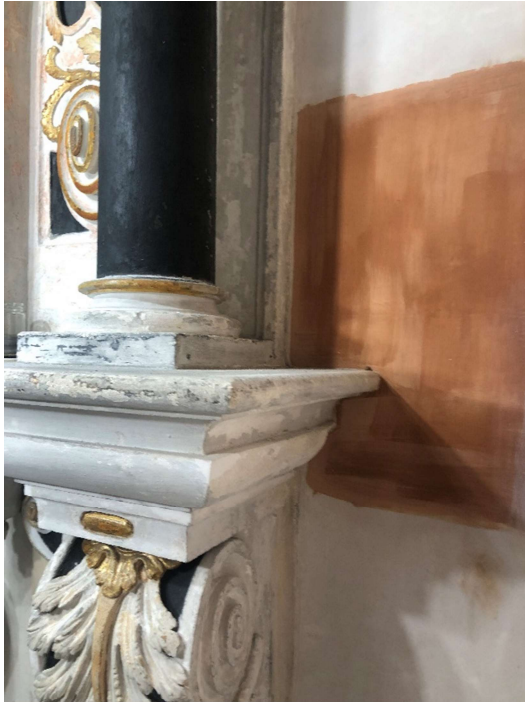
Figure 13 Sample No.1 of the Limewash - Terra Maroc

After carrying out three trials of assorted colours, sienna (soft pink) was chosen. The soft pink was considered to complement the faces of the figures, not clash with the nave white or indeed the monument; the colour is also near to the original Victorian decoration revealed when the white emulsion was removed from the walls.

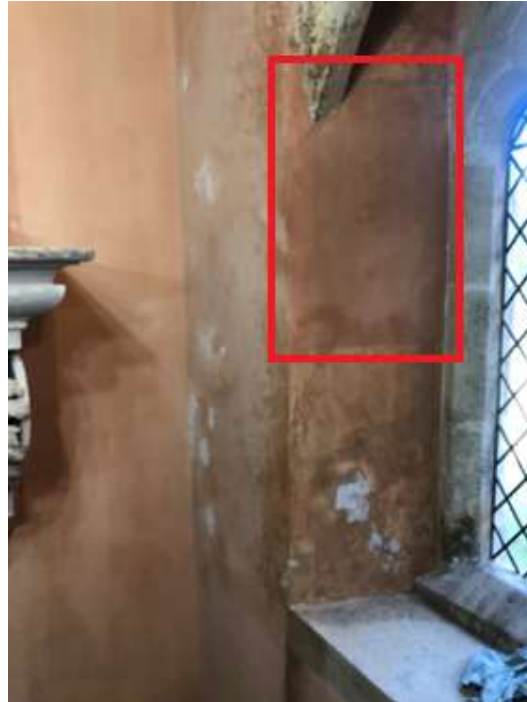
Figure 14 Sample No.2 of the Limewash - Sienna

The paint was a pure limewash type with no casein or other additives. The first coat was watered down and applied to all surfaces to prime the new and paint stripped plaster walls. Four coats of normal strength limewash were then applied.

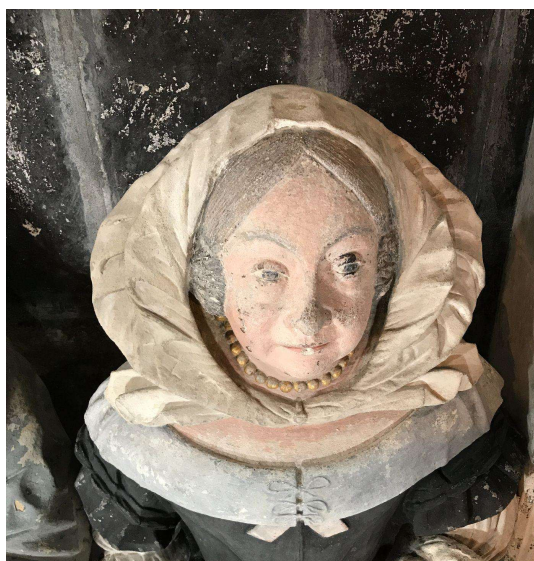
Figure 19 Black painted layer before consolidation

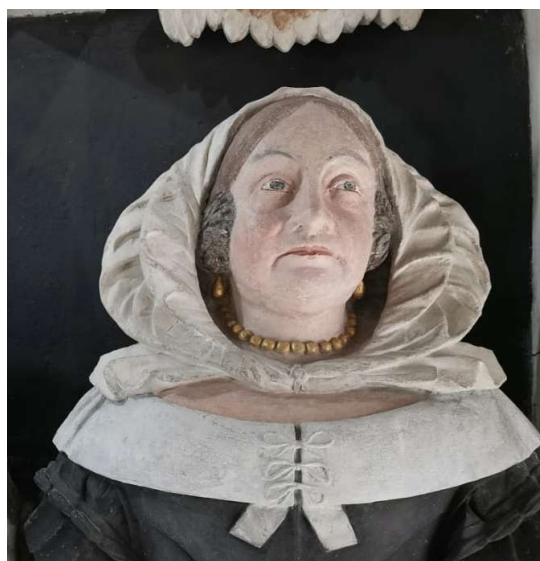
Figure 20 Black painted layer after Consolidation.

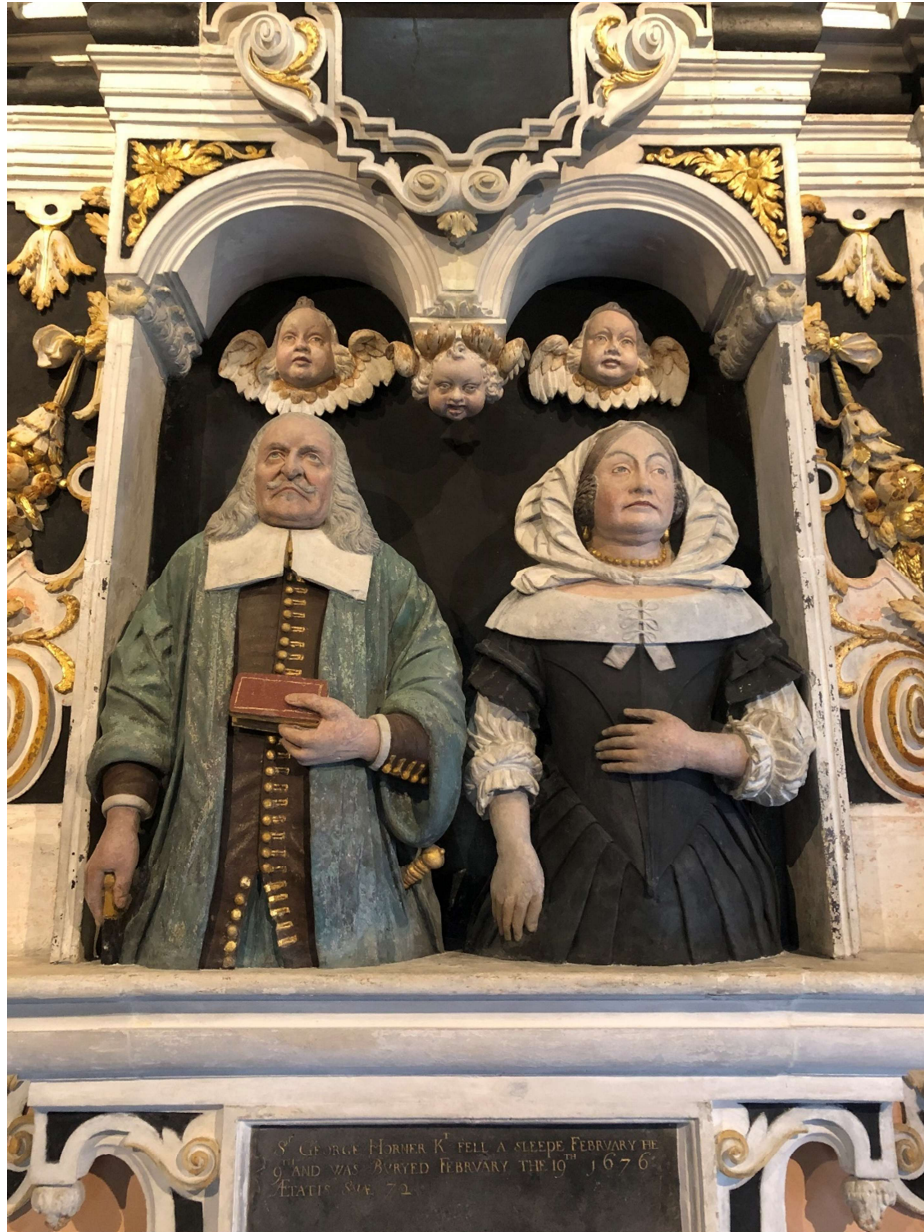
Figure 23 After consolidation and uplifting the cherubs

Once other painted surfaces had been addressed, it was necessary to consider options for treating the three cherubs to bring them up to the same level as the surrounding surfaces. The '2022 SSHC

Evaluation of Trials and Proposed Treatment, The Horner Monument, Cloford Church' report, Section 4: Polychrome, indicated that the eyes, hair, and wings had been in part decorated. The decision was taken to 'colour lift' the three cherubs using the same methods applied to other overpainted areas, as far as emulating what lies underneath and reflecting the earliest colour intent.

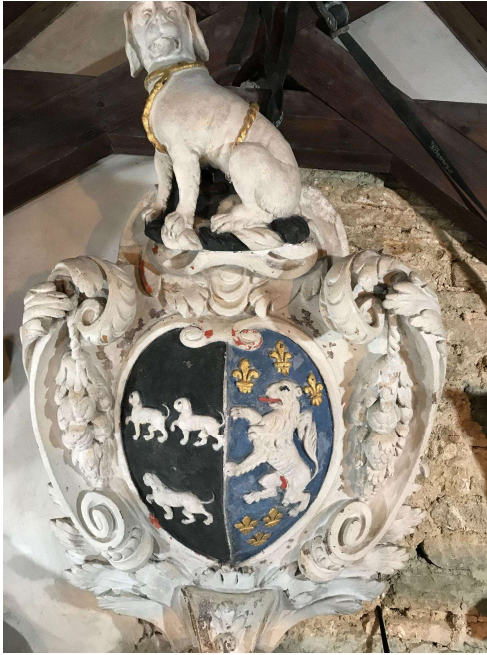
Figure 27. Image to show shield before treatment

One area where it was chosen to remove some of the heavy grey overpaint was to the shield. Here the easily removable overpaint was mechanically removed to reveal as much of the earliest colour scheme as possible, this was followed by tinted consolidation, thus intensifying the depth of colour. The same pigmented 'wash' was also used on top of the sound grey overpaint to tone in areas, helping add uniformity to the shield.

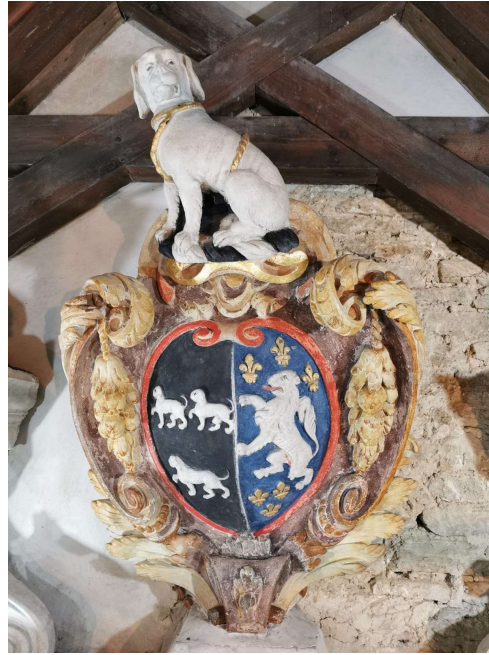
Figure 28 Image to show shield after treatment.

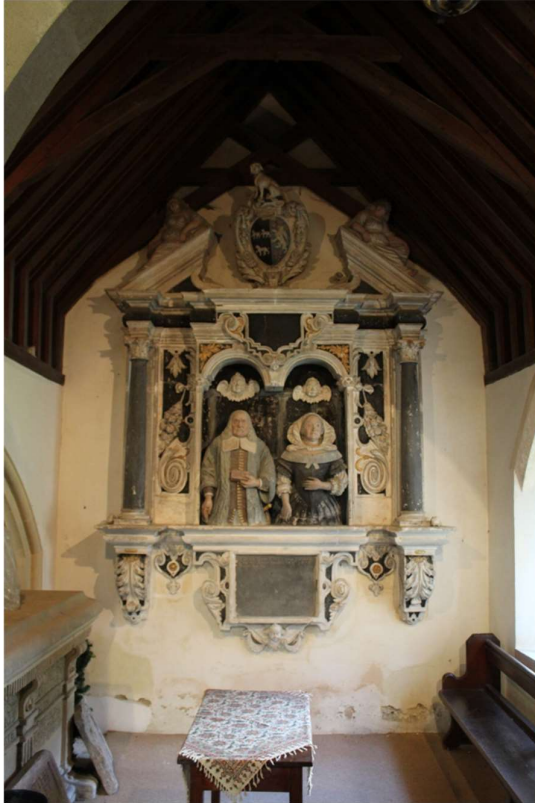
Figure 32 Before conservation 2021

Wet cleaning was carried out towards the end of the consolidation phase. In conjunction with the consolidation of fragile paint layers, additional cleaning trials were undertaken to the painted surfaces where the surfaces were considered sound. Two cleaning solutions were selected, the first being a V & A Mix (50% white spirit / 50% deionised water with a drop of Synperonic A7) and for more stubborn deposits a solution of 3-5% Vulpex in deionised water was used. These were both applied on cotton wool swabs and exceptionally fine meshed fabric wipes in a controlled manner. So as not to over saturate the delicate surfaces any excess was wiped away with cotton swabs and the cleaned surfaces neutralised with a further wipe of deionised water and dried with a cotton wool swab.

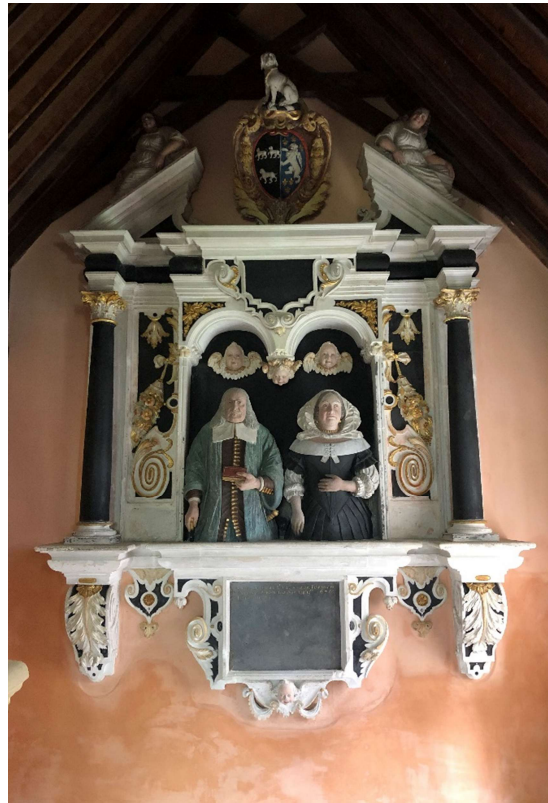
Figure 33 After conservation 2022

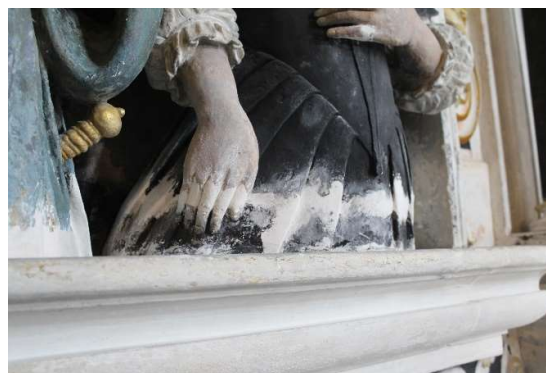
Figure 37 Lady Anne's right hand during conservation work

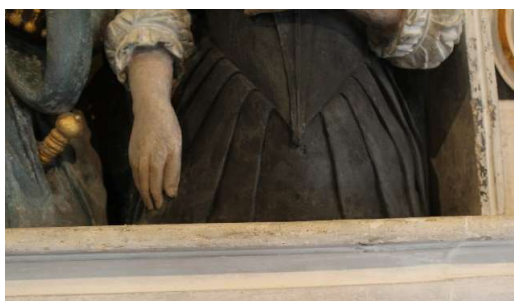
Figure 38 Lady Anne's right hand after conservation work

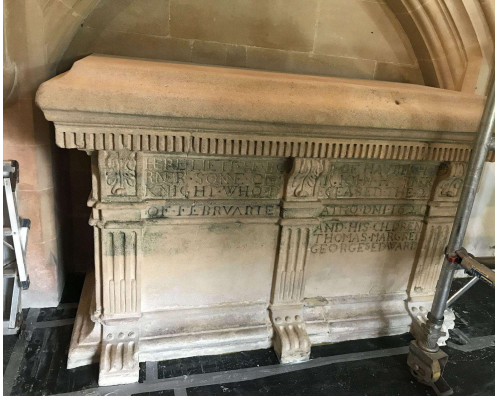
Figure 60 Before treatment

Initially dry cleaning was undertaken - the use of soft brushes in conjunction with extraction by a vacuum loosened any surface dirt. Once clear of any surface dirt, the monument was cleaned using a variety of bristled brushes in warm deionised water; this proved highly effective and was enough to eradicate the appearance of the scratch marks to the top of the monument. During the first clean particular care was taken to the areas where there appeared to be the remains of a green pigment as mentioned in the original SSHC condition survey/ treatment report 2020 (paint analysis later showed there to be no traces of pigment to this residue and was identified as being biological). With the identification of the green substance being identified as being biological the tomb was cleaned again.

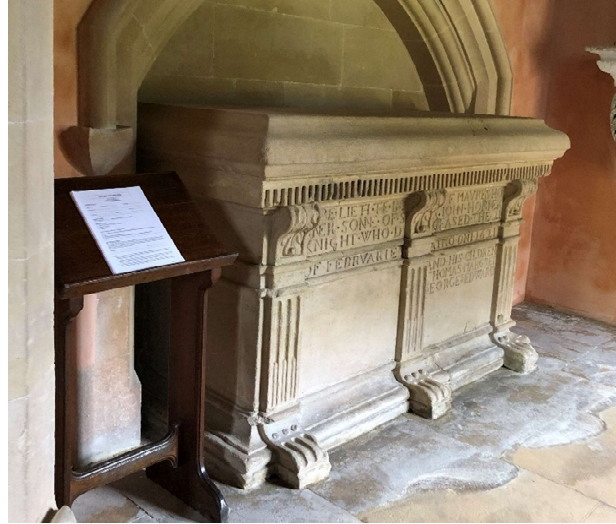
Figure 61 After treatment

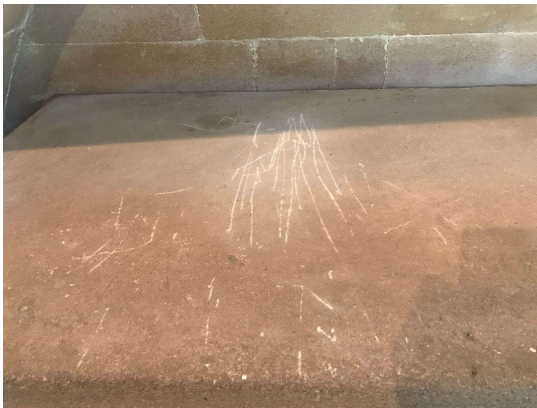
Figure 62 Before treatment

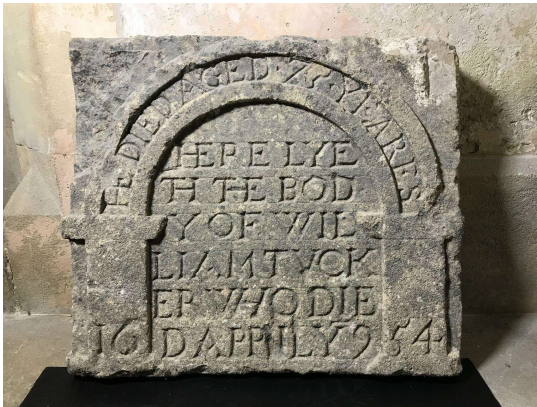
Figure 64 Image to show before treatment

Dry cleaning with the use of soft bristled brushes in conjunction with extraction by a Hoover worked to loosen any surface dirt as an initial treatment. Once clear of any surface deposits, the monument was cleaned using warm deionised water applied through a variety of bristled brushes to agitate any remaining deposits to the stone. This proved to be effective and achieved the desired level of surface clean.

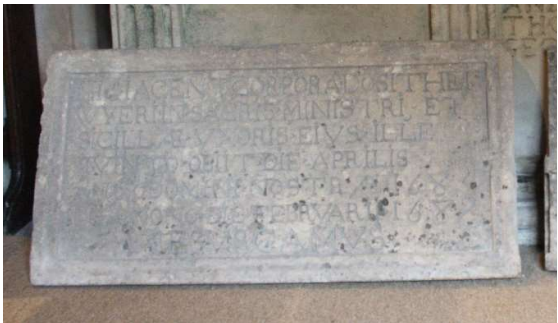
Figure 66 Image to show monument before treatment

Dry cleaning with the use of soft bristled brushes in conjunction with extraction by a Hoover worked to loosen any surface dirt as an initial treatment. Once clear of any surface deposits, the monument was cleaned using warm deionised water applied through a variety of bristled brushes to agitate any remaining deposits to the stone. This proved effective and achieved the desired level of surface clean.

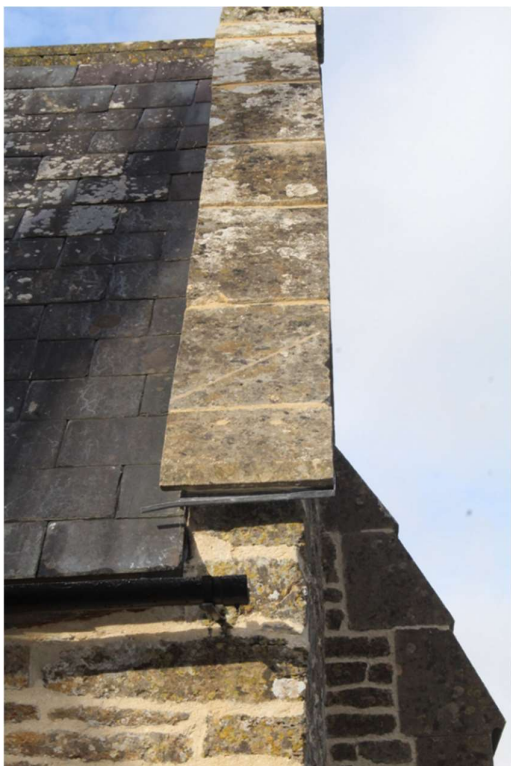
Figure 68 The east coping 45 degree cut in the dry

- 45-degree angle cut – installed to move the rain run-off on to the slate roof and into the gutter before it reaches the end of the coping. The effectiveness of the 45-degree cut made in the east side copings strengthens the case for deciding to implement this cut into the west coping.
- Lead tray - built into the joint beneath the kneeler to catch any drips. These drips are then channelled again onto the slate roof and into the gutter below. Very heavy rain will shoot over these interventions and should clear the base of the chapel.

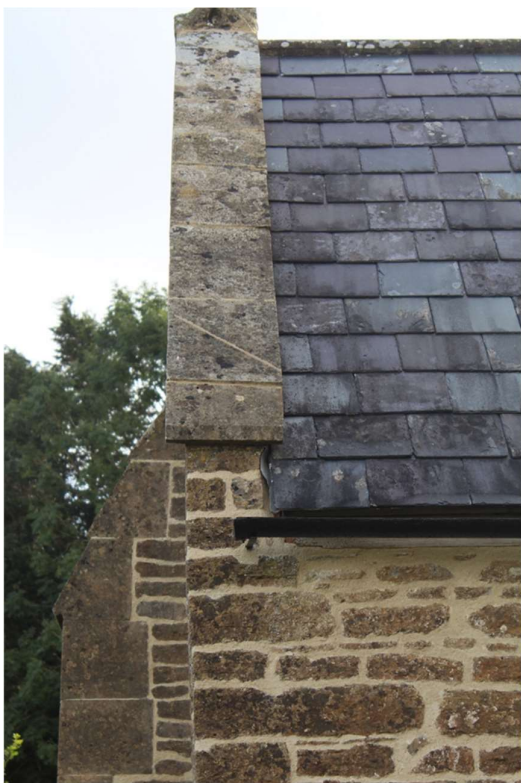
Figure 70 The east coping 45 degree cut

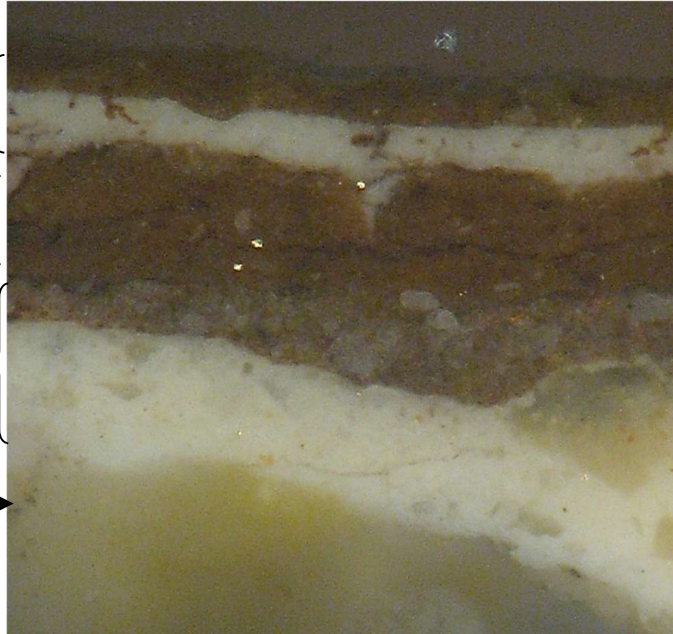
SAMPLE 3

Man's hand

Showing pink of 2<sup>nd</sup> scheme  
tinted with vermilion

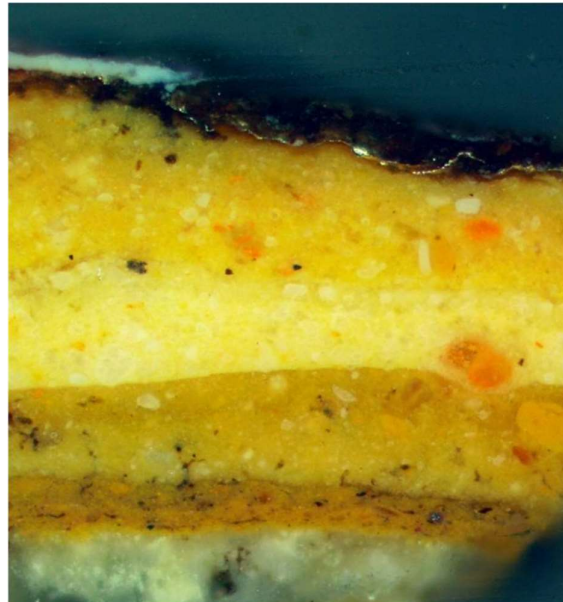
Fragment (ii) With later white repaints  
pink/brown layer used to  
cover silver at time of first  
repaint

Tarnished silver leaf

upper ground layers  
with distinctive lumps of red  
lead & lead white

lower ground layers  
mostly ochre

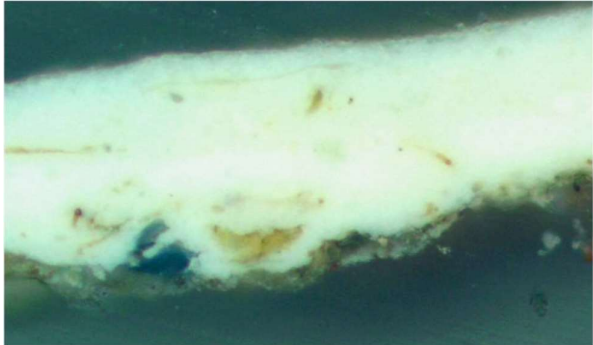
Fragment (ii) In this piece the later white repaints are over the remains of a thin layer of pure red iron oxide

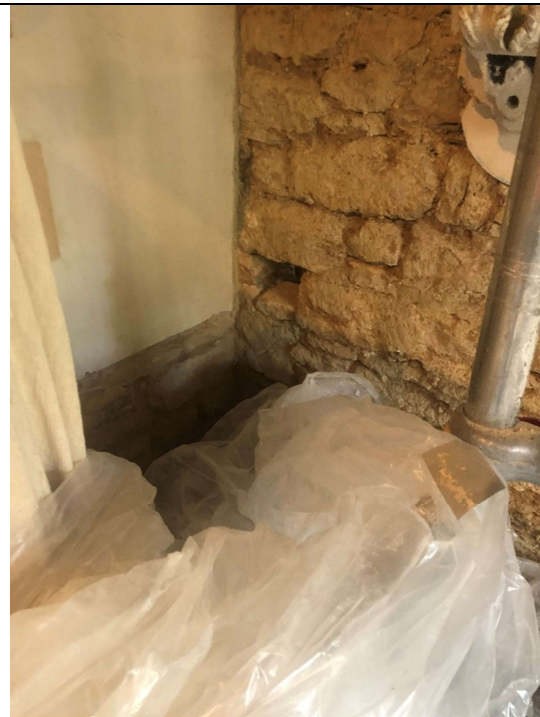
Figure 91 Interior north-west lower putlog hole
