**NEVILLE HALL
FREELANCE ARCHAEOLOGIST & CONSULTANT**

AN ARCHAEOLOGICAL WATCHING BRIEF AT
THE CHURCH OF ST. ANDREW, FIRSBY ROAD,
HALTON HOLEGATE, LINCOLNSHIRE.

PREPARED FOR THE HALTON HOLEGATE PAROCHIAL CHURCH COUNCIL

March 2025

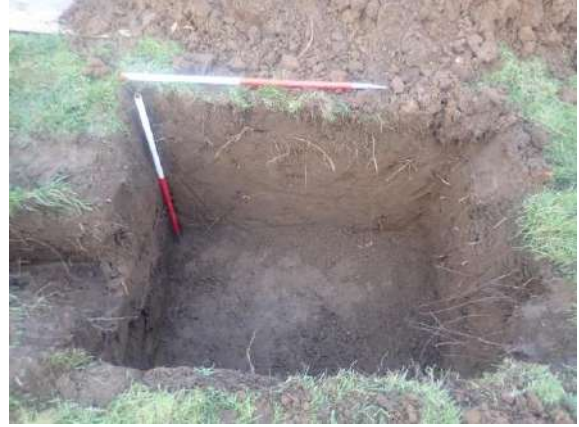
Plate 164: Representative Section 20, from the south

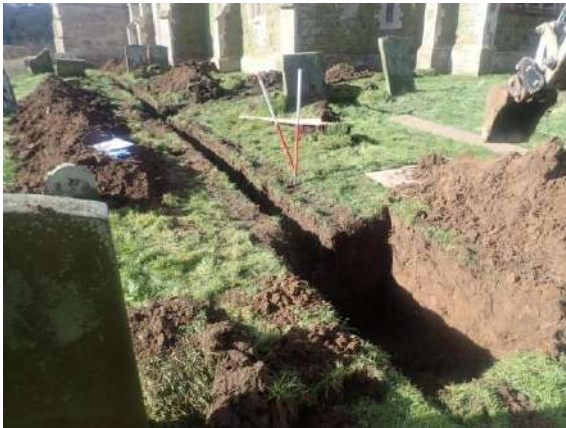
Plate 162: Excavation of the second soakaway, from the east

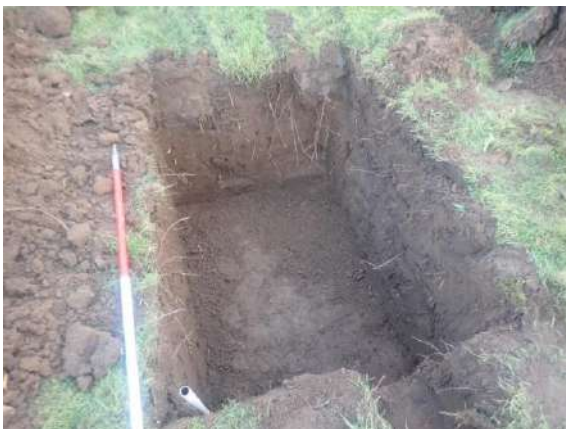
Plate 163: Excavation of the second soakaway, from the west
