# SECTION I - SCHEDULE OF WORK

- 1.01 The works described in this schedule form the main contract for the repairs to the cemetery Chapels at Keynsham. This schedule is written as a description of the method and sequence of repair. This schedule is based on the site survey carried out by use of a cherry picker. Certain elements have been assumed as a full opening up was not possible. Additional provisional items of repair are included at the end of this schedule as provisional sums to be directed or omitted during the course of the contract.

KEYNSHAM
CEMETRY CHAPEL

# Structural Report

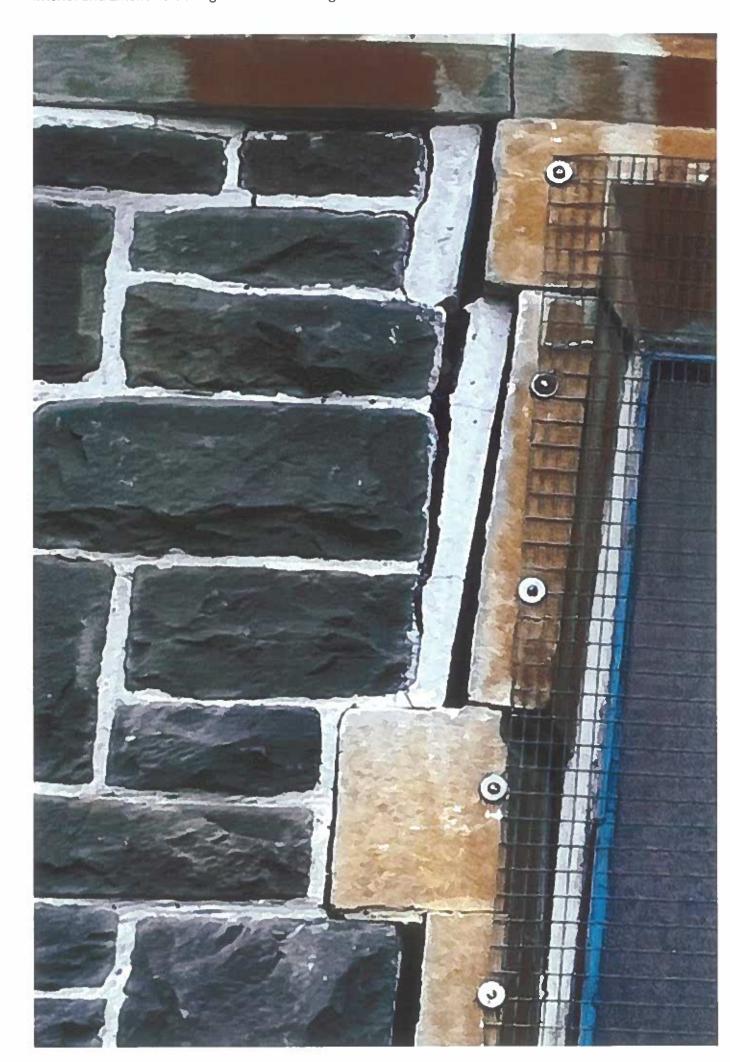
Photo of East Elevation cracking November 2022

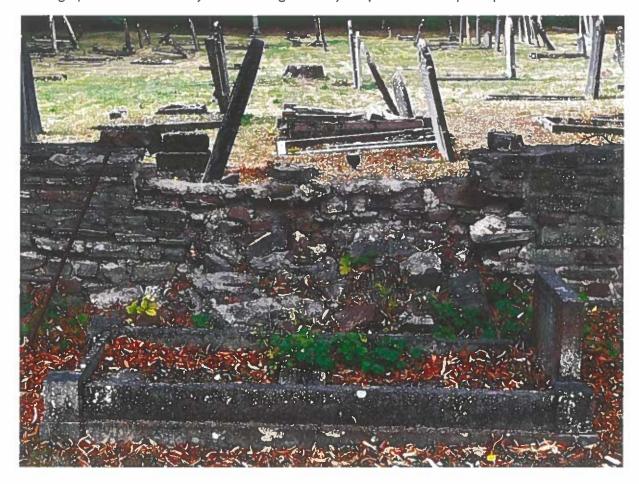
Photographs of the boundary wall needing one major repair and two spot repairs.

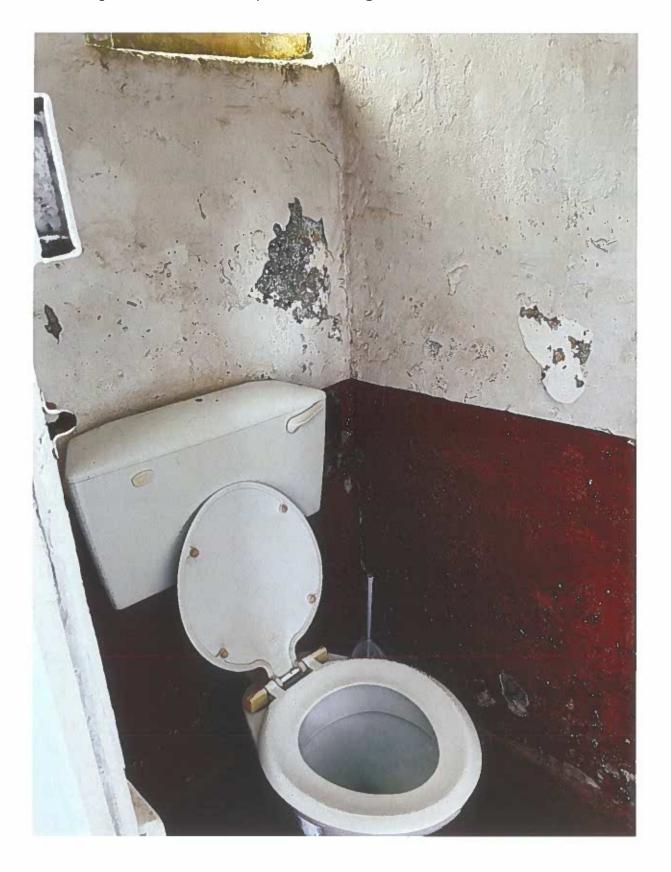
Photos August 2025 of toilet used by visitors including wall that could take a corner washbasin

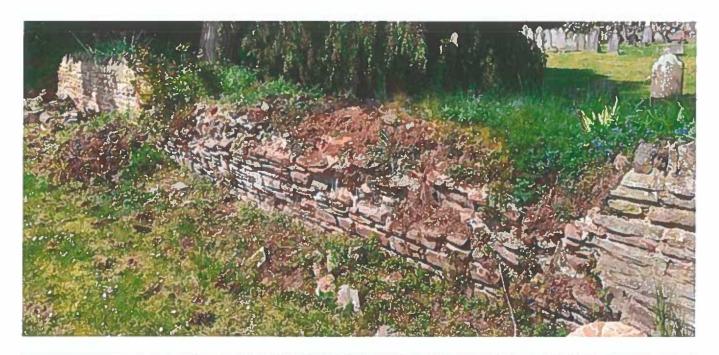
Above: The norther boundary wall onto Durley Lane showing areas of loose and falling stonework Below left: The entrance gate pier and low stone wall showing the open joint between the two Below right: The low wall to the side of the drive showing signs of partial collapse.

junction between the RHS pier and stone wall has an open joint indicating some settlement in the structure. Further south this boundary is formed with a split chestnut fence.
