**Conservation report for the reredos, communion rail,
candlesticks, vestry door, exterior chancel east wall, pinnacles and
coping stones**

**All Saints Church, Mackworth
Diocese of Derby**

July 2017

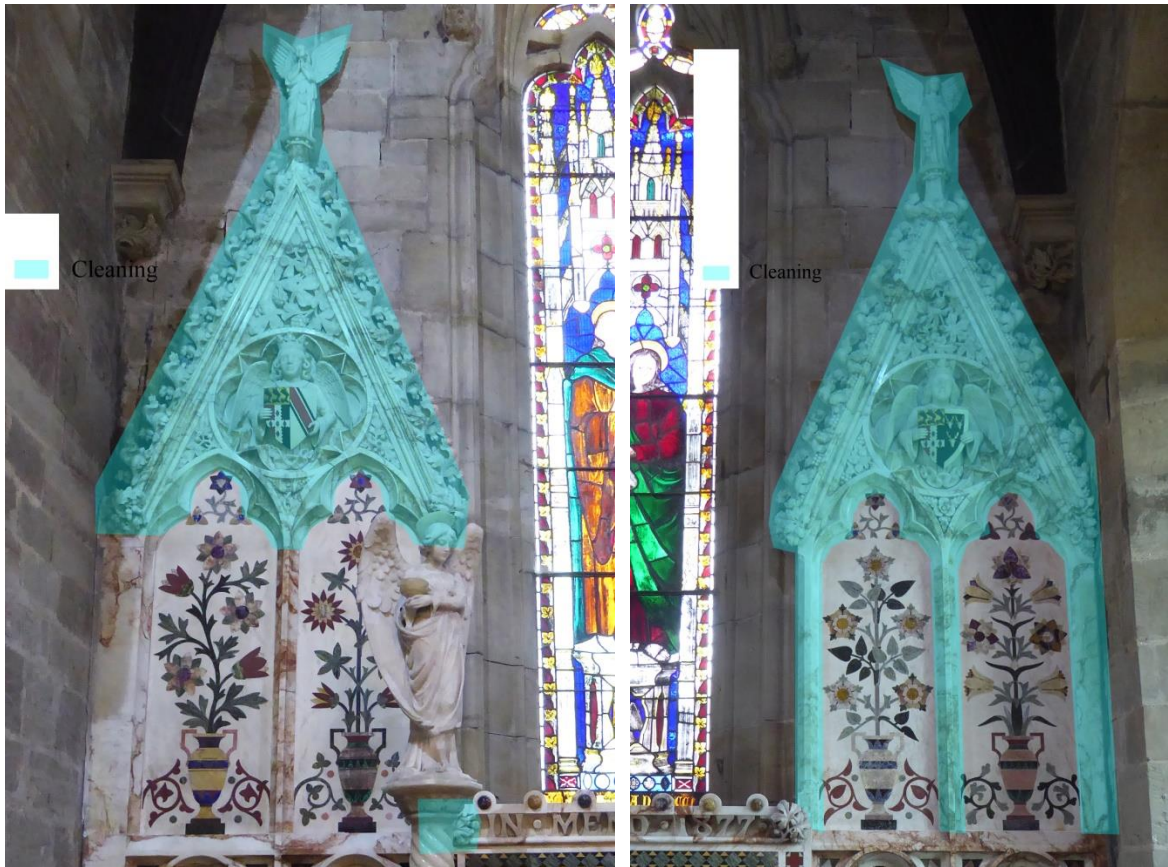
Figure 5 Location of cleaned areas to reredos

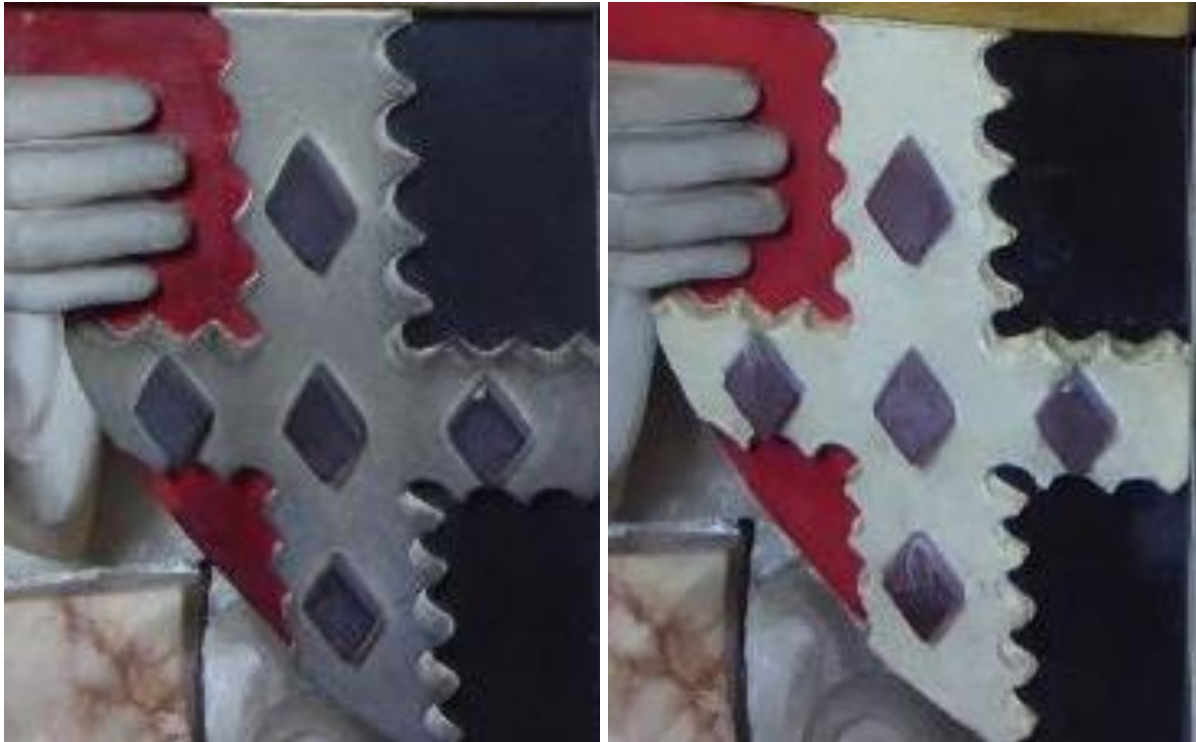
The two polychromed shields to the upper sections were cleaned in the same way as the rest of the alabaster.

Figure 7 Detail of the polychromed shield before and after cleaning

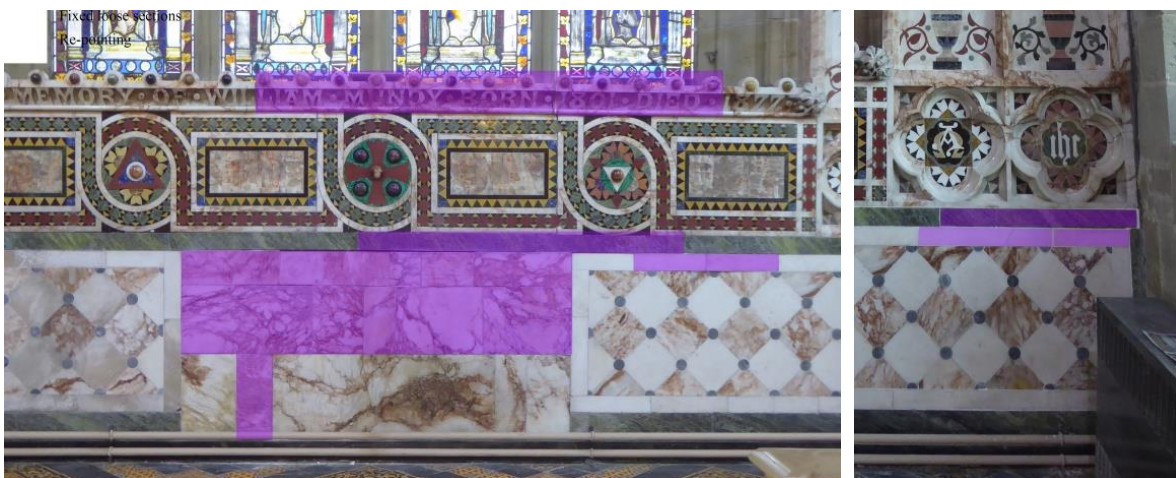
Some of the stone blocks of the reredos had moved forward due to the corrosion and expansion of the ferrous cramps used during its construction. See condition report for a more detailed description and location of the displaced blocks and metal cramps (page 9, 16 and Appendix C in the condition report).

There were three areas where blocks were dismantled: upper and lower sections to the central area and lower section to the right side, as viewed.

Figure 8 Location of dismantled blocks to reredos

Three large blocks of alabaster were removed from the upper section of the central area. They were loose and no metal cramps or rods were found in two of the three blocks. The two blocks located to the sides were pinned to the adjacent lateral blocks and all three blocks were also pinned to the lower row of blocks with stainless steel rods and polyester resin³. The alabaster blocks were relocated, bedded in gypsum with no aggregates.

Two green marble blocks and twelve alabaster blocks were dismantled to the lower central section of the reredos. The rusted iron cramps and most of the cement based mortar used for their fixing to the wall were removed. See Appendix B for mortar analysis results. The blocks were fixed to the wall with stainless steel rods and polyester resin. The stone blocks were relocated, bedded in gypsum with no aggregates.

A large green marble block and two alabaster blocks to the right lower section of the reredos, as viewed, were carefully dismantled. The rusted iron cramps were removed and replaced for stainless steel rods fixed to the wall and stone with polyester resin. The stone blocks were relocated, bedded in gypsum with no aggregates.

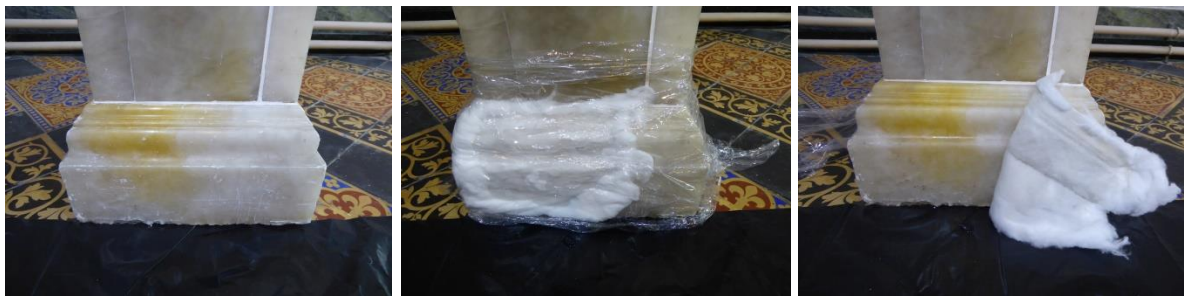
Some trials were performed to reduce the ferrous stain to the surface of the alabaster. Poultices of EDTA, ammonium carbonate, tri-ammonium citrate, hydrogen peroxide and sodium hydrosulphite were tried but staining was not reduced.

Figure 24 Trials to reduce the ferrous stains to the alabaster surface

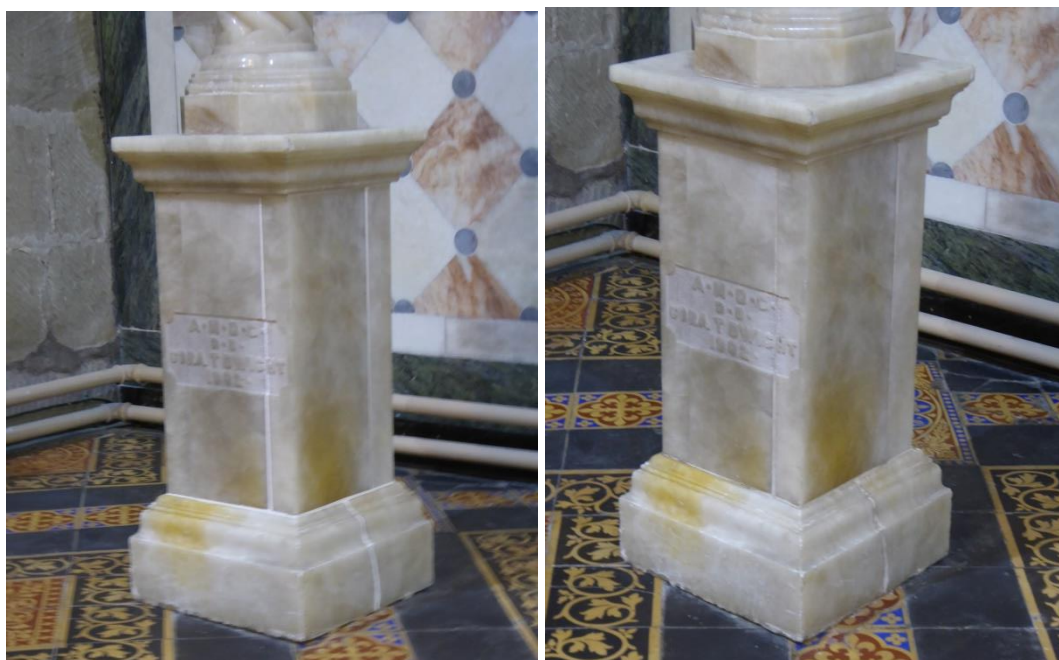
Figure 25 New pointing before and after the colour retouching

The new pointing was also toned down as in the reredos with water colours.

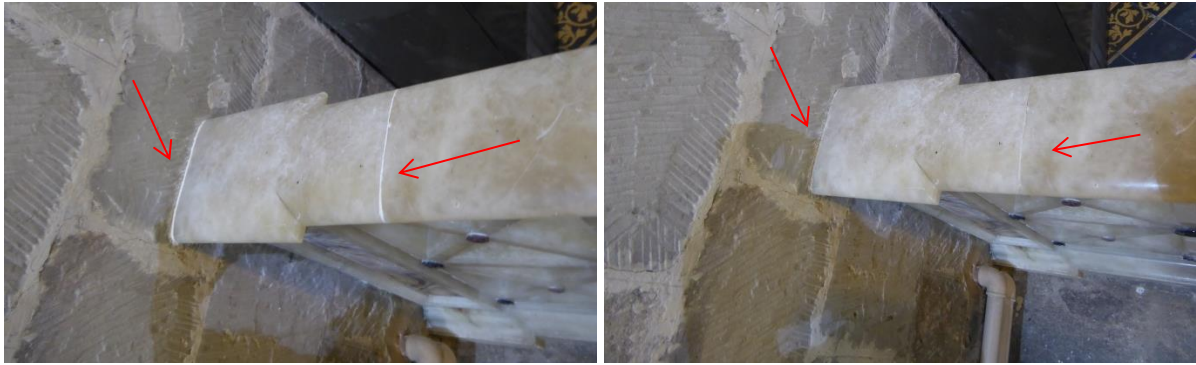
Figure 28 Pointing before and after toning down with water colours

The treatment consisted of the removal and replacement of these iron cramps with stainless steel cramps, fixed with polyester resin. The alabaster block was relocated, bedded in gypsum without aggregates. The same material was used for pointing, toned down with water colours.

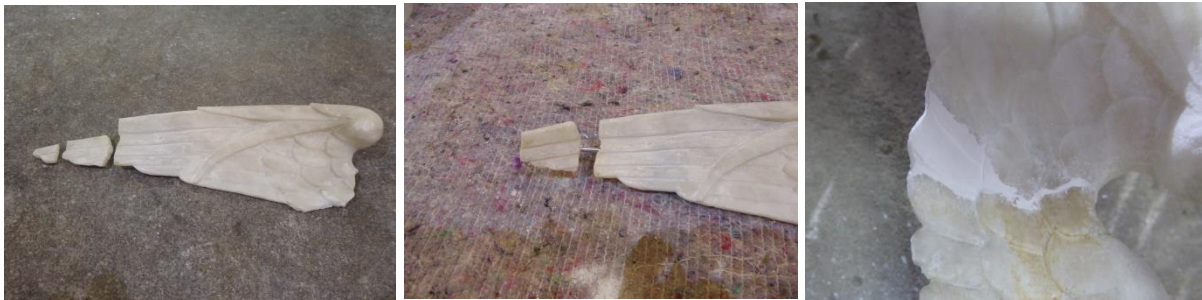
Figure 31 Pinning and re-fixing angel wing

The pieces were cleaned and pinned together. The wing was double pinned and fixed with polyester resin to the angel. The crack and a small missing section were filled with gypsum. Finally the gypsum was toned down with water colours.

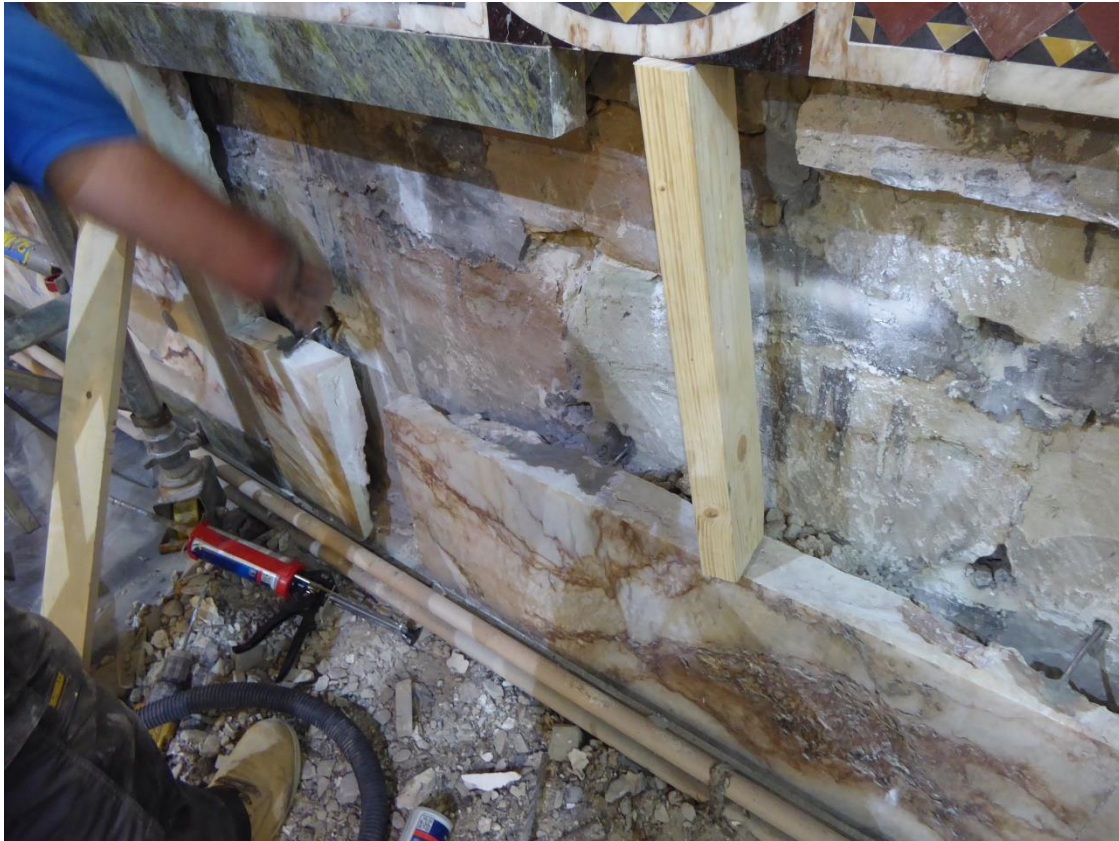
Figure 53 Fixing the alabaster blocks to the wall

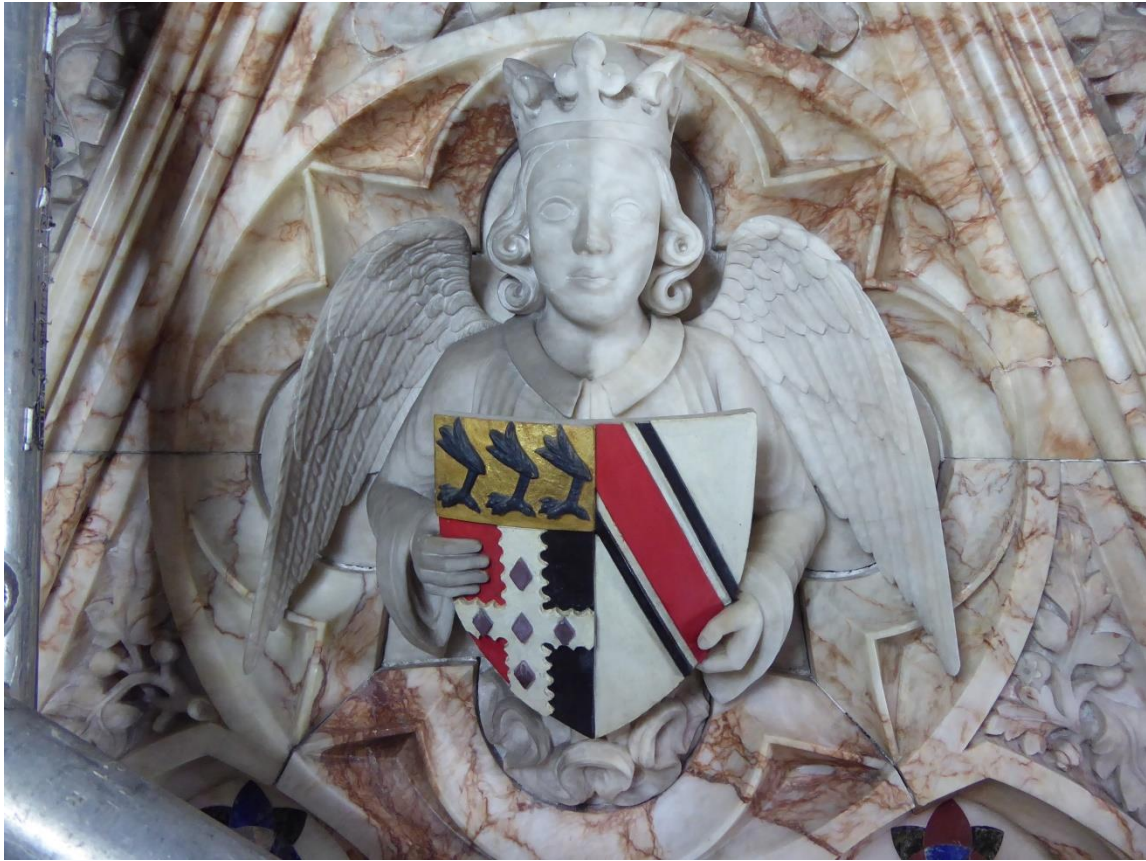
Figure 57 Cleaning of upper section to reredos

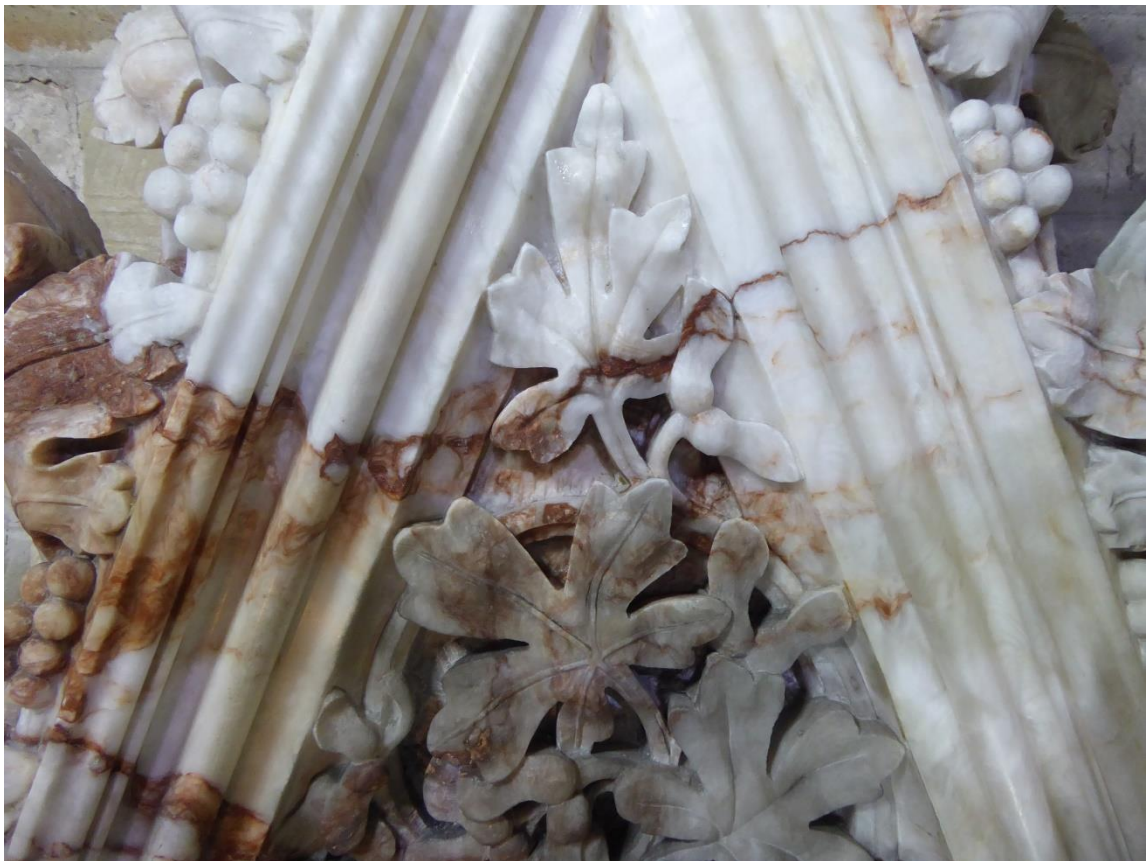
Figure 58 Cleaning of upper section to reredos

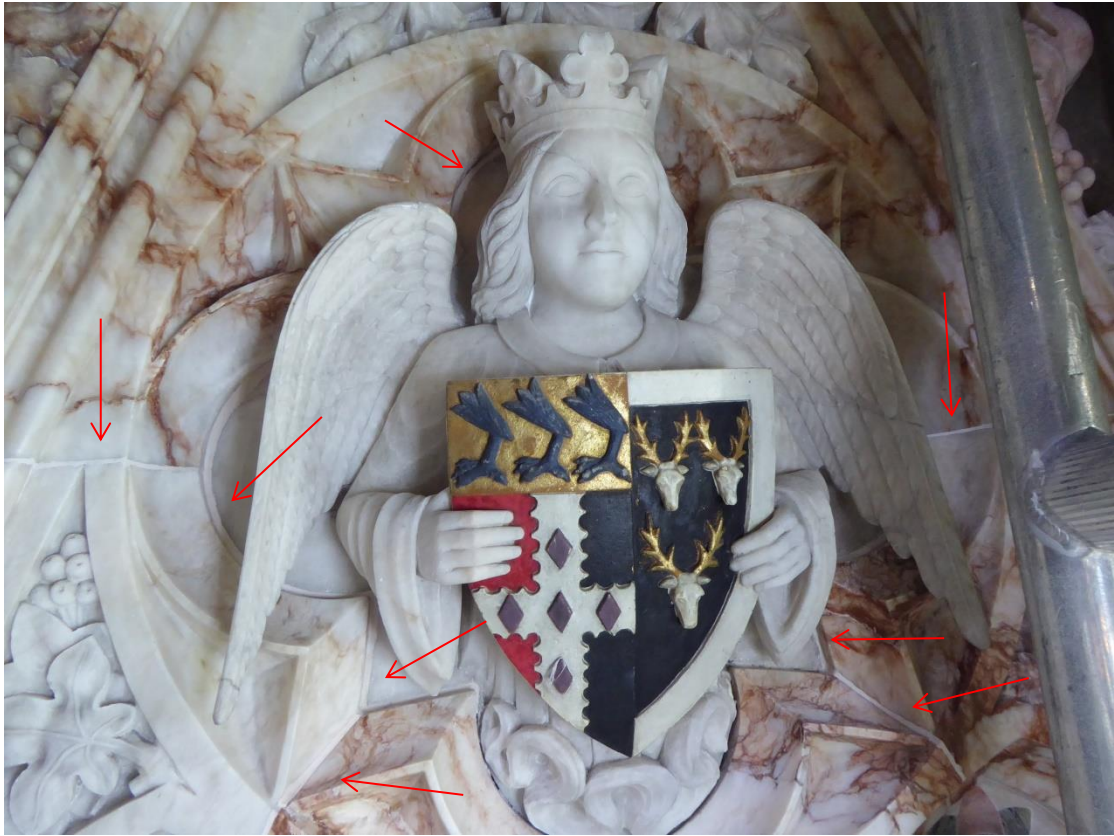
Figure 61 New pointing to reredos

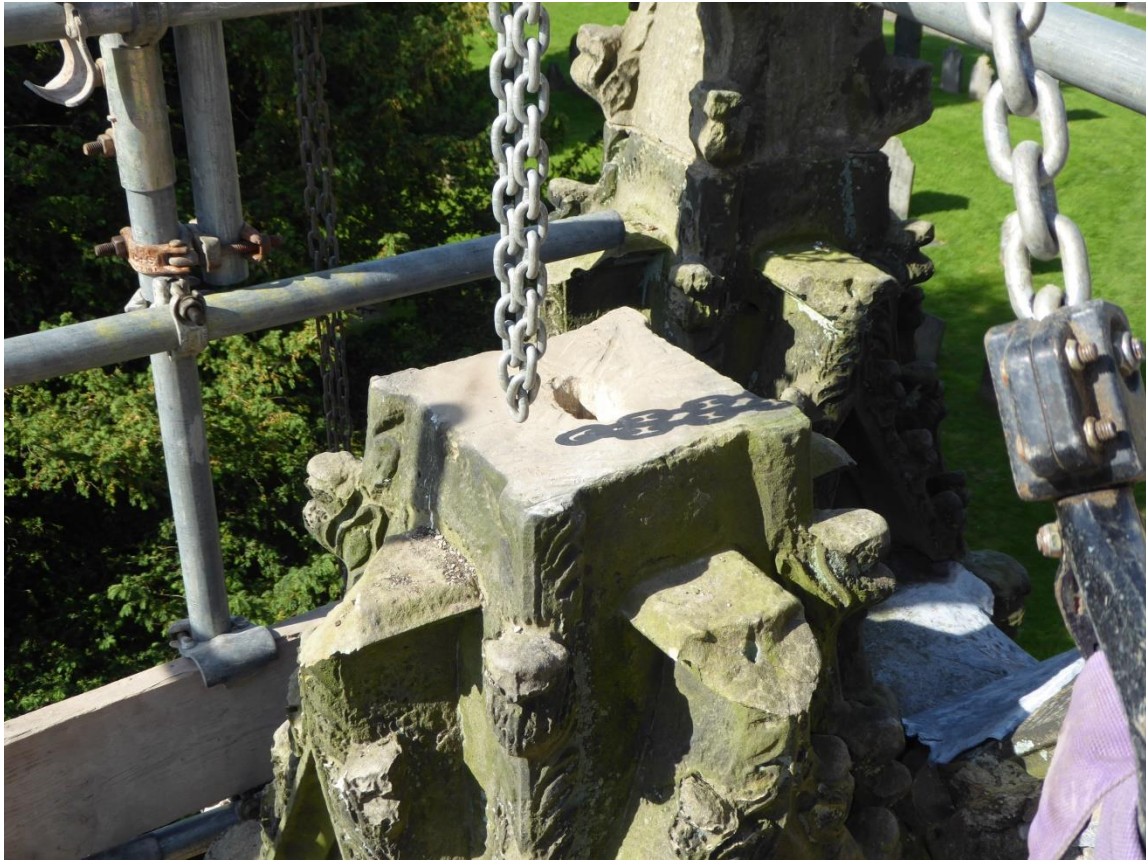
Figure 81 Cleaning of joint from previous mortars and resins

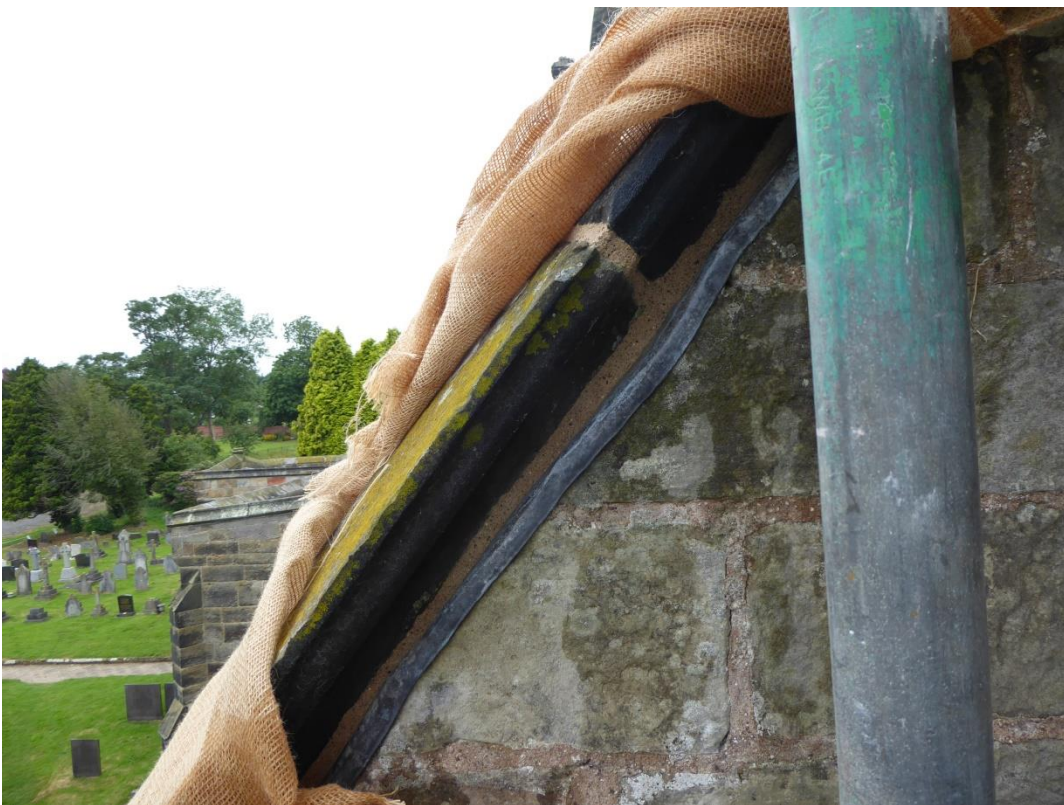
Figure 84 Pointing base coat to coping stones

The joints gaps were filled where possible with pieces of slate. A base coat of lime mortar [NHL 3.5 and sharp sand (1:3)], was applied, followed by a top coat of lime mortar, [NHL 3.5, sieved sharp sand and sharp sand (1:2:1)]. They were all protected with hessian to prevent cracks and quick drying.
